APPENDIX 1

NASSCO PIPELINE ASSESSMENT CERTIFICATION
PROGRAM (PACP)

APPENDIX 2

MCAS Beaufort Stormwater Repair (Existing Conditions)

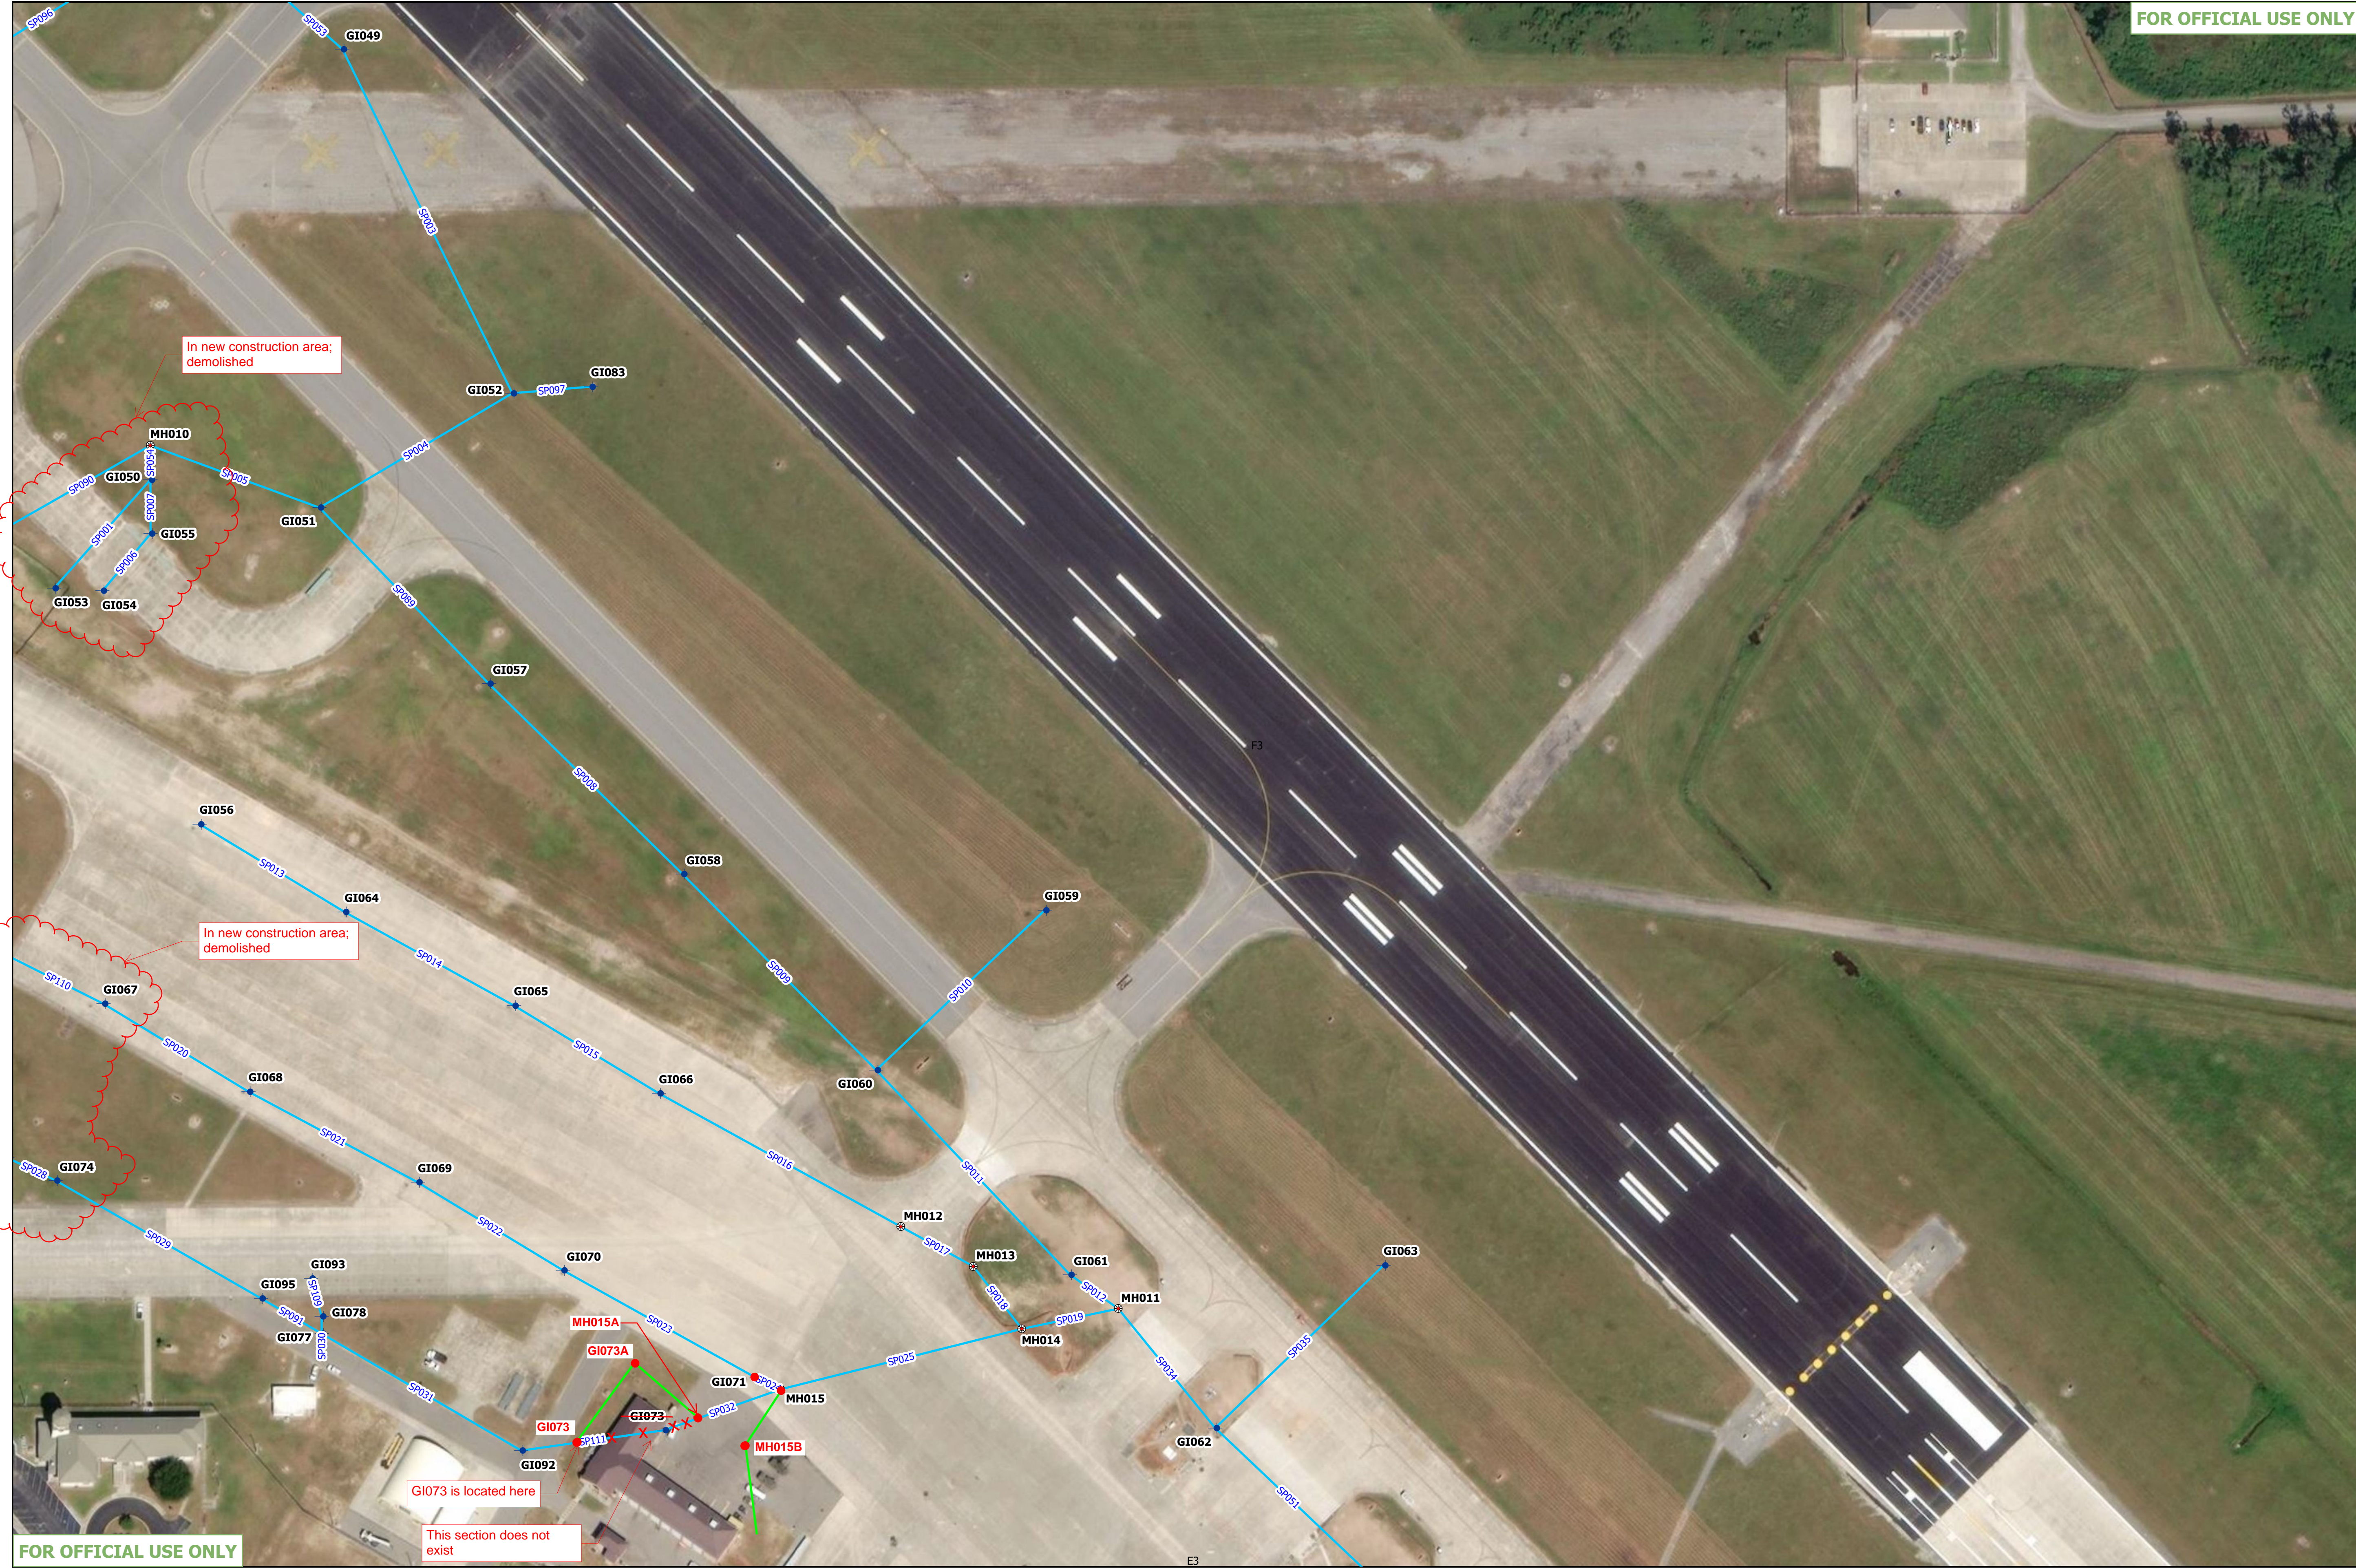
GI073 is located here

This section does not exist

In new construction area; demolished
