# **CITY OF COLUMBIA**

**PROJECT: BID020-20-21-LAG - Lower Saluda River Relief Sewer and Pipe Rehabilitation (SS7428) CDBE**

## **ADDENDUM No. 2**

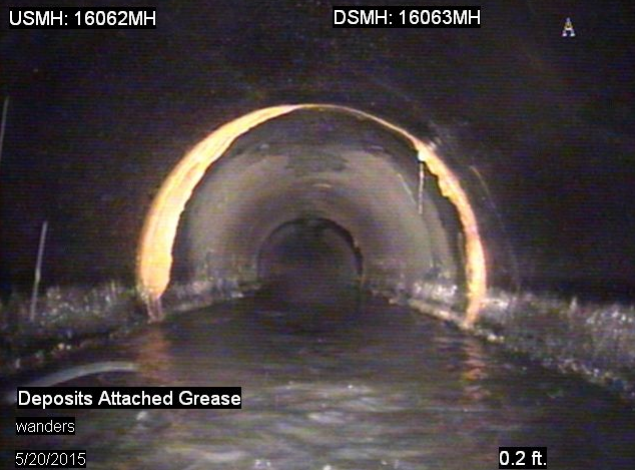
Distance	Fault Observation	Time	Picture
0.2	<p><b>Deposits Attached Grease</b>  <b>Position: 8 To 4</b>  <b>Severity: None</b>  <b>Cont Defect: S01</b>  <b>Percent: 5</b>  <b>Attention Required</b>  <b>Remarks: wanders</b>  <b>Maint Weight: 2</b></p>	04:33

<p>USMH: 16062MH DSMH: 16063MH</p> <p>Deposits Attached Grease wanders 5/20/2015 0.2 ft.</p>

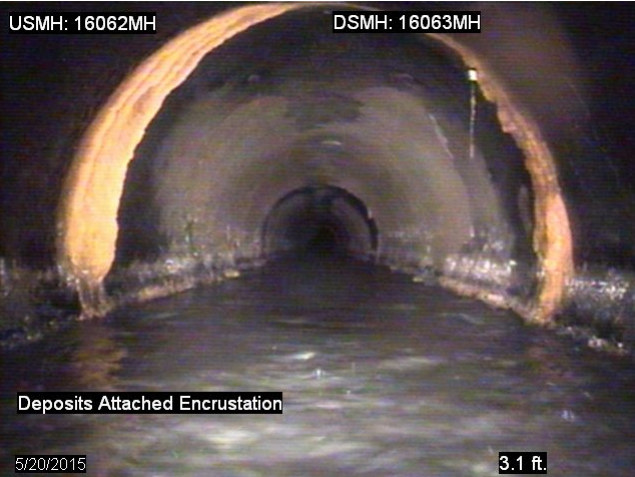
3.1	<p><b>Deposits Attached Encrustation</b>  <b>Position: 8 To 4</b>  <b>Severity: None</b>  <b>Percent: 10</b>  <b>Joint</b>  <b>Attention Required</b>  <b>Maint Weight: 2</b></p>	05:43

<p>USMH: 16062MH DSMH: 16063MH</p> <p>Deposits Attached Encrustation 5/20/2015 3.1 ft.</p>

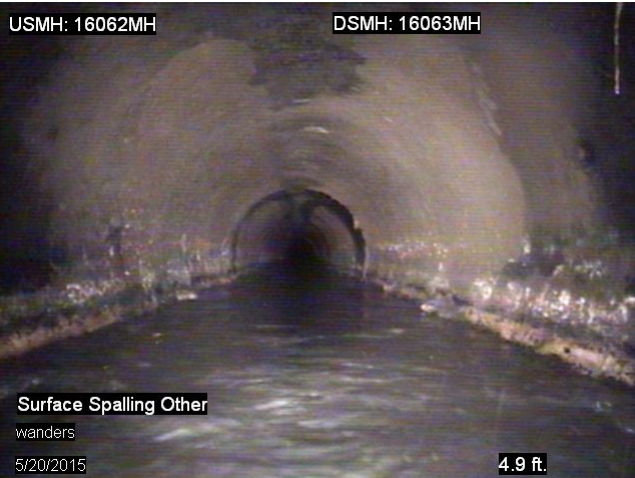
4.9	<p><b>Surface Spalling Other</b>  <b>Position: 8 To 4</b>  <b>Severity: None</b>  <b>Cont Defect: S02</b>  <b>Percent: 0</b>  <b>Attention Required</b>  <b>Remarks: wanders</b>  <b>Struct Weight: 2</b></p>	06:49

<p>USMH: 16062MH DSMH: 16063MH</p> <p>Surface Spalling Other wanders 5/20/2015 4.9 ft.</p>

(4.9) SSSZ - Surface Spalling Other - Position: 8 To  
4 - Cont Def: S02 Remark: wanders

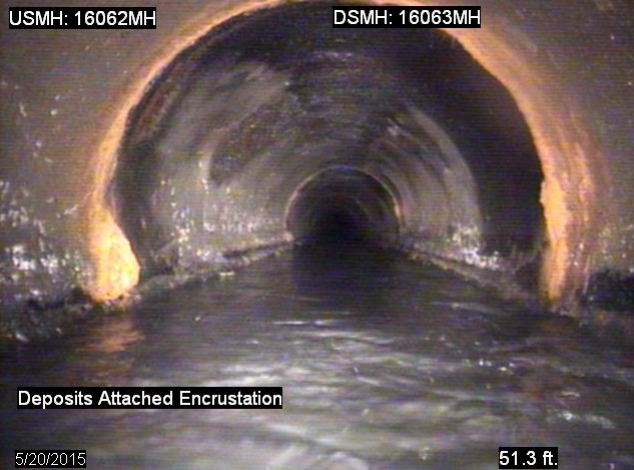
Distance	Fault Observation	Time	Picture
51.3	<p>Deposits Attached Encrustation Position: 8 To 4 Severity: None Percent: 5 Joint Attention Required Maint Weight: 2</p>	12:04

<p>USMH: 16062MH DSMH: 16063MH</p> <p>Deposits Attached Encrustation</p> <p>5/20/2015 51.3 ft.</p>
53.1	<p>Deposits Settled Other Position: 6 Severity: None Cont Defect: S03 Percent: 5 Attention Required Remarks: under water Maint Weight: 2</p>	13:16

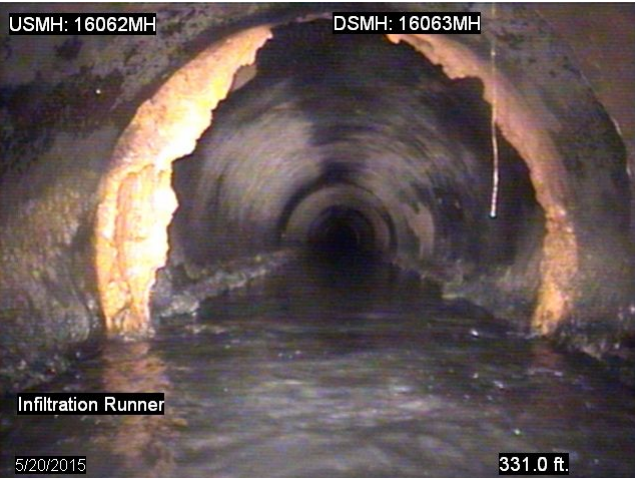
<p>USMH: 16062MH DSMH: 16063MH</p> <p>Infiltration Runner</p> <p>5/20/2015 331.0 ft.</p>

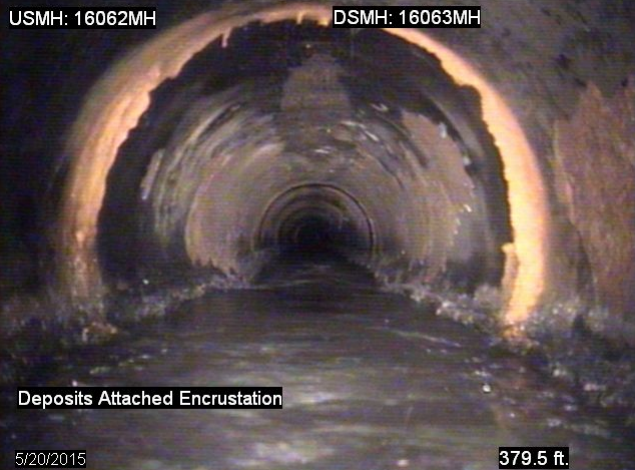
Distance	Fault Observation	Time	Picture
379.5	<b>Deposits Attached Encrustation</b> <b>Position: 8 To 4</b> <b>Severity: None</b> <b>Percent: 5</b> <b>Joint</b> <b>Attention Required</b> <b>Maint Weight: 2</b>	40:42

<p>USMH: 16062MH DSMH: 16063MH</p> <p>Deposits Attached Encrustation</p> <p>5/20/2015 379.5 ft.</p>

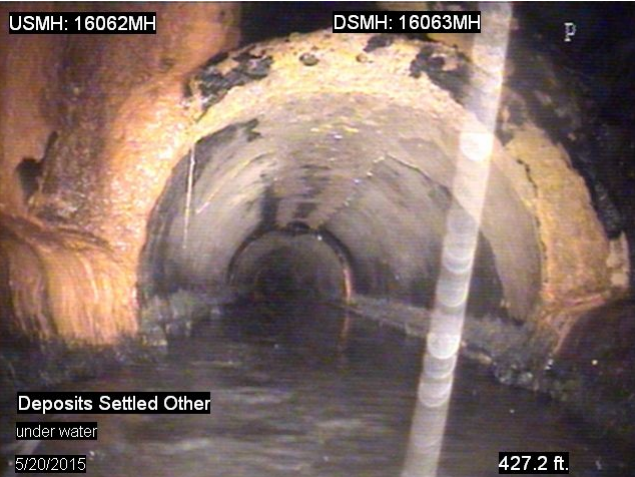
427.2	<b>Deposits Settled Other</b> <b>Position: 6</b> <b>Severity: None</b> <b>Cont Defect: F03</b> <b>Percent: 5</b> <b>Attention Required</b> <b>Remarks: under water</b> <b>Maint Weight: 2</b>	42:55

<p>USMH: 16062MH DSMH: 16063MH</p> <p>Deposits Settled Other</p> <p>under water</p> <p>5/20/2015 427.2 ft.</p>

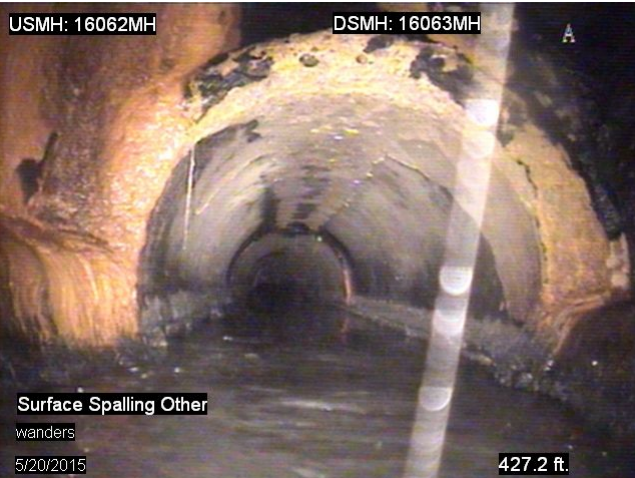
427.2	<b>Surface Spalling Other</b> <b>Position: 8 To 4</b> <b>Severity: None</b> <b>Cont Defect: F02</b> <b>Percent: 0</b> <b>Attention Required</b> <b>Remarks: wanders</b> <b>Struct Weight: 2</b>	43:11

<p>USMH: 16062MH DSMH: 16063MH</p> <p>Surface Spalling Other</p> <p>wanders</p> <p>5/20/2015 427.2 ft.</p>

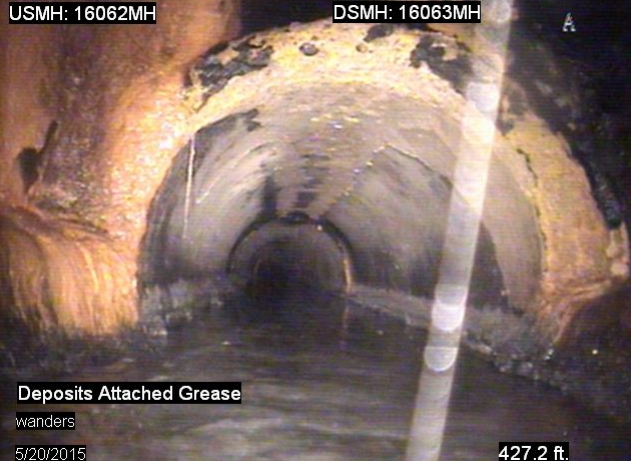
Distance	Fault Observation	Time	Picture
427.2	<p><b>Deposits Attached Grease</b>  <b>Position: 8 To 4</b>  <b>Severity: None</b>  <b>Cont Defect: F01</b>  <b>Percent: 5</b>  <b>Attention Required</b>  <b>Remarks: wanders</b>  <b>Maint Weight: 2</b></p>	43:24

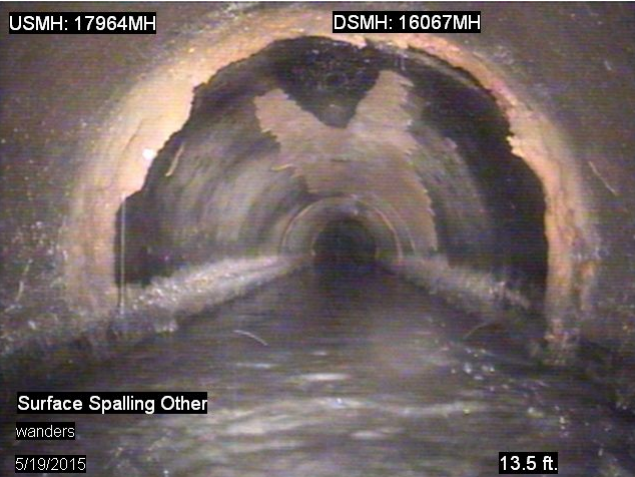
13.5	<p><b>Surface Spalling Other</b>  <b>Position: 9 To 4</b>  <b>Severity: None</b>  <b>Cont Defect: S01</b>  <b>Percent: 0</b>  <b>Attention Required</b>  <b>Remarks: wanders</b>  <b>Struct Weight: 2</b></p>	04:50

<p>USMH: 17964MH DSMH: 16067MH</p> <p>Surface Spalling Other</p> <p>wanders</p> <p>5/19/2015 13.5 ft.</p>

(13.5) SSSZ - Surface Spalling Other - Position: 9  
To 4 - Cont Def: S01 Remark: wanders

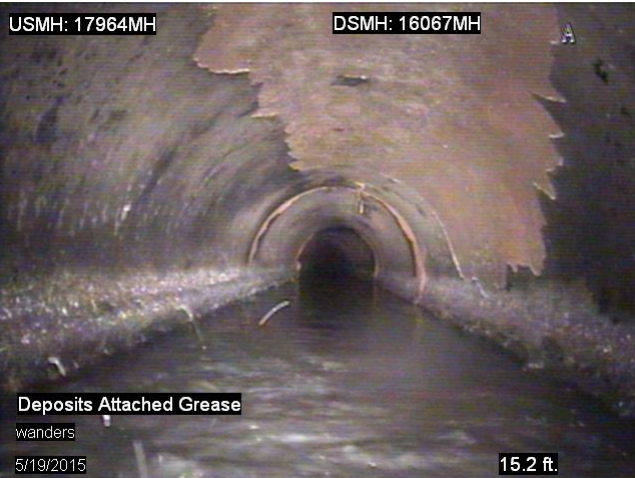
15.2	<p><b>Deposits Attached Grease</b>  <b>Position: 8 To 4</b>  <b>Severity: None</b>  <b>Cont Defect: S02</b>  <b>Percent: 5</b>  <b>Attention Required</b>  <b>Remarks: wanders</b>  <b>Maint Weight: 2</b></p>	05:58

<p>USMH: 17964MH DSMH: 16067MH</p> <p>Deposits Attached Grease</p> <p>wanders</p> <p>5/19/2015 15.2 ft.</p>

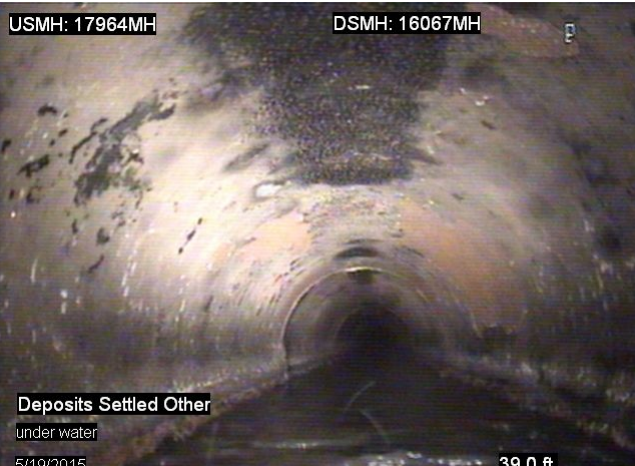
39.0	<b>Deposits Settled Other</b> <b>Position: 6</b> <b>Severity: None</b> <b>Cont Defect: S03</b> <b>Percent: 5</b> <b>Attention Required</b> <b>Remarks: under water</b> <b>Maint Weight: 2</b>	10:35

<p>USMH: 17964MH DSMH: 16067MH</p> <p>Deposits Settled Other</p> <p>under water</p> <p>5/19/2015 39.0 ft.</p>

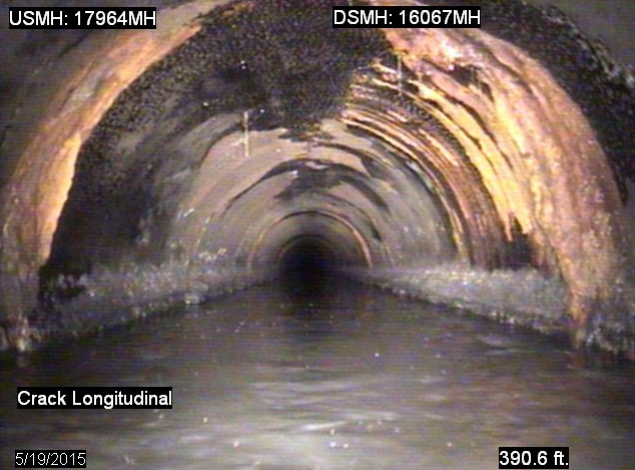
Distance	Fault Observation	Time	Picture
390.6	<p><b>Crack Longitudinal</b>  <b>Position: 12</b>  <b>Severity: None</b>  <b>Percent: 0</b>  <b>Attention Required</b>  <b>Struct Weight: 2</b></p>	39:54

(390.6) CL - Crack Longitudinal - Position: 12

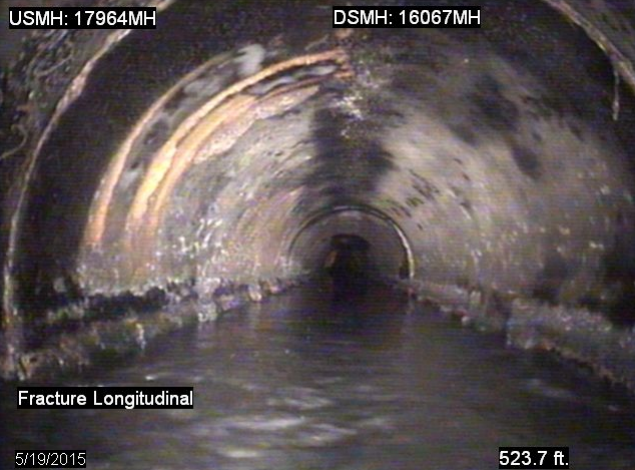
Distance	Fault Observation	Time	Picture
523.7	<b>Fracture Longitudinal</b> <b>Position: 12</b> <b>Severity: None</b> <b>Percent: 0</b> <b>Joint</b> <b>Attention Required</b> <b>Struct Weight: 3</b>	52:38

<p>USMH: 17964MH DSMH: 16067MH</p> <p>Fracture Longitudinal</p> <p>5/19/2015 523.7 ft.</p>
523.7	<b>Deposits Attached Encrustation</b> <b>Position: 8 To 12</b> <b>Severity: None</b> <b>Percent: 5</b> <b>Attention Required</b> <b>Maint Weight: 2</b>	53:10

(523.7) FL - Fracture Longitudinal - Position: 12

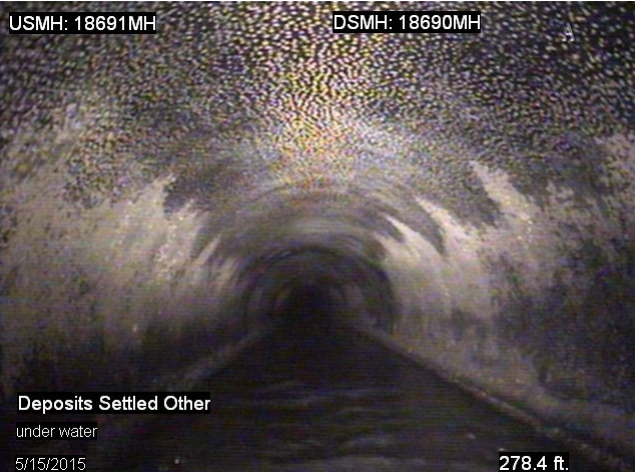
278.4	<b>Deposits Settled Other</b> <b>Position: 6</b> <b>Severity: None</b> <b>Cont Defect: S02</b> <b>Percent: 10</b> <b>Attention Required</b> <b>Remarks: under water</b> <b>Maint Weight: 2</b>	26:53

<p>USMH: 18691MH DSMH: 18690MH</p> <p>Deposits Settled Other</p> <p>under water</p> <p>5/15/2015 278.4 ft.</p>

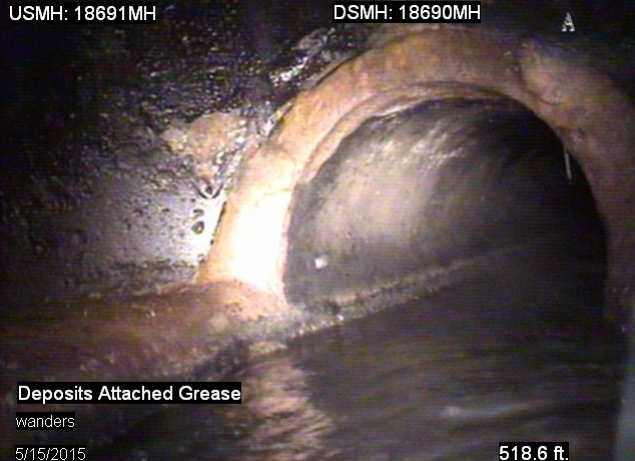
Distance	Fault Observation	Time	Picture
518.6	<p><b>Deposits Attached Grease</b>  <b>Position: 7 To 5</b>  <b>Severity: None</b>  <b>Cont Defect: F01</b>  <b>Percent: 5</b>  <b>Attention Required</b>  <b>Remarks: wanders</b>  <b>Maint Weight: 2</b></p>	44:18

<p>USMH: 18691MH DSMH: 18690MH A</p> <p>Deposits Attached Grease wanders 5/15/2015 518.6 ft.</p>

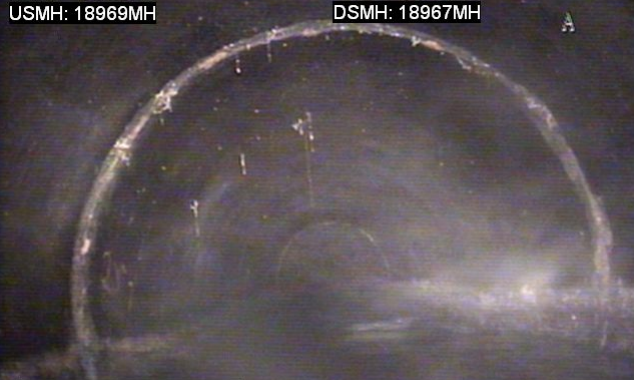
Distance	Fault Observation	Time	Picture
3.8	<b>Deposits Attached Grease</b> <b>Position: 8 To 4</b> <b>Severity: None</b> <b>Cont Defect: S01</b> <b>Percent: 5</b> <b>Attention Required</b> <b>Remarks: wanders</b> <b>Maint Weight: 2</b>	02:12

<p>USMH: 18969MH DSMH: 18967MH</p> <p><b>Deposits Attached Grease</b> wanders 5/14/2015 <b>3.8 ft.</b></p>

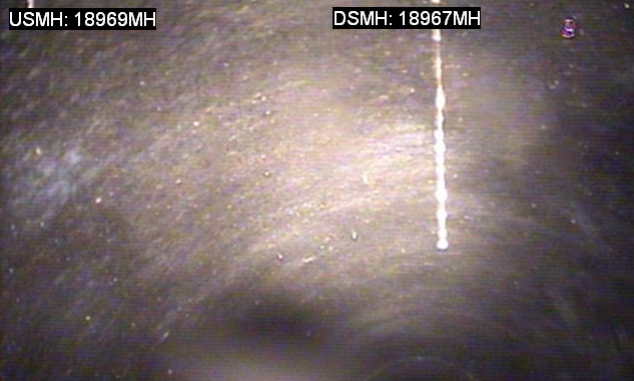
<p>USMH: 18969MH DSMH: 18967MH</p> <p><b>Obstacle Other</b> under water 5/14/2015 <b>7.8 ft.</b></p>

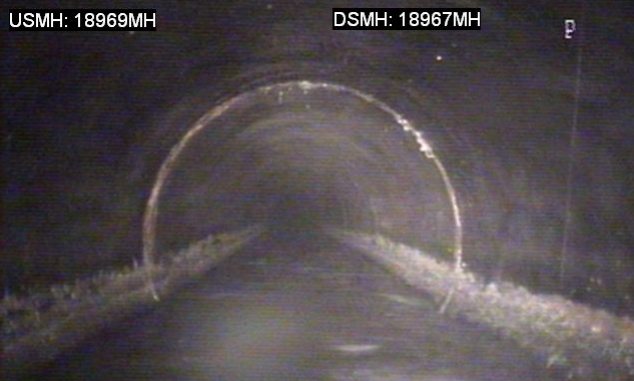
<p>USMH: 18969MH DSMH: 18967MH</p> <p><b>Deposits Settled Other</b> under water 5/14/2015 <b>13.0 ft.</b></p>

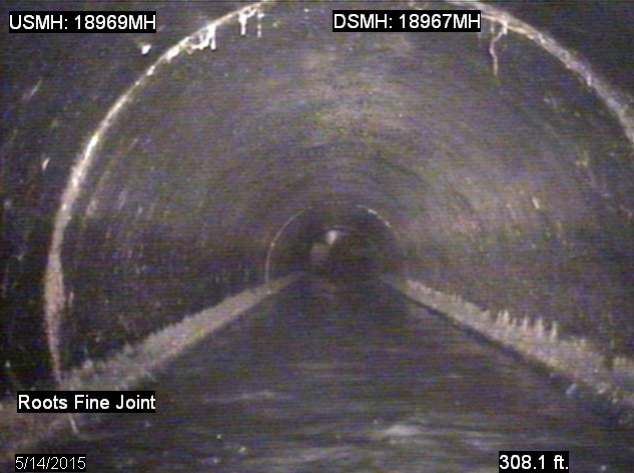
<p>USMH: 18969MH DSMH: 18967MH</p> <p>Roots Fine Joint</p> <p>5/14/2015 308.1 ft.</p>

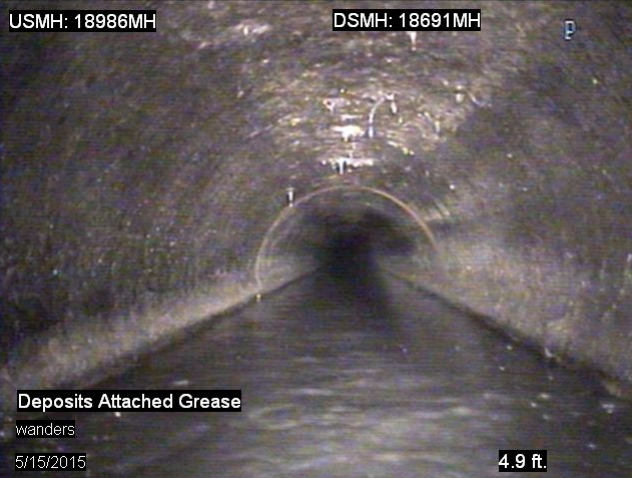
<p>USMH: 18986MH DSMH: 18691MH</p> <p>Deposits Attached Grease wanders 5/15/2015 4.9 ft.</p>
