Addendum No. 1

Tramore Interceptor Sewer Rehabilitation
Program No. S3037

Inspection Report

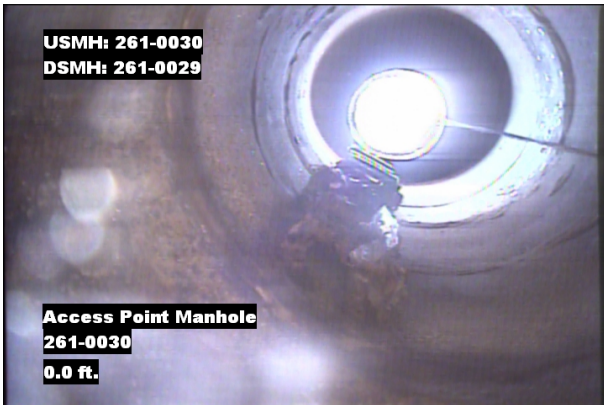
Photo: 261-0030_261-0029_AMH_0.0.jpg, VCR No.: 1
 0FT, Manhole

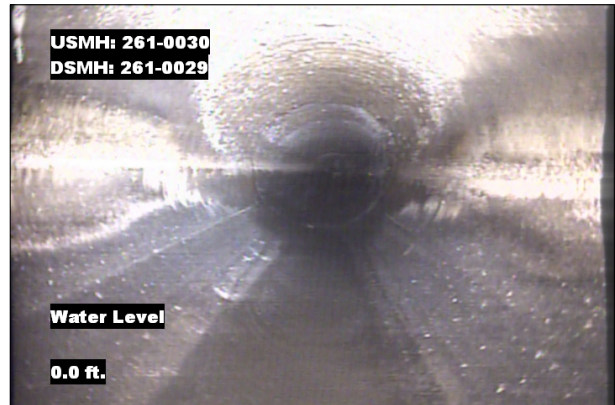
Photo: 261-0030_261-0029_MWL_0.0.jpg, VCR No.: 1
 0FT, Water Level, 5% of cross sectional area

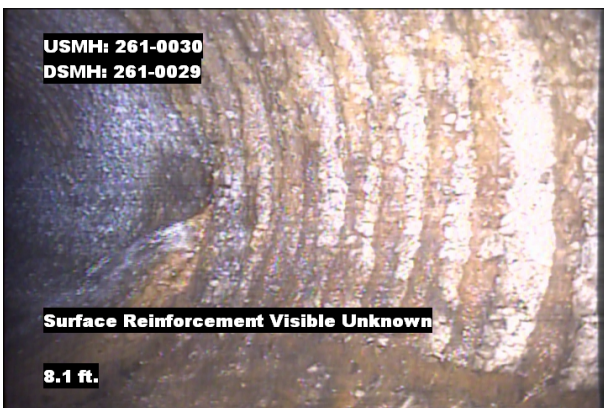
Photo: 261-0030_261-0029_SRVZ_8.1.jpg, VCR No.: 1
 8.1FT, Surface Reinforcement Visible Unknown, from 09 to
 03 o'clock, within 8 inches: YES

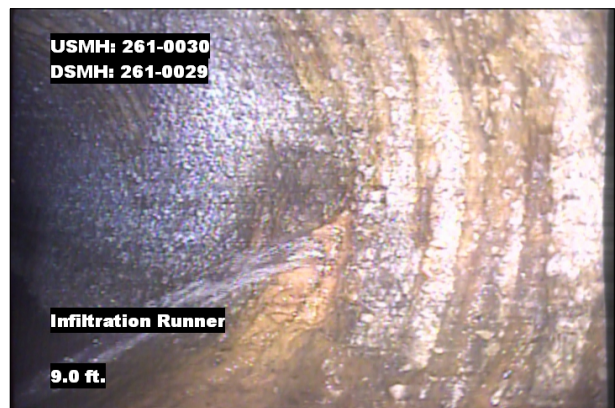
Photo: 261-0030_261-0029_IR_9.0.jpg, VCR No.: 1
 9FT, Infiltration Runner, at 02 o'clock, within 8 inches: YES

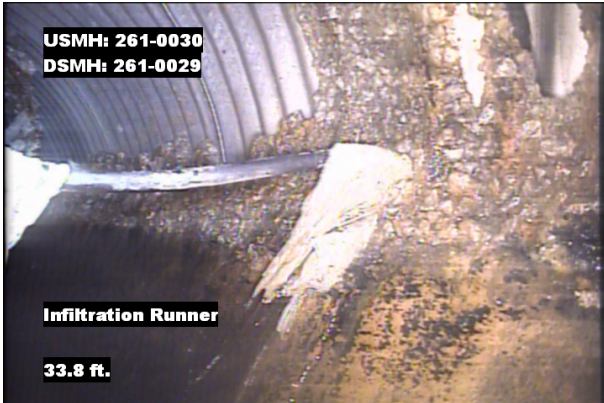
Photo: 261-0030_261-0029_IR_33.8.jpg, VCR No.: 1
 33.8FT, Infiltration Runner, at 02 o'clock, within 8 inches: YES

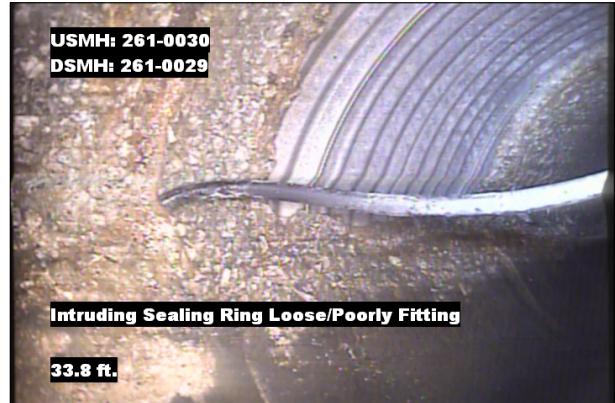
Photo: 261-0030_261-0029_ISSRL_33.8.jpg, VCR No.: 1
 33.8FT, Intruding Sealing Ring Loose/Poorly Fitting, 5% of cross sectional area, from 10 to 02 o'clock

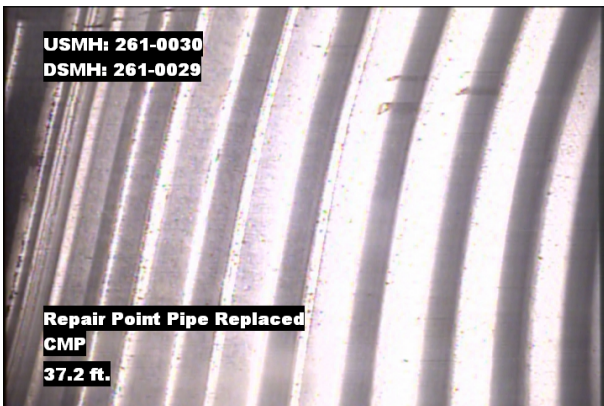
Photo: 261-0030_261-0029_RPR_37.2.jpg, VCR No.: 1
 37.2FT, Repair Pipe Replaced, within 8 inches: YES, REMARK: CMP

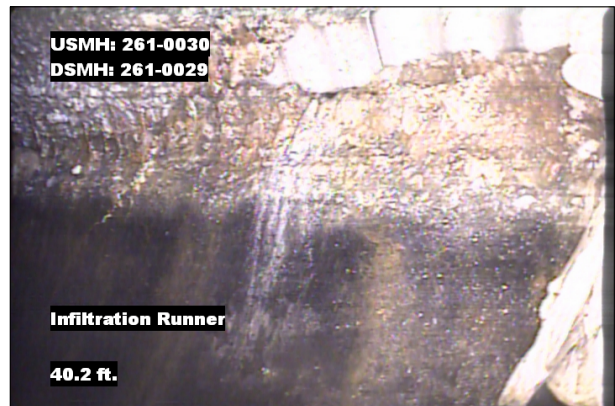
Photo: 261-0030_261-0029_IR_40.2.jpg, VCR No.: 1
 40.2FT, Infiltration Runner, at 03 o'clock, within 8 inches: NO

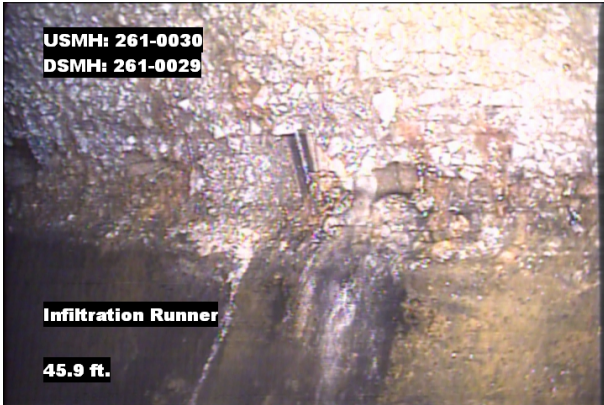
Photo: 261-0030_261-0029_IR_45.9.jpg, VCR No.: 1
 45.9FT, Infiltration Runner, at 03 o'clock, within 8 inches: YES

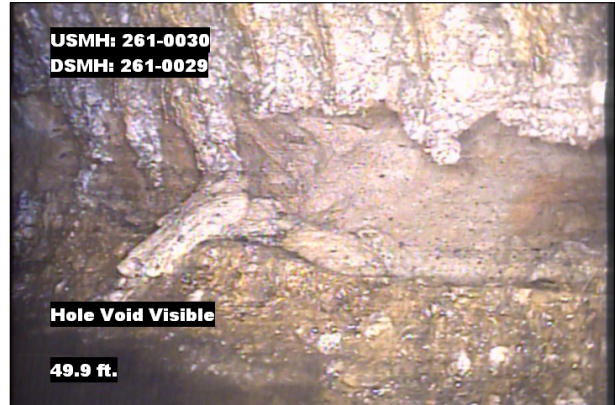
Photo: 261-0030_261-0029_HVV_49.9.jpg, VCR No.: 1
 49.9FT, Hole Void Visible, , at 02 o'clock, within 8 inches: NO

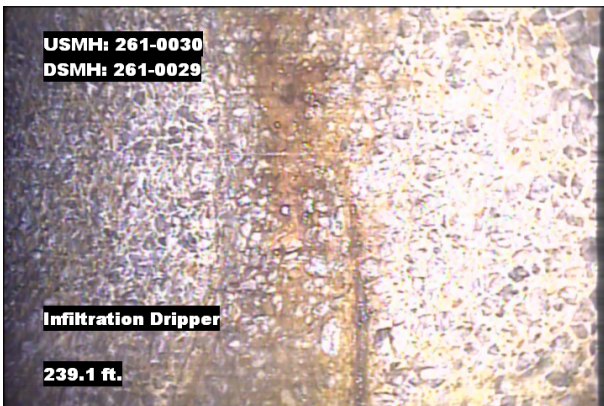
Photo: 261-0030_261-0029_ID_239.1.jpg, VCR No.: 1
 239.1FT, Infiltration Dripper, at 12 o'clock, within 8 inches: YES

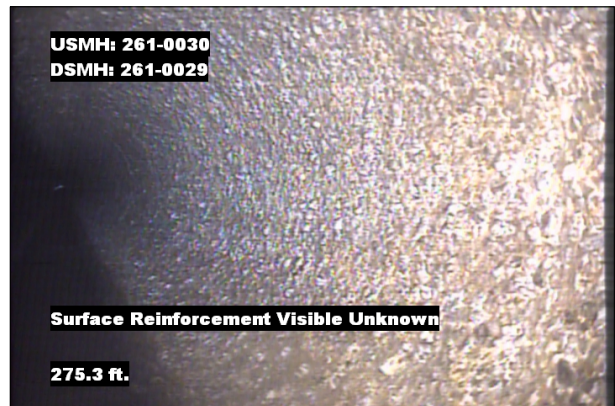
Photo: 261-0030_261-0029_SRVZ_275.3.jpg, VCR No.: 1
 275.3FT, Surface Reinforcement Visible Unknown, from 09 to 03 o'clock, within 8 inches: NO

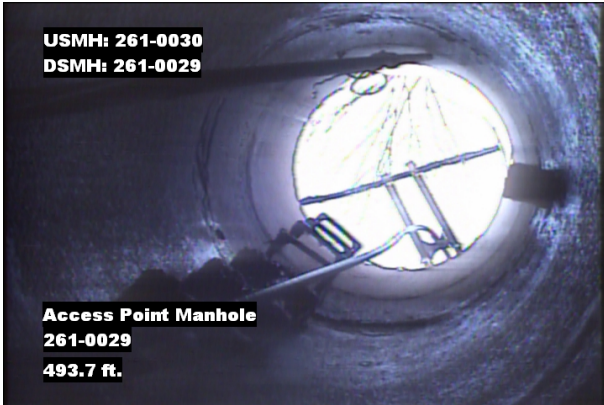
Photo: 261-0030_261-0029_AMH_493.7.jpg, VCR No.: 1
493.7FT, Manhole
