# **CITY OF COLUMBIA**

**PROJECT: BID020-20-21-LAG - Lower Saluda River Relief Sewer and Pipe Rehabilitation (SS7428) CDBE**

## **ADDENDUM No. 2**

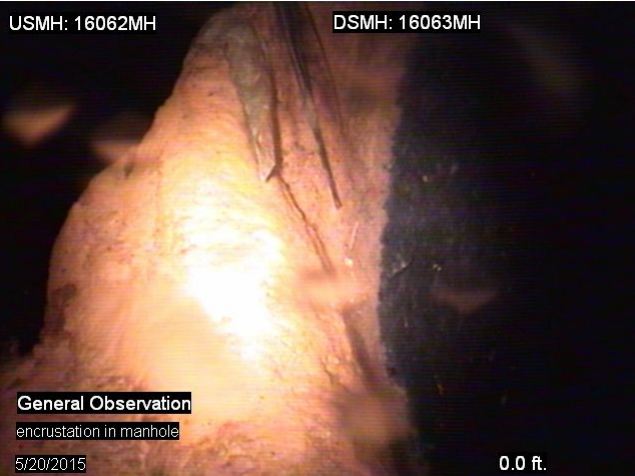
0.0	<p align="center"> <b>General Observation</b>  <b>Severity: None</b>  <b>Percent: 0</b>  <b>Attention Required</b>  <b>Remarks: encrustation in manhole</b> </p>	01:06

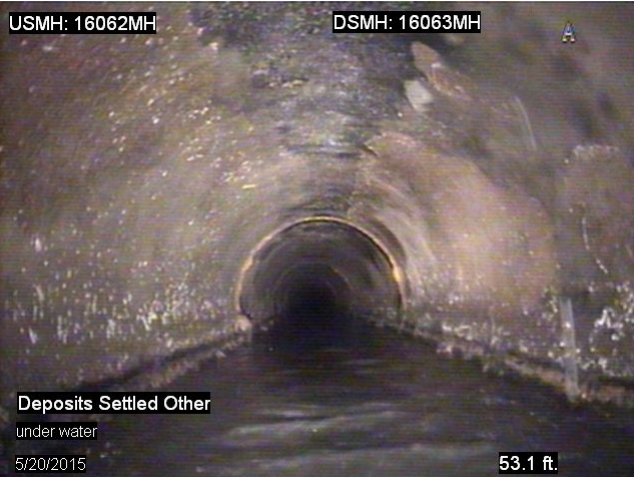
<p>USMH: 16062MH DSMH: 16063MH</p> <p>Deposits Attached Encrustation</p> <p>5/20/2015 51.3 ft.</p>
53.1	<p>Deposits Settled Other Position: 6 Severity: None Cont Defect: S03 Percent: 5 Attention Required Remarks: under water Maint Weight: 2</p>	13:16

<p>USMH: 16062MH DSMH: 16063MH</p> <p>Deposits Settled Other</p> <p>under water</p> <p>5/20/2015 53.1 ft.</p>
63.7	<p>Deposits Attached Encrustation Position: 8 To 4 Severity: None Percent: 5 Joint Attention Required Maint Weight: 2</p>	15:28

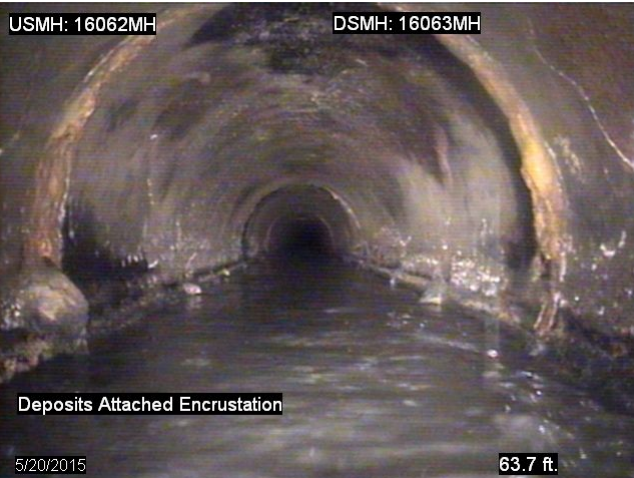
<p>USMH: 16062MH DSMH: 16063MH</p> <p>Deposits Attached Encrustation</p> <p>5/20/2015 63.7 ft.</p>

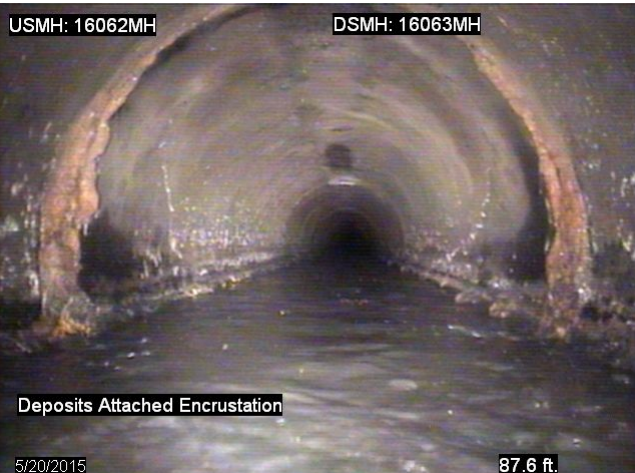
Distance	Fault Observation	Time	Picture
87.6	<p>Deposits Attached Encrustation Position: 8 To 4 Severity: None Percent: 5 Joint Attention Required Maint Weight: 2</p>	17:40

<p>USMH: 16062MH DSMH: 16063MH</p> <p>Deposits Attached Encrustation</p> <p>5/20/2015 87.6 ft.</p>
148.5	<p>Deposits Attached Encrustation Position: 8 To 4 Severity: None Percent: 5 Joint Attention Required Maint Weight: 2</p>	21:18

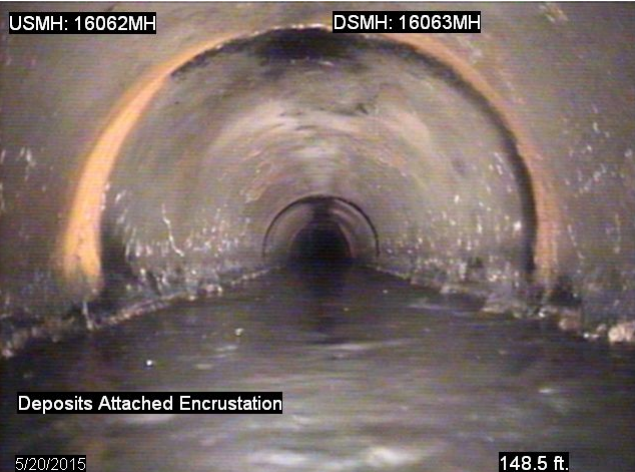
<p>USMH: 16062MH DSMH: 16063MH</p> <p>Deposits Attached Encrustation</p> <p>5/20/2015 148.5 ft.</p>
172.9	<p>Deposits Attached Encrustation Position: 9 To 4 Severity: None Percent: 10 Joint Attention Required Maint Weight: 2</p>	23:32

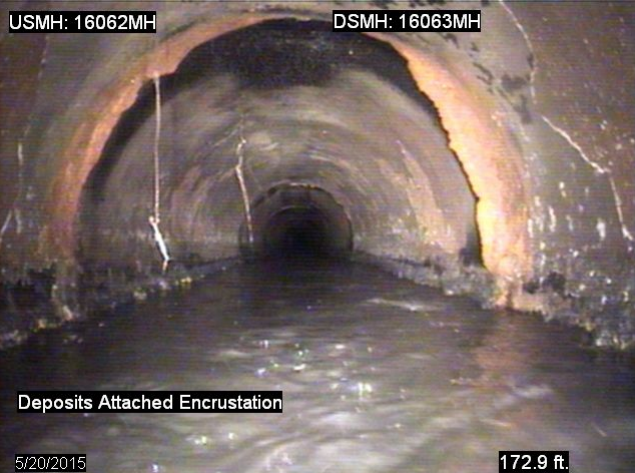
<p>USMH: 16062MH DSMH: 16063MH</p> <p>Deposits Attached Encrustation</p> <p>5/20/2015 172.9 ft.</p>

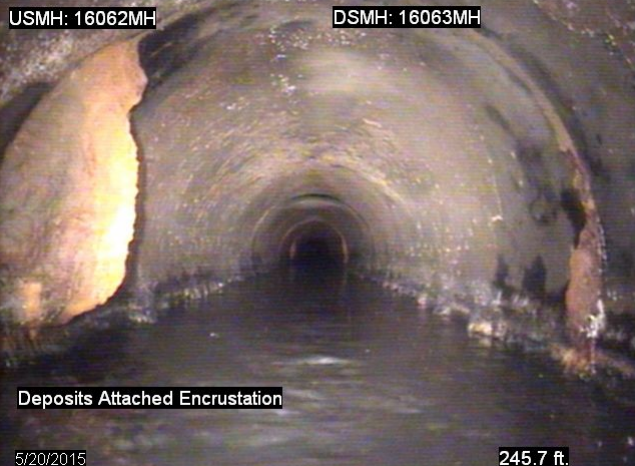
Distance	Fault Observation	Time	Picture
245.7	<p><b>Deposits Attached Encrustation</b>  <b>Position: 8 To 4</b>  <b>Severity: None</b>  <b>Percent: 20</b>  <b>Joint</b>  <b>Attention Required</b>  <b>Maint Weight: 3</b></p>	27:35

<p>USMH: 16062MH DSMH: 16063MH</p> <p>Deposits Attached Encrustation</p> <p>5/20/2015 245.7 ft.</p>

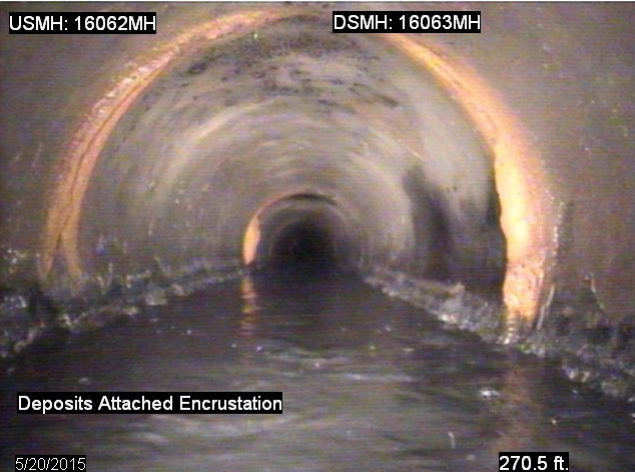
270.5	<p><b>Deposits Attached Encrustation</b>  <b>Position: 9 To 4</b>  <b>Severity: None</b>  <b>Percent: 5</b>  <b>Joint</b>  <b>Attention Required</b>  <b>Maint Weight: 2</b></p>	29:44

<p>USMH: 16062MH DSMH: 16063MH</p> <p>Deposits Attached Encrustation</p> <p>5/20/2015 270.5 ft.</p>

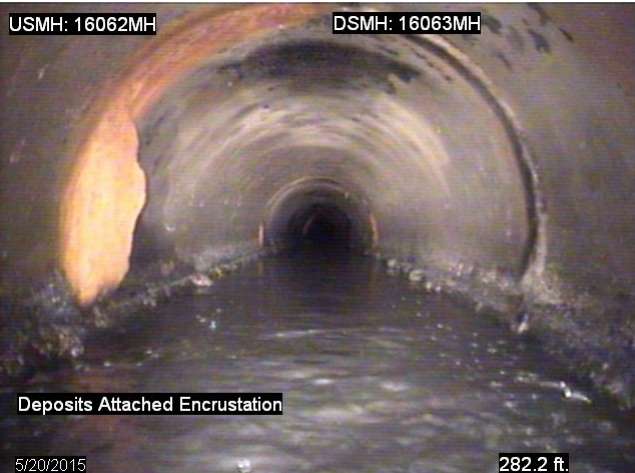
282.2	<p><b>Deposits Attached Encrustation</b>  <b>Position: 8 To 12</b>  <b>Severity: None</b>  <b>Percent: 10</b>  <b>Joint</b>  <b>Attention Required</b>  <b>Maint Weight: 2</b></p>	31:15

<p>USMH: 16062MH DSMH: 16063MH</p> <p>Deposits Attached Encrustation</p> <p>5/20/2015 282.2 ft.</p>

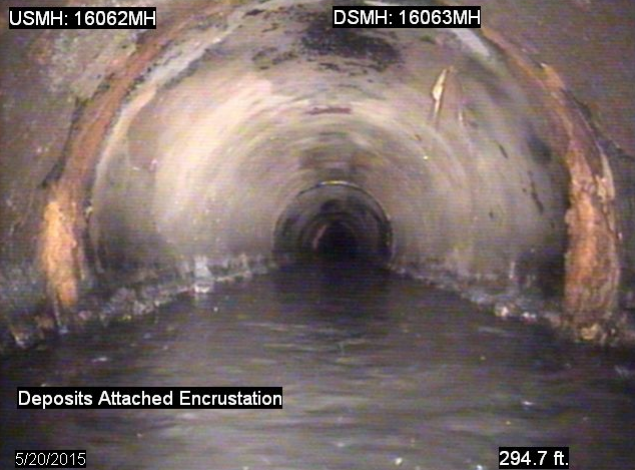
Distance	Fault Observation	Time	Picture
294.7	<p>Deposits Attached Encrustation Position: 8 To 4 Severity: None Percent: 5 Joint Attention Required Maint Weight: 2</p>	32:41

<p>USMH: 16062MH DSMH: 16063MH</p> <p>Deposits Attached Encrustation</p> <p>5/20/2015 294.7 ft.</p>
331.0	<p>Deposits Attached Encrustation Position: 8 To 4 Severity: None Percent: 15 Joint Attention Required Maint Weight: 3</p>	36:18

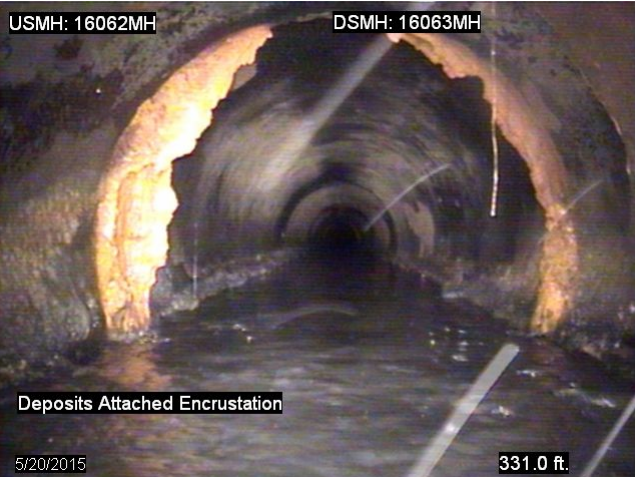
<p>USMH: 16062MH DSMH: 16063MH</p> <p>Deposits Attached Encrustation</p> <p>5/20/2015 331.0 ft.</p>
331.0	<p>Infil Runner Position: 9 Severity: None Percent: 0 Joint Attention Required Maint Weight: 4</p>	36:41

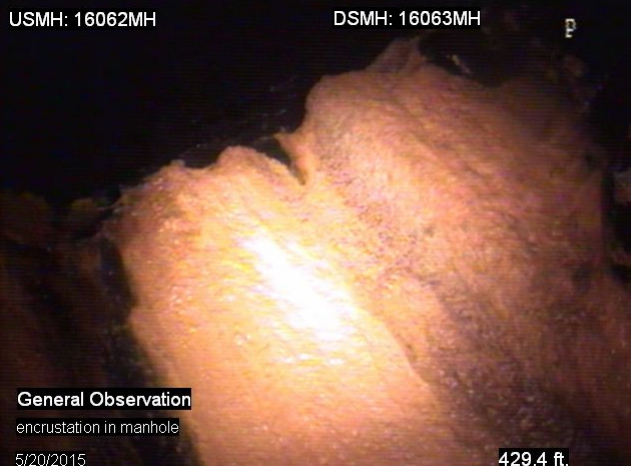
<p>USMH: 16062MH DSMH: 16063MH</p> <p><b>Deposits Attached Grease</b> wanders 5/20/2015 427.2 ft.</p>
429.4	<p><b>General Observation</b>  <b>Severity: None</b>  <b>Percent: 0</b>  <b>Attention Required</b>  <b>Remarks: encrustation in manhole</b></p>	44:13

<p>USMH: 16062MH DSMH: 16063MH</p> <p><b>General Observation</b> encrustation in manhole 5/20/2015 429.4 ft.</p>
429.4	<p><b>Manhole</b>  <b>Severity: None</b>  <b>Percent: 0</b>  <b>Attention Required</b>  <b>Remarks: 16063MH</b></p>	44:43

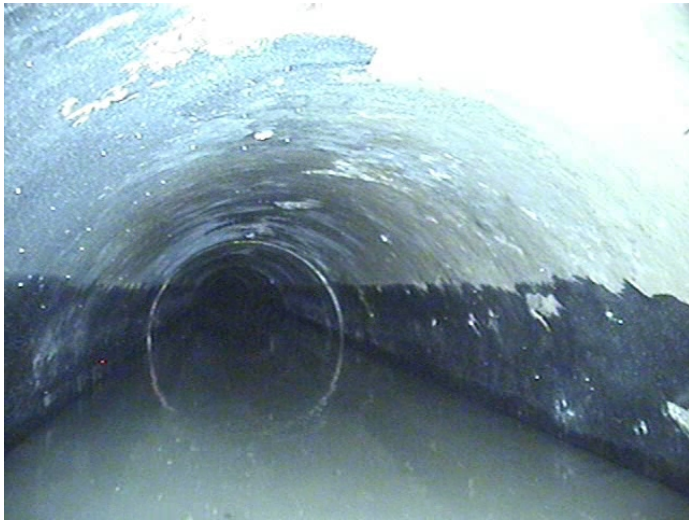
Code: **DAGS**  
Description: **Deposits Attached Grease**

Distance (ft): **.0**  
Structural Grade: **0**  
O&M Grade: **3**  
Clock Start/From: **9**  
Clock To: **3**  
1st Value:  
2nd Value:  
Value Percent: **5**  
Continuous Index: **S02**  
Within 8" of Joint: **YES**  
Remarks: **grease film**

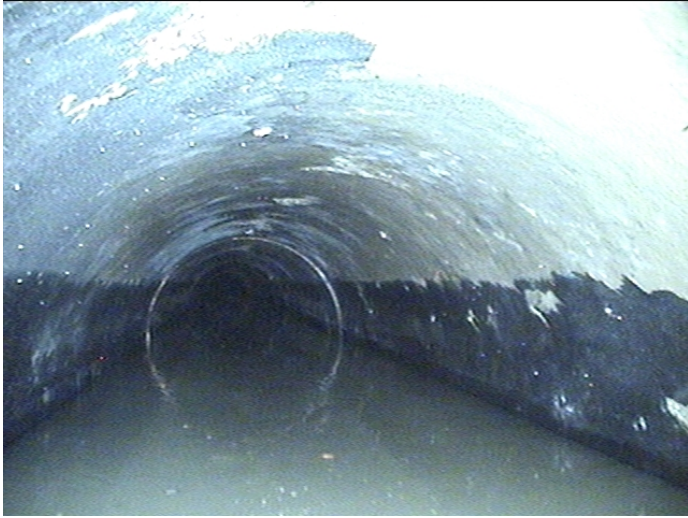
Code: **SSS**  
Description: **Surface Spalling**

Distance (ft): **.0**  
Structural Grade: **2**  
O&M Grade: **0**  
Clock Start/From: **10**  
Clock To: **2**  
1st Value:  
2nd Value:  
Value Percent:  
Continuous Index: **S01**  
Within 8" of Joint: **NO**  
Remarks:

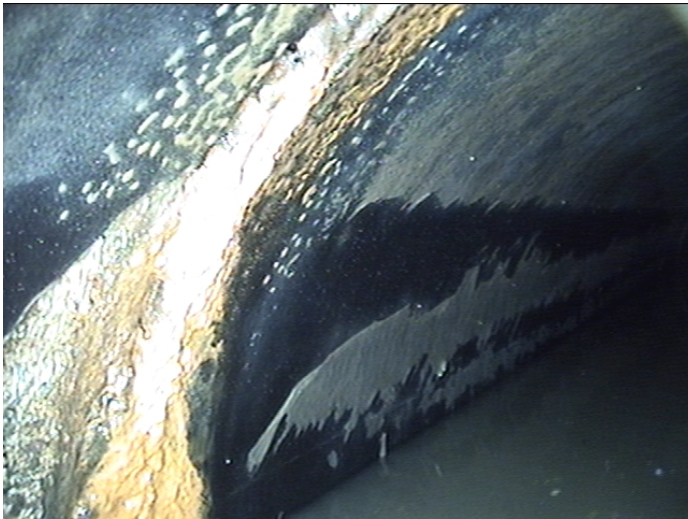
Code: **DAE**  
Description: **Deposits Attached Encrustation**

Distance (ft): **5.5**  
Structural Grade: **0**  
O&M Grade: **3**  
Clock Start/From: **9**  
Clock To: **11**  
1st Value:  
2nd Value:  
Value Percent: **5**  
Continuous Index:  
Within 8" of Joint: **YES**  
Remarks:

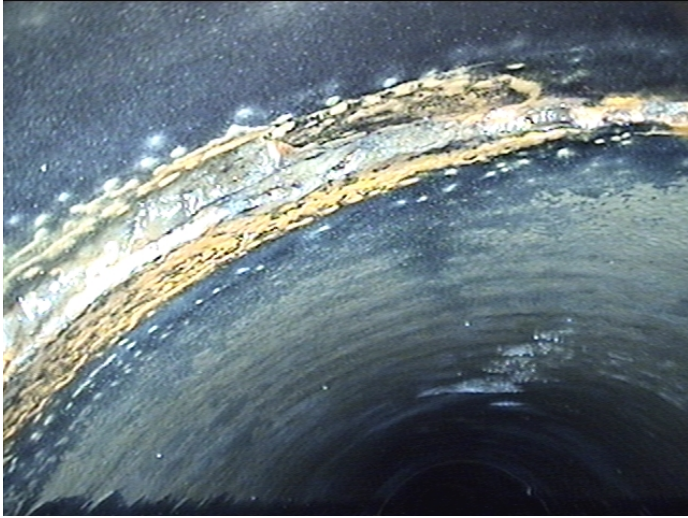
Code: **ID**  
Description: **Infil Dripper**

Distance (ft): **5.5**  
Structural Grade: **0**  
O&M Grade: **3**  
Clock Start/From: **11**  
Clock To:  
1st Value:  
2nd Value:  
Value Percent:  
Continuous Index:  
Within 8" of Joint: **YES**  
Remarks:

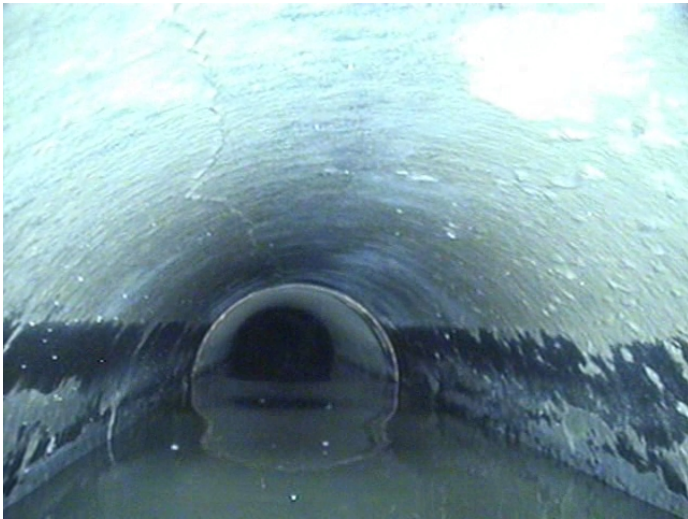
Code: **CL**  
Description: **Crack Longitudinal**

Distance (ft): **26.2**  
Structural Grade: **2**  
O&M Grade: **0**  
Clock Start/From: **11**  
Clock To:  
1st Value:  
2nd Value:  
Value Percent:  
Continuous Index: **S03**  
Within 8" of Joint: **YES**  
Remarks:

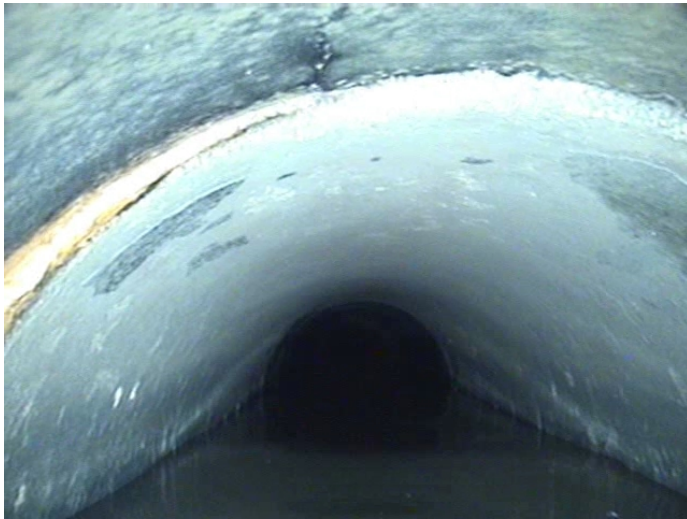
Code: **CL**  
Description: **Crack Longitudinal**

Distance (ft): **36.1**  
Structural Grade: **2**  
O&M Grade: **0**  
Clock Start/From: **11**  
Clock To:  
1st Value:  
2nd Value:  
Value Percent:  
Continuous Index: **F03**  
Within 8" of Joint: **YES**  
Remarks:

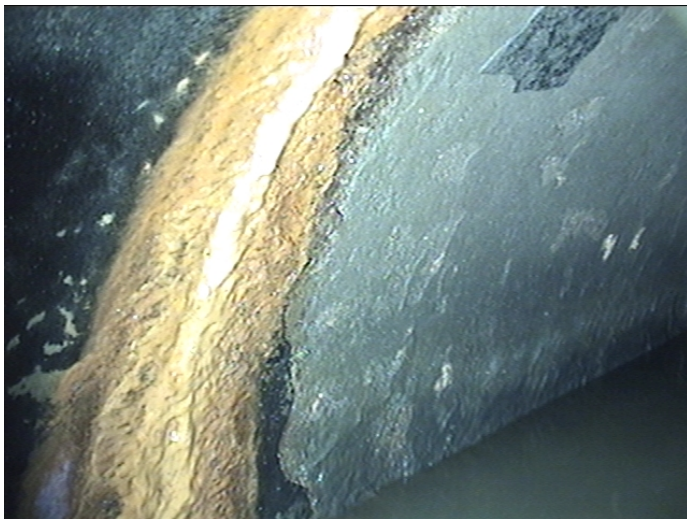
Code: **DAE**  
Description: **Deposits Attached Encrustation**

Distance (ft): **37.7**  
Structural Grade: **0**  
O&M Grade: **3**  
Clock Start/From: **9**  
Clock To: **12**  
1st Value:  
2nd Value:  
Value Percent: **5**  
Continuous Index:  
Within 8" of Joint: **YES**  
Remarks:

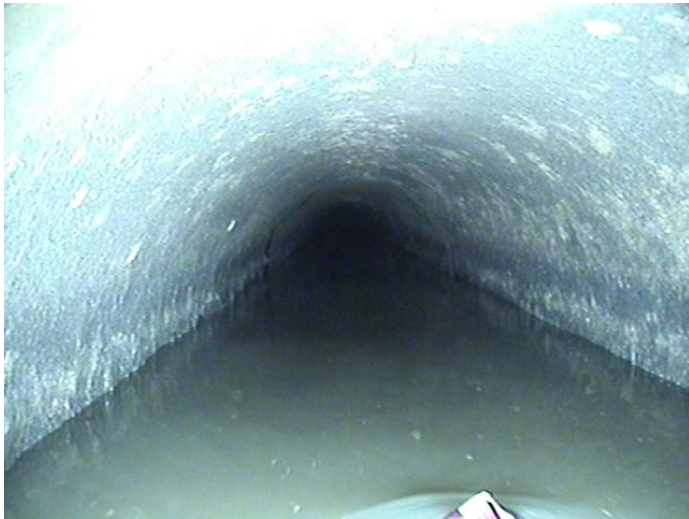
Code: **DAGS**  
Description: **Deposits Attached Grease**

Distance (ft): **73.5**  
Structural Grade: **0**  
O&M Grade: **3**  
Clock Start/From: **9**  
Clock To: **3**  
1st Value:  
2nd Value:  
Value Percent: **5**  
Continuous Index: **F02**  
Within 8" of Joint: **YES**  
Remarks: **grease film**

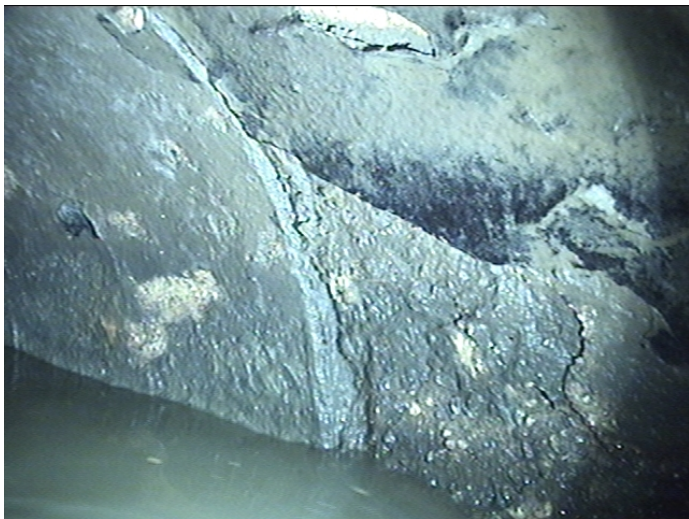
Code: **SAV**  
Description: **Surface Aggregate Visible**

Distance (ft): **120.8**  
Structural Grade: **3**  
O&M Grade: **0**  
Clock Start/From: **9**  
Clock To: **3**  
1st Value:  
2nd Value:  
Value Percent:  
Continuous Index:  
Within 8" of Joint: **YES**  
Remarks:

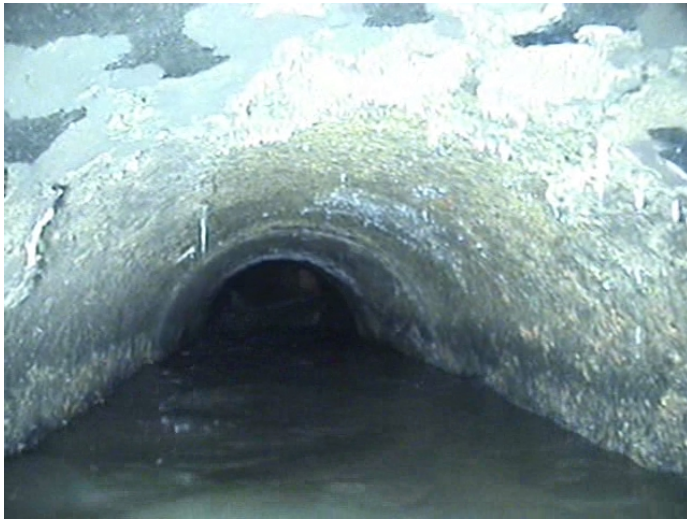
Code: **SSS**  
Description: **Surface Spalling**

Distance (ft): **137.3**  
Structural Grade: **2**  
O&M Grade: **0**  
Clock Start/From: **10**  
Clock To: **2**  
1st Value:  
2nd Value:  
Value Percent:  
Continuous Index: **F01**  
Within 8" of Joint: **NO**  
Remarks:

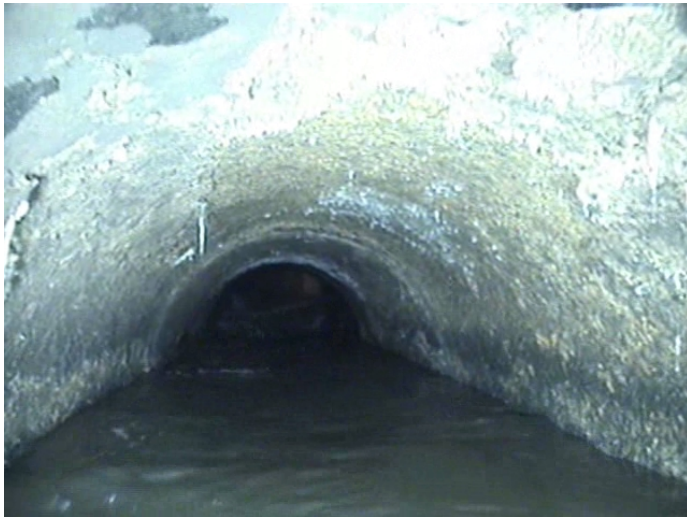
Code: **SAV**  
Description: **Surface Aggregate Visible**

Distance (ft): **137.7**  
Structural Grade: **3**  
O&M Grade: **0**  
Clock Start/From: **8**  
Clock To: **4**  
1st Value:  
2nd Value:  
Value Percent:  
Continuous Index: **S04**  
Within 8" of Joint: **YES**  
Remarks:

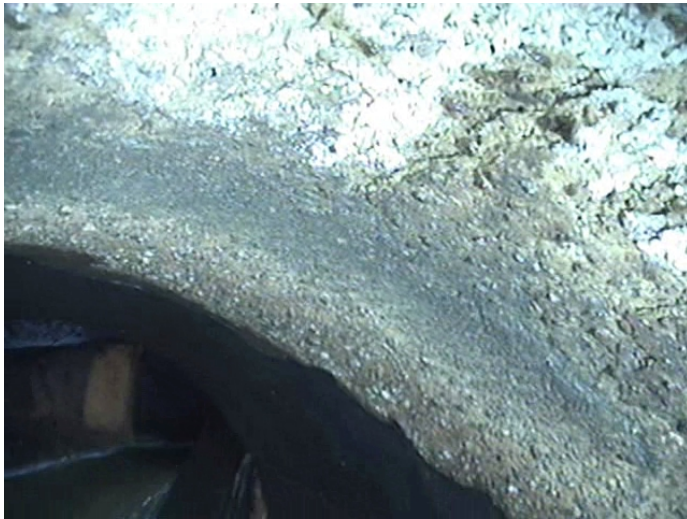
Code: **SAV**  
Description: **Surface Aggregate Visible**

Distance (ft): **153.3**  
Structural Grade: **3**  
O&M Grade: **0**  
Clock Start/From: **8**  
Clock To: **4**  
1st Value:  
2nd Value:  
Value Percent:  
Continuous Index: **F04**  
Within 8" of Joint: **YES**  
Remarks:

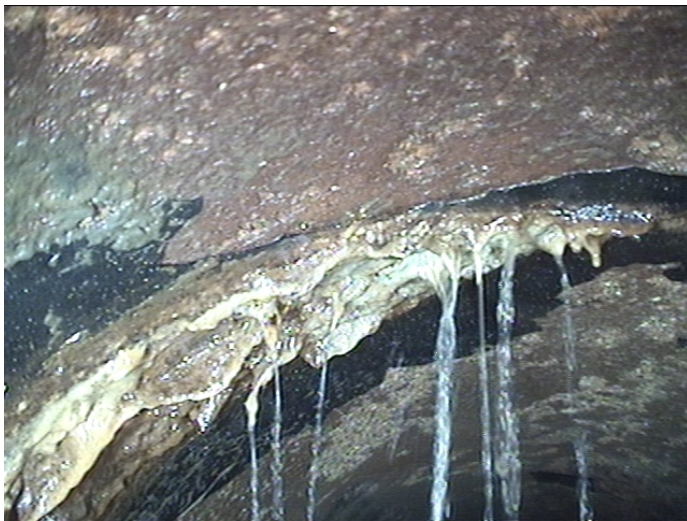
Code: **IG**  
Description: **Infil Gusher**

Distance (ft): **12.3**  
Structural Grade: **0**  
O&M Grade: **5**  
Clock Start/From: **10**  
Clock To: **12**  
1st Value:  
2nd Value:  
Value Percent:  
Continuous Index:  
Within 8" of Joint: **NO**  
Remarks:

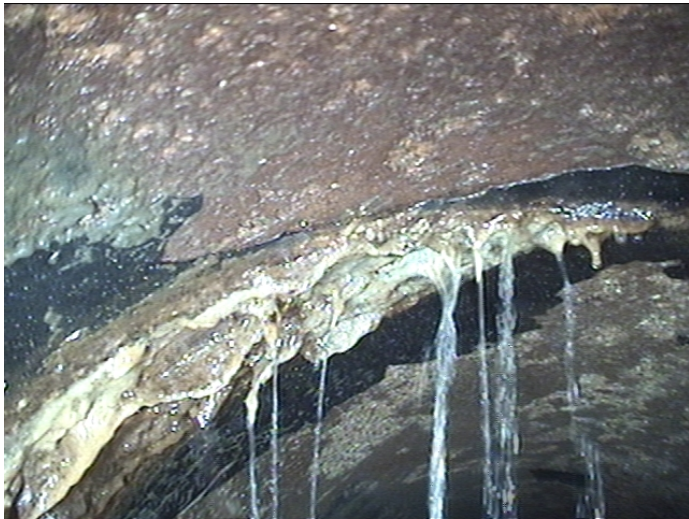
Code: **DAE**  
Description: **Deposits Attached Encrustation**

Distance (ft): **12.3**  
Structural Grade: **0**  
O&M Grade: **3**  
Clock Start/From: **8**  
Clock To: **12**  
1st Value:  
2nd Value:  
Value Percent: **5**  
Continuous Index:  
Within 8" of Joint: **NO**  
Remarks:

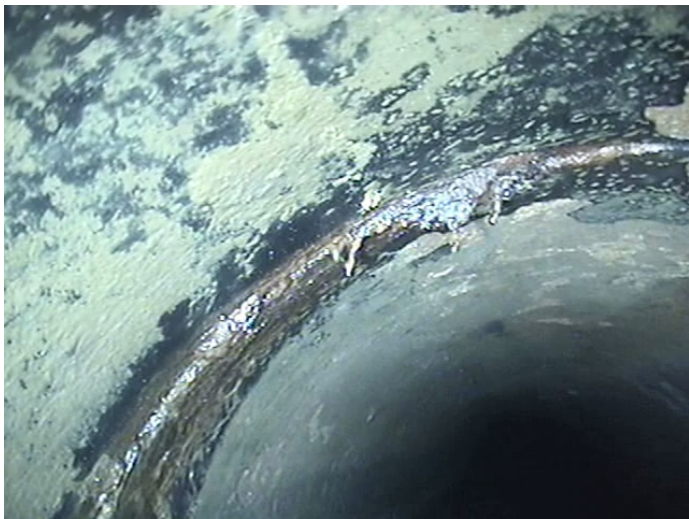
Code: **DAE**  
Description: **Deposits Attached Encrustation**

Distance (ft): **29.5**  
Structural Grade: **0**  
O&M Grade: **3**  
Clock Start/From: **9**  
Clock To: **12**  
1st Value:  
2nd Value:  
Value Percent: **5**  
Continuous Index:  
Within 8" of Joint: **YES**  
Remarks:

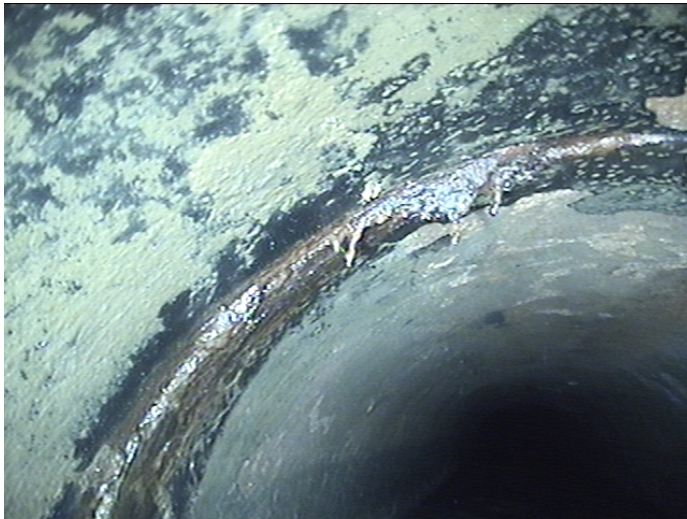
Code: **ID**  
Description: **Infil Dripper**

Distance (ft): **29.5**  
Structural Grade: **0**  
O&M Grade: **3**  
Clock Start/From: **10**  
Clock To: **12**  
1st Value:  
2nd Value:  
Value Percent:  
Continuous Index:  
Within 8" of Joint: **NO**  
Remarks:

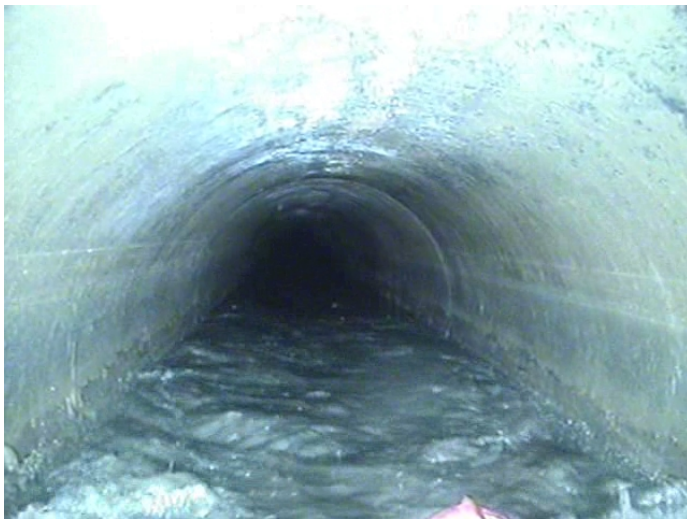
Code: **OBZ**  
Description: **Obstacle Other**

Distance (ft): **111.6**  
Structural Grade: **0**  
O&M Grade: **3**  
Clock Start/From: **5**  
Clock To: **7**  
1st Value:  
2nd Value:  
Value Percent: **5**  
Continuous Index:  
Within 8" of Joint: **NO**  
Remarks: **debris/sediment - see sonar**

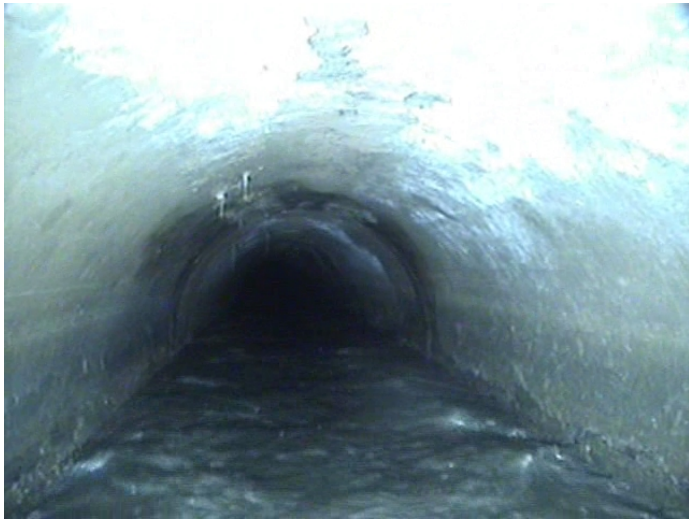
Code: **SRI**  
Description: **Surface Roughness Increased**

Distance (ft): **197.1**  
Structural Grade: **1**  
O&M Grade: **0**  
Clock Start/From: **11**  
Clock To: **1**  
1st Value:  
2nd Value:  
Value Percent:  
Continuous Index: **S01**  
Within 8" of Joint: **YES**  
Remarks:

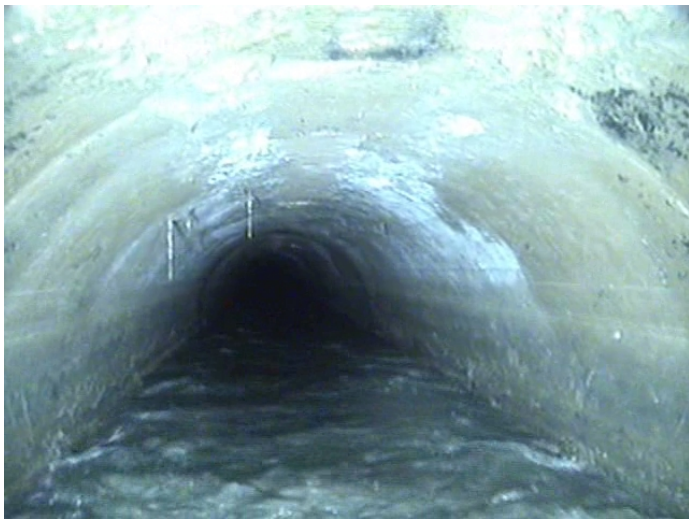
Code: **SRI**  
Description: **Surface Roughness Increased**

Distance (ft): **202.6**  
Structural Grade: **1**  
O&M Grade: **0**  
Clock Start/From: **11**  
Clock To: **1**  
1st Value:  
2nd Value:  
Value Percent:  
Continuous Index: **F01**  
Within 8" of Joint: **YES**  
Remarks:

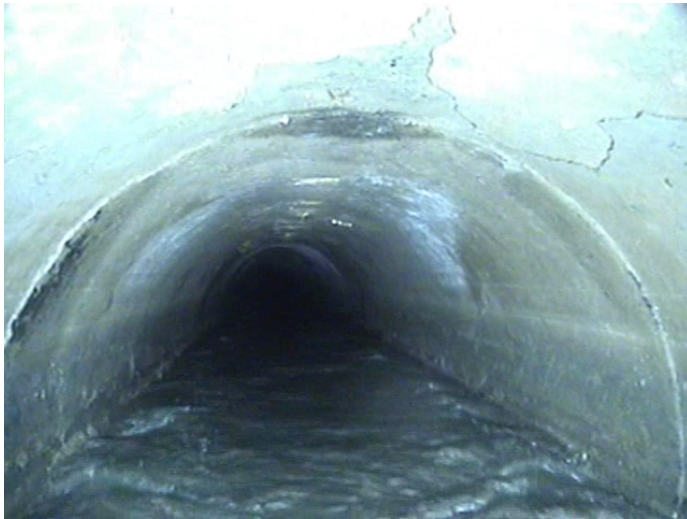
Code: **SRI**  
Description: **Surface Roughness Increased**

Distance (ft): **213.3**  
Structural Grade: **1**  
O&M Grade: **0**  
Clock Start/From: **11**  
Clock To: **2**  
1st Value:  
2nd Value:  
Value Percent:  
Continuous Index:  
Within 8" of Joint: **YES**  
Remarks:

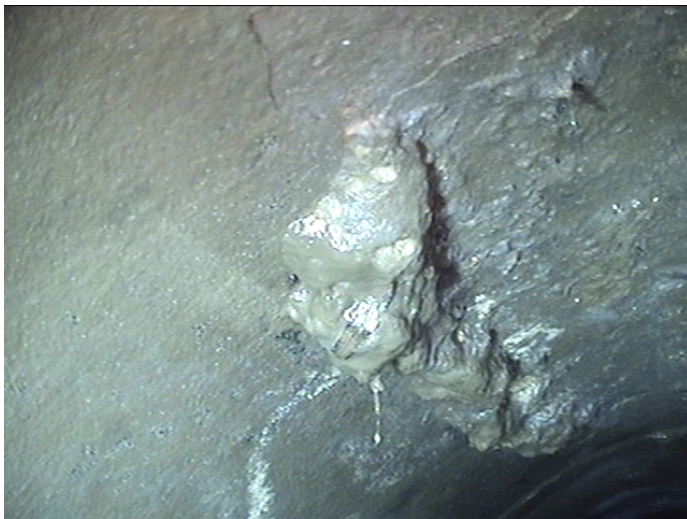
Code: **DAGS**  
Description: **Deposits Attached Grease**

Distance (ft): **225.5**  
Structural Grade: **0**  
O&M Grade: **3**  
Clock Start/From: **11**  
Clock To:  
1st Value:  
2nd Value:  
Value Percent: **5**  
Continuous Index:  
Within 8" of Joint: **NO**  
Remarks:

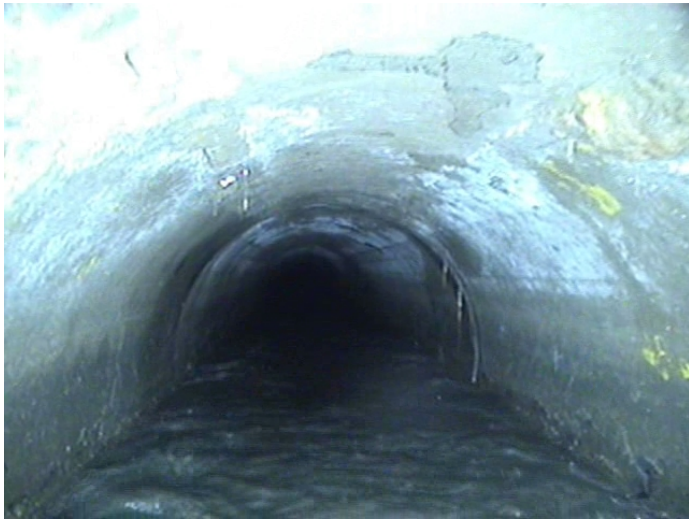
Code: **DAGS**  
Description: **Deposits Attached Grease**

Distance (ft): **245.5**  
Structural Grade: **0**  
O&M Grade: **3**  
Clock Start/From: **1**  
Clock To:  
1st Value:  
2nd Value:  
Value Percent: **5**  
Continuous Index:  
Within 8" of Joint: **NO**  
Remarks:

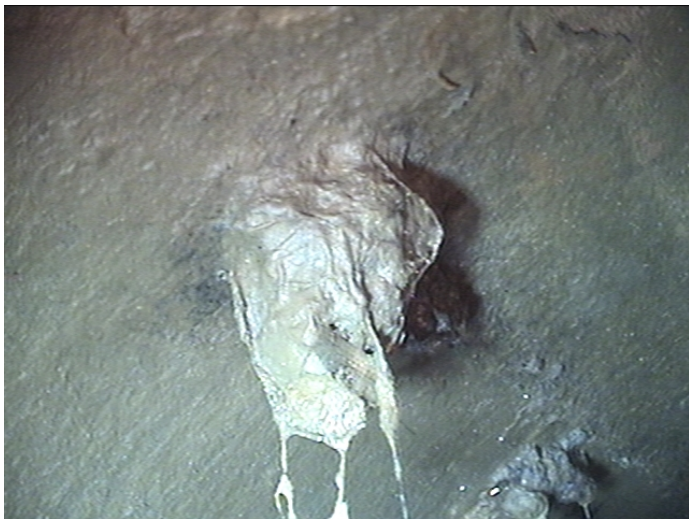
Code: **DAR**  
Description: **Deposits Attached Ragging**

Distance (ft): **351.3**  
Structural Grade: **0**  
O&M Grade: **3**  
Clock Start/From: **11**  
Clock To:  
1st Value:  
2nd Value:  
Value Percent: **5**  
Continuous Index:  
Within 8" of Joint: **NO**  
Remarks:

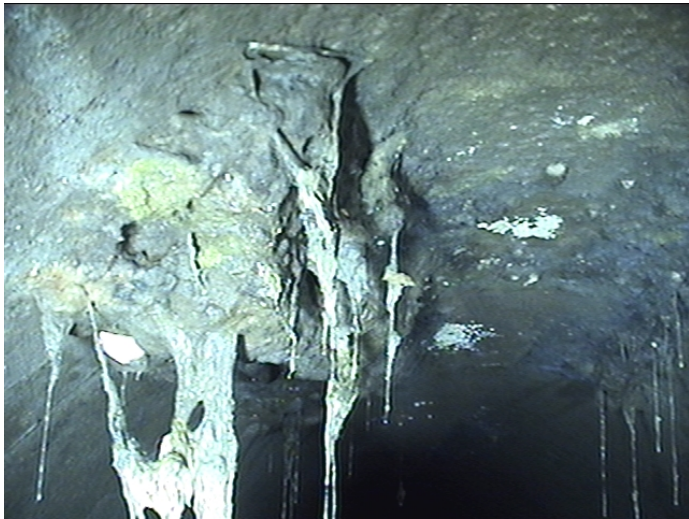
Code: **DAGS**  
Description: **Deposits Attached Grease**

Distance (ft): **371.6**  
Structural Grade: **0**  
O&M Grade: **3**  
Clock Start/From: **11**  
Clock To:  
1st Value:  
2nd Value:  
Value Percent: **5**  
Continuous Index:  
Within 8" of Joint: **NO**  
Remarks:

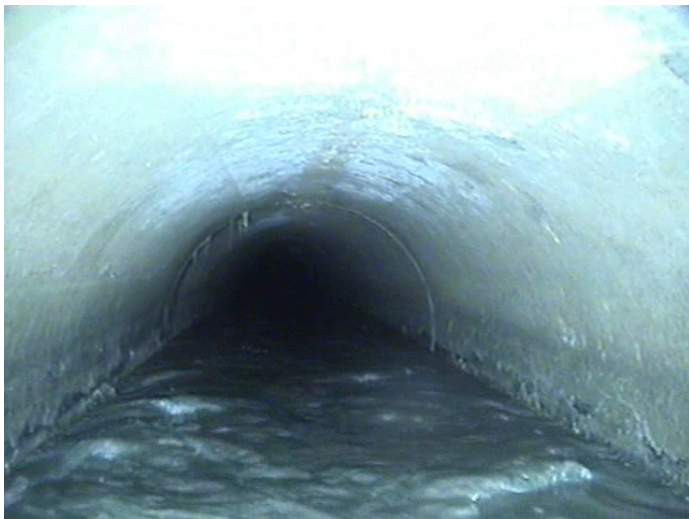
Code: **SRI**  
Description: **Surface Roughness Increased**

Distance (ft): **388.2**  
Structural Grade: **1**  
O&M Grade: **0**  
Clock Start/From: **9**  
Clock To: **3**  
1st Value:  
2nd Value:  
Value Percent:  
Continuous Index: **S02**  
Within 8" of Joint: **YES**  
Remarks:

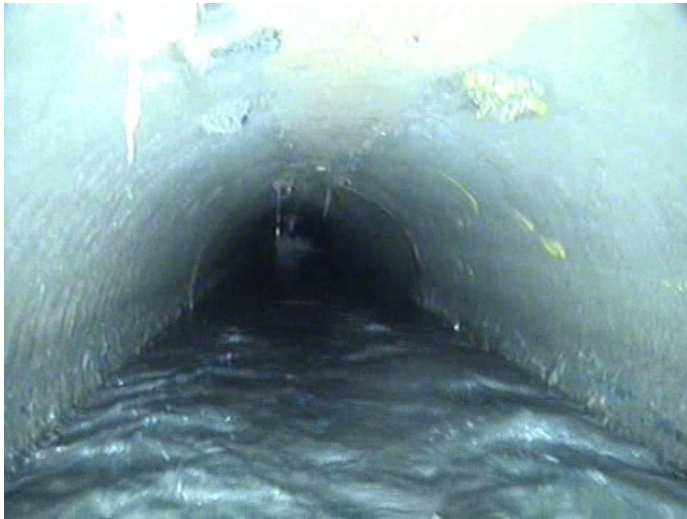
Code: **DAGS**  
Description: **Deposits Attached Grease**

Distance (ft): **447.7**  
Structural Grade: **0**  
O&M Grade: **3**  
Clock Start/From: **11**  
Clock To: **1**  
1st Value:  
2nd Value:  
Value Percent: **5**  
Continuous Index:  
Within 8" of Joint: **NO**  
Remarks:

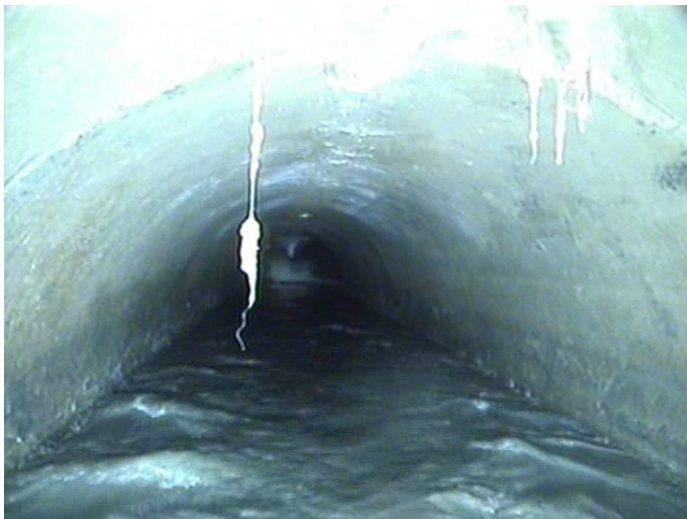
Code: **DAGS**  
Description: **Deposits Attached Grease**

Distance (ft): **455.7**  
Structural Grade: **0**  
O&M Grade: **3**  
Clock Start/From: **12**  
Clock To:  
1st Value:  
2nd Value:  
Value Percent: **5**  
Continuous Index:  
Within 8" of Joint: **YES**  
Remarks:

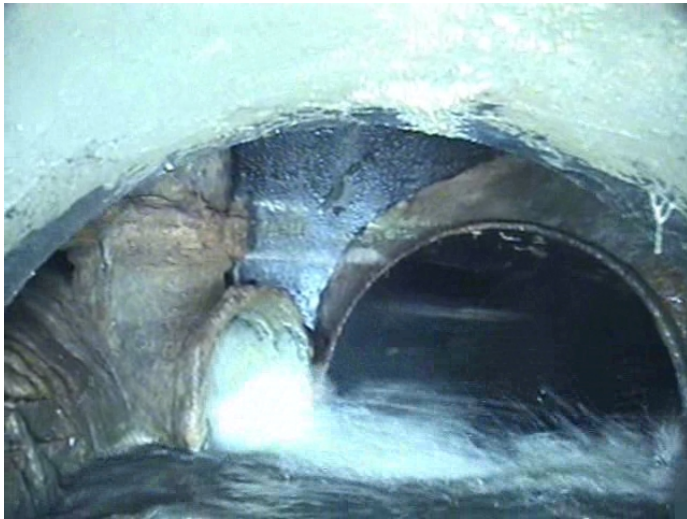
Code: **SRI**  
Description: **Surface Roughness Increased**

Distance (ft): **479.6**  
Structural Grade: **1**  
O&M Grade: **0**  
Clock Start/From: **9**  
Clock To: **3**  
1st Value:  
2nd Value:  
Value Percent:  
Continuous Index: **F02**  
Within 8" of Joint: **YES**  
Remarks:

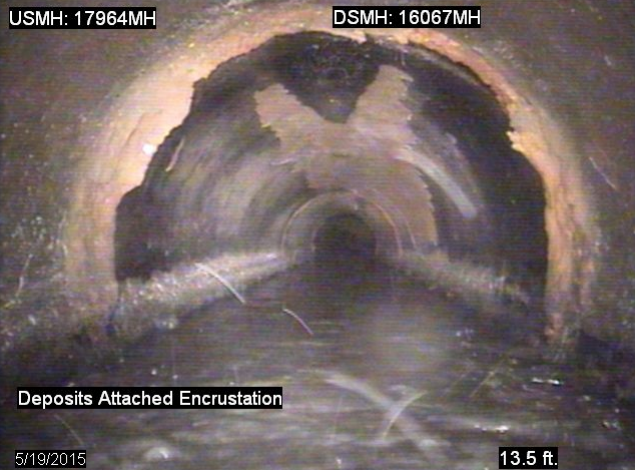
Distance	Fault Observation	Time	Picture
13.5	<p><b>Deposits Attached Encrustation</b>  <b>Position: 8 To 4</b>  <b>Severity: None</b>  <b>Percent: 5</b>  <b>Joint</b>  <b>Attention Required</b>  <b>Maint Weight: 2</b></p>	04:16

<p>USMH: 17964MH DSMH: 16067MH</p> <p>Deposits Attached Encrustation</p> <p>5/19/2015 13.5 ft.</p>

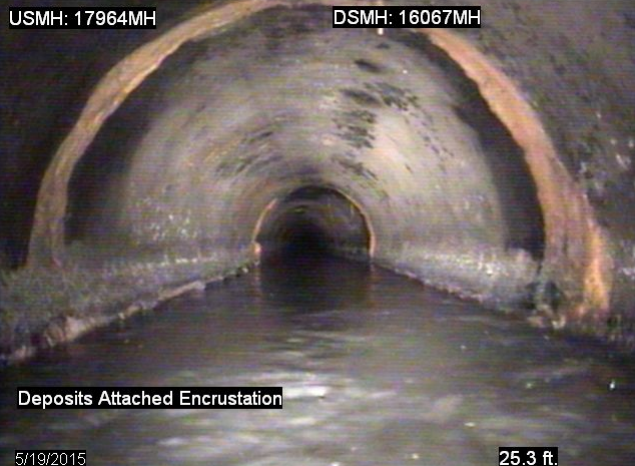
Distance	Fault Observation	Time	Picture
25.3	<b>Deposits Attached Encrustation</b> <b>Position: 8 To 4</b> <b>Severity: None</b> <b>Percent: 5</b> <b>Joint</b> <b>Attention Required</b> <b>Maint Weight: 2</b>	8:10

<p>USMH: 17964MH DSMH: 16067MH</p> <p>Deposits Attached Encrustation</p> <p>5/19/2015 25.3 ft.</p>

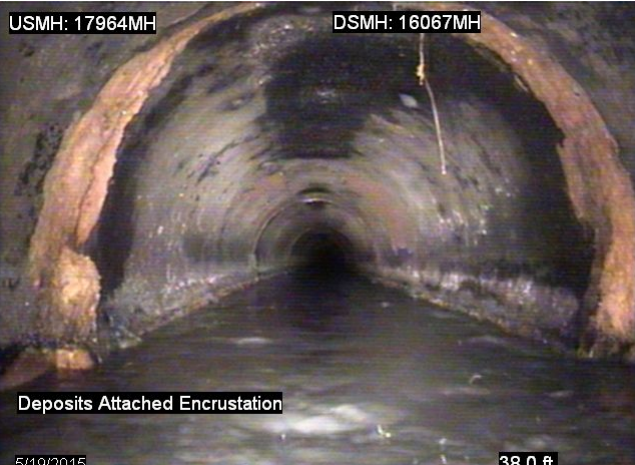
38.0	<b>Deposits Attached Encrustation</b> <b>Position: 8 To 4</b> <b>Severity: None</b> <b>Percent: 5</b> <b>Joint</b> <b>Attention Required</b> <b>Maint Weight: 2</b>	09:34

<p>USMH: 17964MH DSMH: 16067MH</p> <p>Deposits Attached Encrustation</p> <p>5/19/2015 38.0 ft.</p>

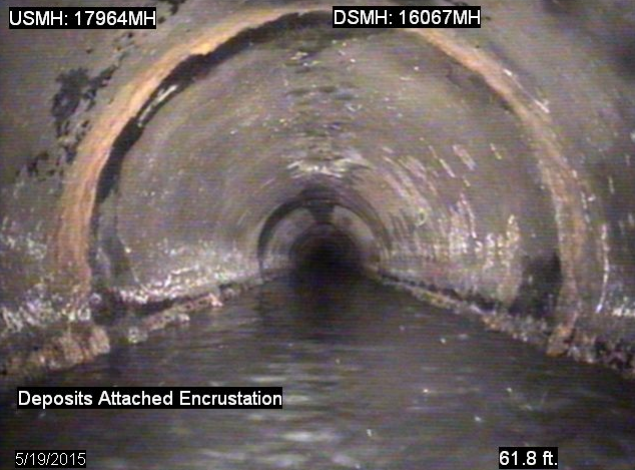
Distance	Fault Observation	Time	Picture
61.8	<p><b>Deposits Attached Encrustation</b>  <b>Position: 8 To 4</b>  <b>Severity: None</b>  <b>Percent: 5</b>  <b>Joint</b>  <b>Attention Required</b>  <b>Maint Weight: 2</b></p>	12:52

<p>USMH: 17964MH DSMH: 16067MH</p> <p>Deposits Attached Encrustation</p> <p>5/19/2015 61.8 ft.</p>

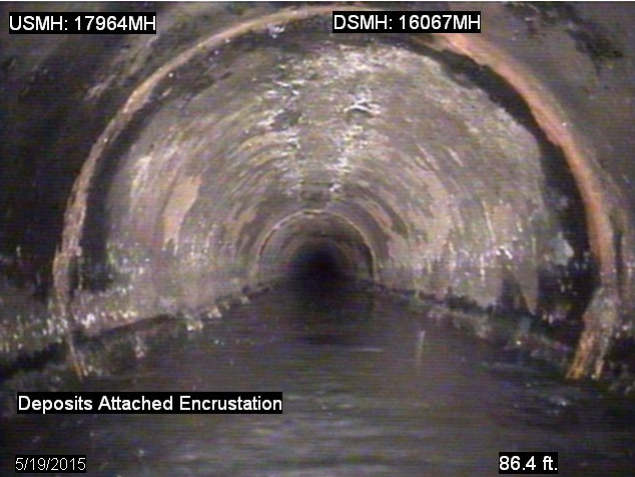
86.4	<p><b>Deposits Attached Encrustation</b>  <b>Position: 8 To 3</b>  <b>Severity: None</b>  <b>Percent: 5</b>  <b>Joint</b>  <b>Attention Required</b>  <b>Maint Weight: 2</b></p>	15:06

<p>USMH: 17964MH DSMH: 16067MH</p> <p>Deposits Attached Encrustation</p> <p>5/19/2015 86.4 ft.</p>

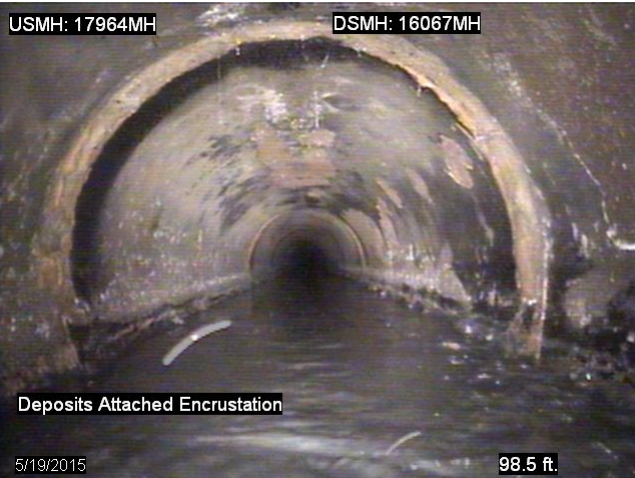
98.5	<p><b>Deposits Attached Encrustation</b>  <b>Position: 8 To 4</b>  <b>Severity: None</b>  <b>Percent: 5</b>  <b>Joint</b>  <b>Attention Required</b>  <b>Maint Weight: 2</b></p>	16:44

<p>USMH: 17964MH DSMH: 16067MH</p> <p>Deposits Attached Encrustation</p> <p>5/19/2015 98.5 ft.</p>

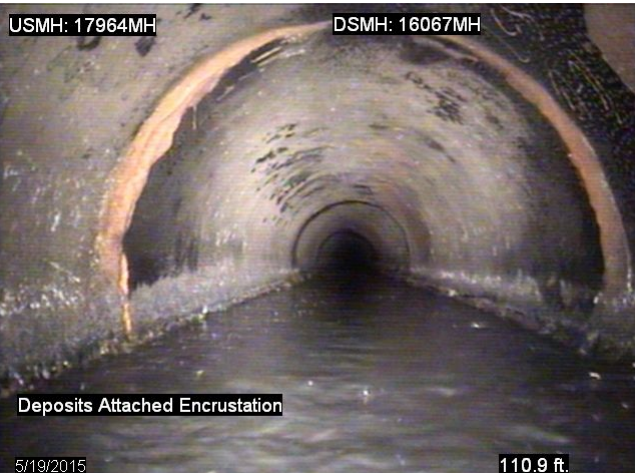
Distance	Fault Observation	Time	Picture
110.9	<p><b>Deposits Attached Encrustation</b>  <b>Position: 8 To 4</b>  <b>Severity: None</b>  <b>Percent: 5</b>  <b>Joint</b>  <b>Attention Required</b>  <b>Maint Weight: 2</b></p>	18:08

<p>USMH: 17964MH DSMH: 16067MH</p> <p>Deposits Attached Encrustation</p> <p>5/19/2015 110.9 ft.</p>

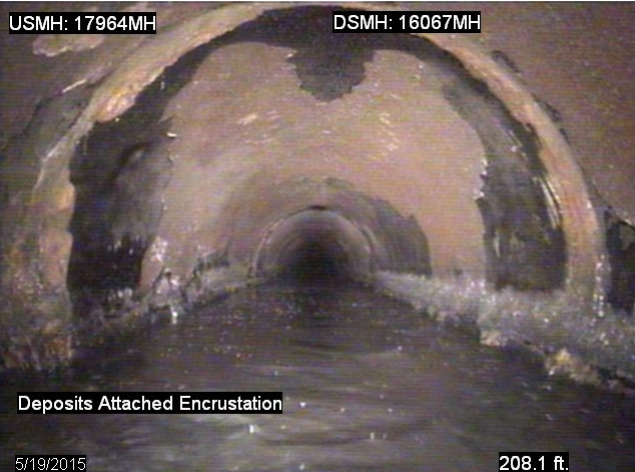
208.1	<p><b>Deposits Attached Encrustation</b>  <b>Position: 8 To 4</b>  <b>Severity: None</b>  <b>Percent: 5</b>  <b>Joint</b>  <b>Attention Required</b>  <b>Maint Weight: 2</b></p>	23:57

<p>USMH: 17964MH DSMH: 16067MH</p> <p>Deposits Attached Encrustation</p> <p>5/19/2015 208.1 ft.</p>

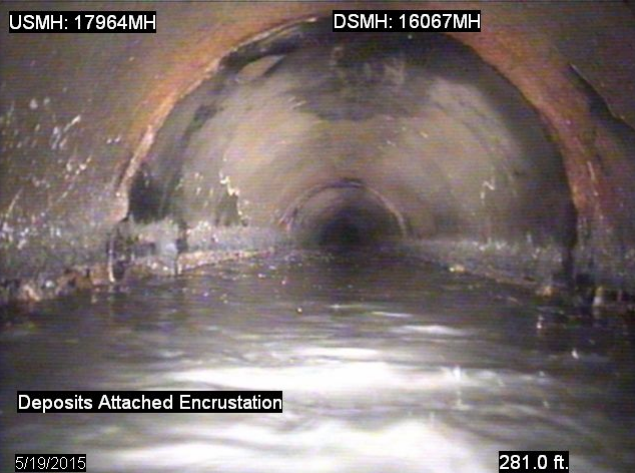
281.0	<p><b>Deposits Attached Encrustation</b>  <b>Position: 10 To 4</b>  <b>Severity: None</b>  <b>Percent: 5</b>  <b>Joint</b>  <b>Attention Required</b>  <b>Maint Weight: 2</b></p>	30:00

<p>USMH: 17964MH DSMH: 16067MH</p> <p>Deposits Attached Encrustation</p> <p>5/19/2015 281.0 ft.</p>

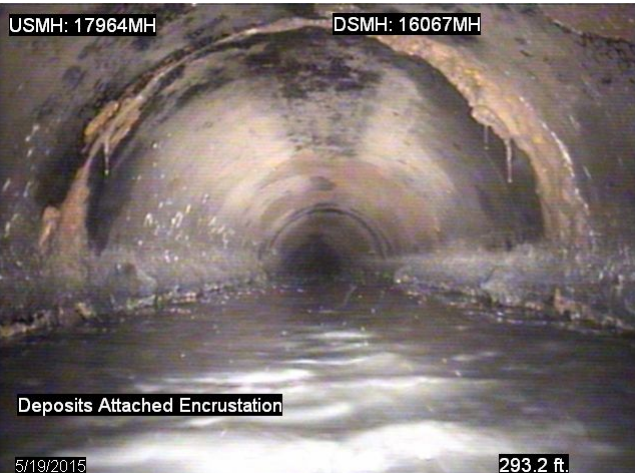
Distance	Fault Observation	Time	Picture
293.2	<p>Deposits Attached Encrustation Position: 8 To 4 Severity: None Percent: 5 Joint Attention Required Maint Weight: 2</p>	31:39

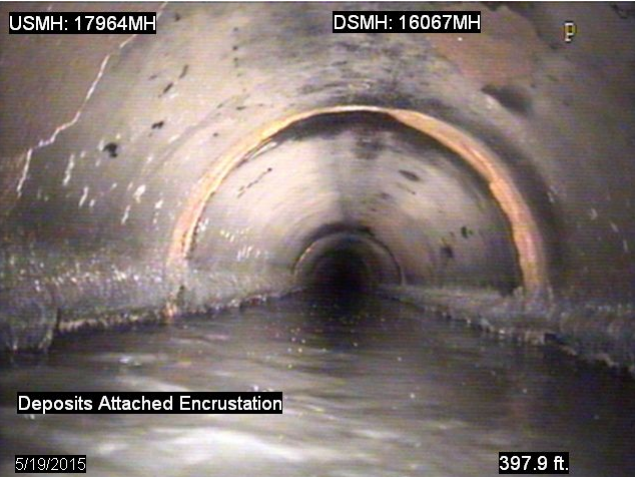
397.9	<p><b>Deposits Attached Encrustation</b>  <b>Position: 8 To 4</b>  <b>Severity: None</b>  <b>Cont Defect: F04</b>  <b>Percent: 10</b>  <b>Attention Required</b>  <b>Maint Weight: 2</b></p>	40:49

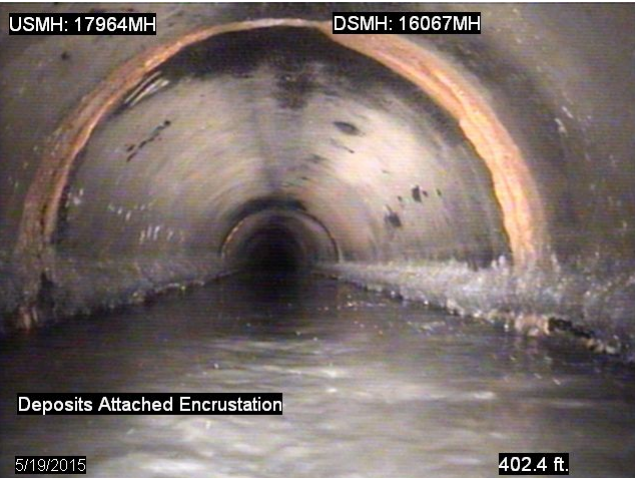
402.4	<p><b>Deposits Attached Encrustation</b>  <b>Position: 8 To 4</b>  <b>Severity: None</b>  <b>Percent: 5</b>  <b>Joint</b>  <b>Attention Required</b>  <b>Maint Weight: 2</b></p>	41:57

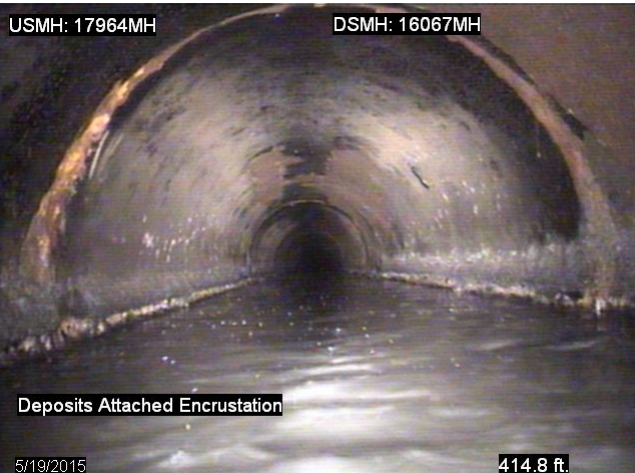
Distance	Fault Observation	Time	Picture
414.8	<p><b>Deposits Attached Encrustation</b>  <b>Position: 8 To 10</b>  <b>Severity: None</b>  <b>Percent: 5</b>  <b>Joint</b>  <b>Attention Required</b>  <b>Maint Weight: 2</b></p>	43:30

<p>USMH: 17964MH DSMH: 16067MH</p> <p>Deposits Attached Encrustation</p> <p>5/19/2015 414.8 ft.</p>

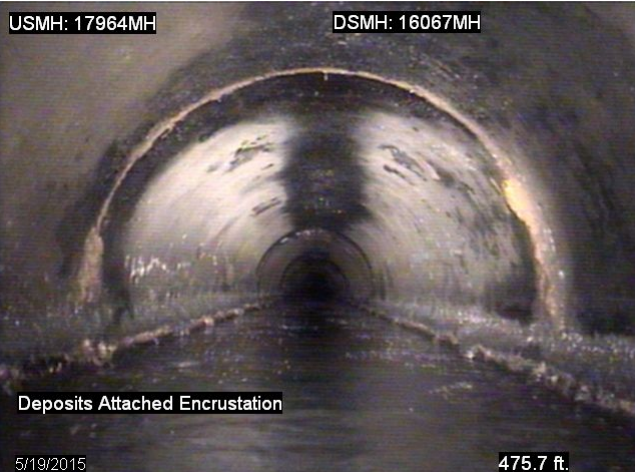
475.7	<p><b>Deposits Attached Encrustation</b>  <b>Position: 8 To 3</b>  <b>Severity: None</b>  <b>Percent: 5</b>  <b>Joint</b>  <b>Attention Required</b>  <b>Maint Weight: 2</b></p>	46:53

<p>USMH: 17964MH DSMH: 16067MH</p> <p>Deposits Attached Encrustation</p> <p>5/19/2015 475.7 ft.</p>

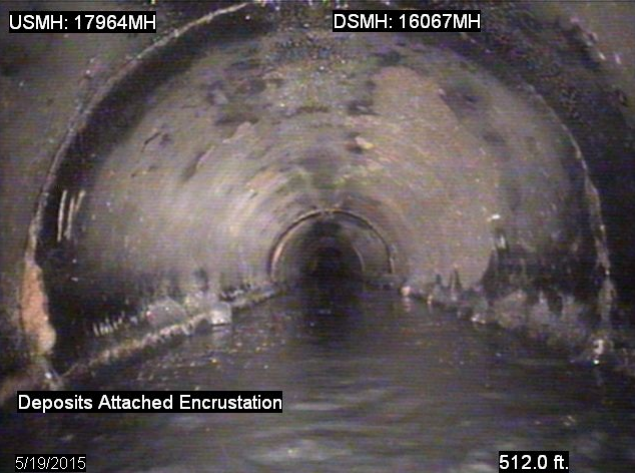
512.0	<p><b>Deposits Attached Encrustation</b>  <b>Position: 8</b>  <b>Severity: None</b>  <b>Percent: 5</b>  <b>Joint</b>  <b>Attention Required</b>  <b>Maint Weight: 2</b></p>	49:42

<p>USMH: 17964MH DSMH: 16067MH</p> <p>Deposits Attached Encrustation</p> <p>5/19/2015 512.0 ft.</p>

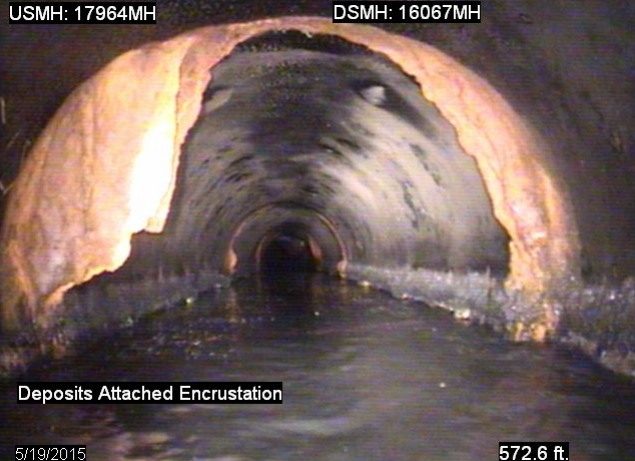
Distance	Fault Observation	Time	Picture
572.6	<p><b>Deposits Attached Encrustation</b>  <b>Position: 8 To 4</b>  <b>Severity: None</b>  <b>Percent: 35</b>  <b>Joint</b>  <b>Attention Required</b>  <b>Maint Weight: 5</b></p>	56:53

<p>USMH: 17964MH DSMH: 16067MH</p> <p>Deposits Attached Encrustation</p> <p>5/19/2015 572.6 ft.</p>
