# **CITY OF COLUMBIA**

**PROJECT: BID020-20-21-LAG - Lower Saluda River Relief Sewer and Pipe Rehabilitation (SS7428) CDBE**

## **ADDENDUM No. 2**

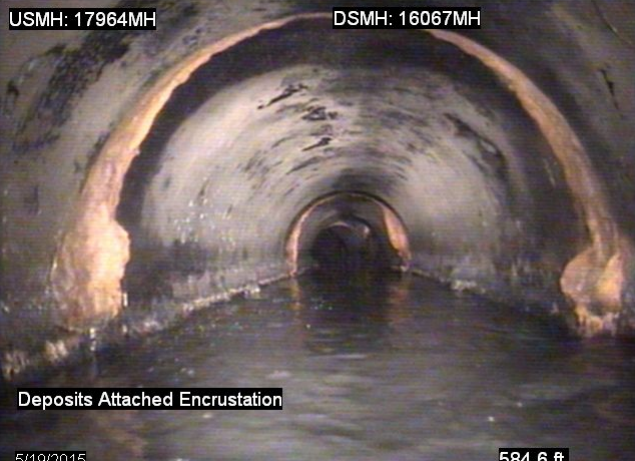
584.6	<p><b>Deposits Attached Encrustation</b>  <b>Position: 8 To 4</b>  <b>Severity: None</b>  <b>Percent: 5</b>  <b>Attention Required</b>  <b>Maint Weight: 2</b></p>	58:27

<p>USMH: 17964MH DSMH: 16067MH</p> <p>Deposits Attached Encrustation</p> <p>5/19/2015 584.6 ft.</p>

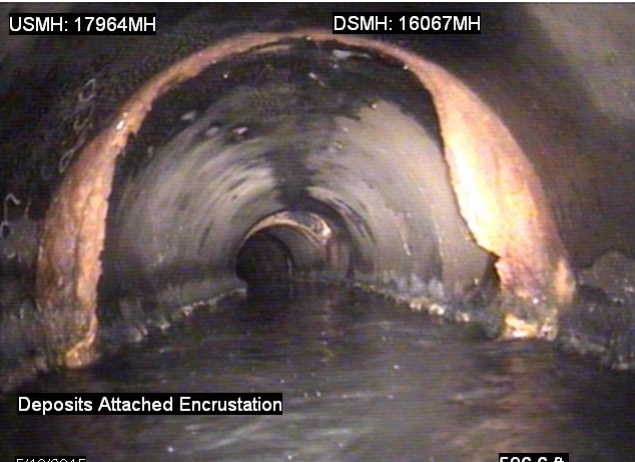
596.6	<p><b>Deposits Attached Encrustation</b>  <b>Position: 8 To 4</b>  <b>Severity: None</b>  <b>Percent: 10</b>  <b>Joint</b>  <b>Attention Required</b>  <b>Maint Weight: 2</b></p>	1:00:13

<p>USMH: 17964MH DSMH: 16067MH</p> <p>Deposits Attached Encrustation</p> <p>5/19/2015 596.6 ft.</p>

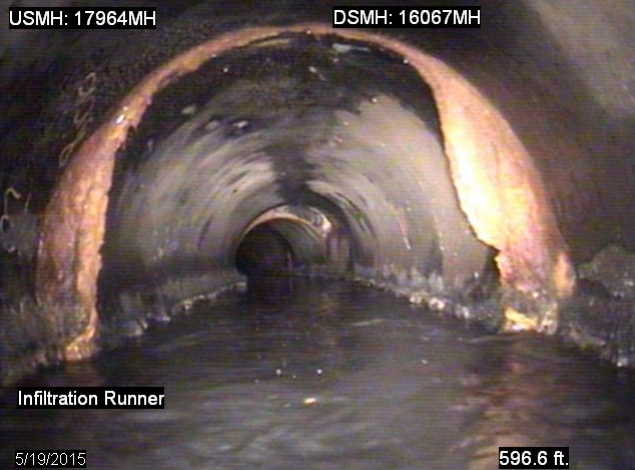
Distance	Fault Observation	Time	Picture
596.6	<p style="text-align: center;"> <b>Infil Runner</b>  <b>Position: 8</b>  <b>Severity: None</b>  <b>Percent: 0</b>  <b>Joint</b>  <b>Attention Required</b>  <b>Maint Weight: 4</b> </p>	1:00:32

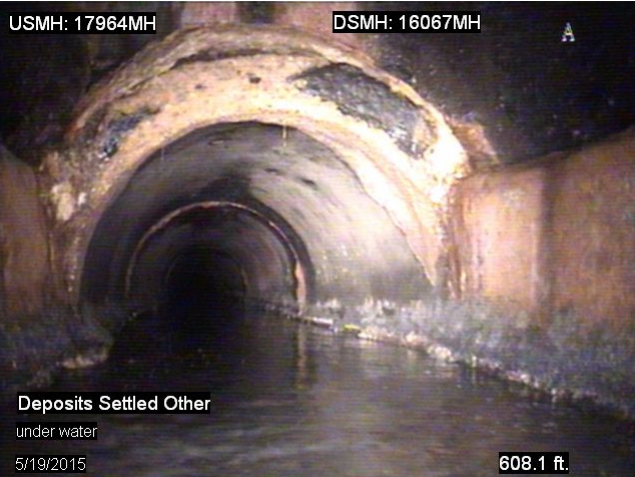
608.1	<p style="text-align: center;"> <b>Deposits Settled Other</b>  <b>Position: 6</b>  <b>Severity: None</b>  <b>Cont Defect: F03</b>  <b>Percent: 5</b>  <b>Attention Required</b>  <b>Remarks: under water</b>  <b>Maint Weight: 2</b> </p>	1:01:22

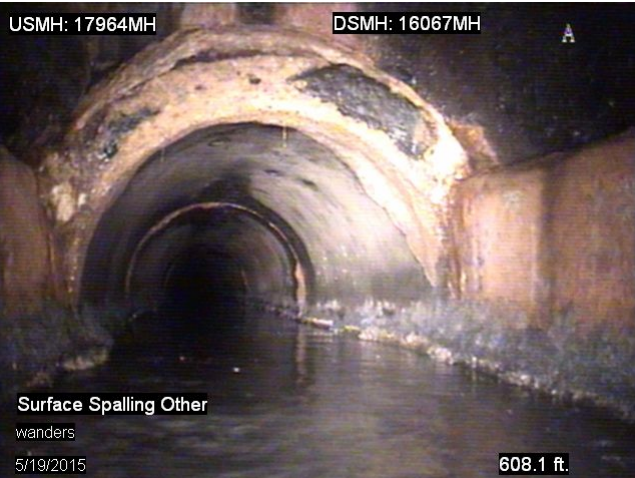
608.1	<p style="text-align: center;"> <b>Surface Spalling Other</b>  <b>Position: 9 To 4</b>  <b>Severity: None</b>  <b>Cont Defect: F01</b>  <b>Percent: 0</b>  <b>Attention Required</b>  <b>Remarks: wanders</b>  <b>Struct Weight: 2</b> </p>	1:01:39

(608.1) SSSZ - Surface Spalling Other - Position: 9 To 4 - Cont Def: F01 Remark: wanders

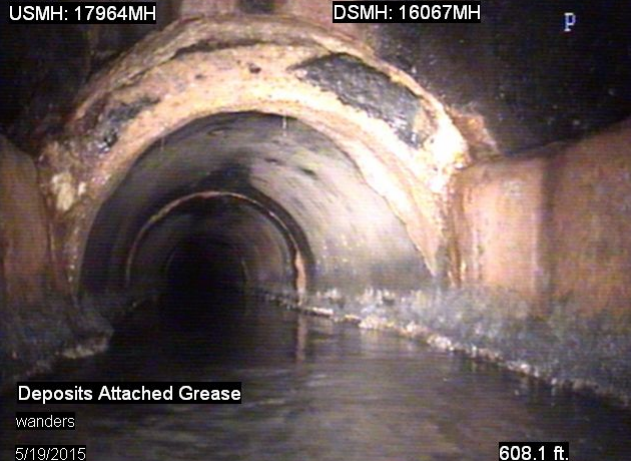
Distance	Fault Observation	Time	Picture
608.1	<p><b>Deposits Attached Grease</b>  <b>Position: 8 To 4</b>  <b>Severity: None</b>  <b>Cont Defect: F02</b>  <b>Percent: 5</b>  <b>Attention Required</b>  <b>Remarks: wanders</b>  <b>Maint Weight: 2</b></p>	1:01:56

<p>USMH: 17964MH DSMH: 16067MH P</p> <p><b>Deposits Attached Grease</b> wanders 5/19/2015 608.1 ft.</p>
610.7	<p><b>General Observation</b>  <b>Severity: None</b>  <b>Percent: 0</b>  <b>Attention Required</b>  <b>Remarks: encrustation in manhole</b></p>	1:03:17

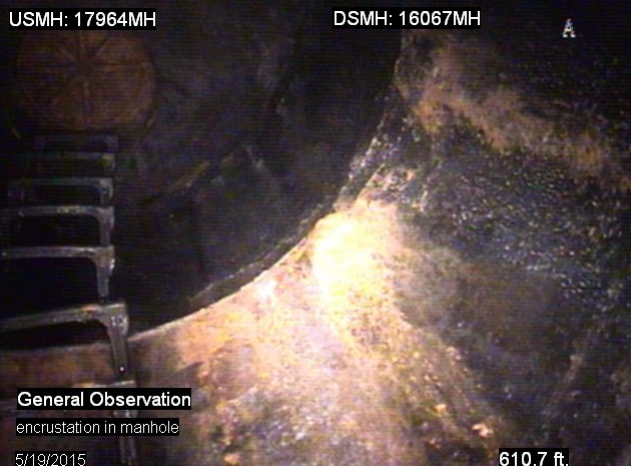
<p>USMH: 17964MH DSMH: 16067MH A</p> <p><b>General Observation</b> encrustation in manhole 5/19/2015 610.7 ft.</p>
610.7	<p><b>Manhole</b>  <b>Severity: None</b>  <b>Percent: 0</b>  <b>Attention Required</b>  <b>Remarks: 16067MH</b></p>	1:03:47

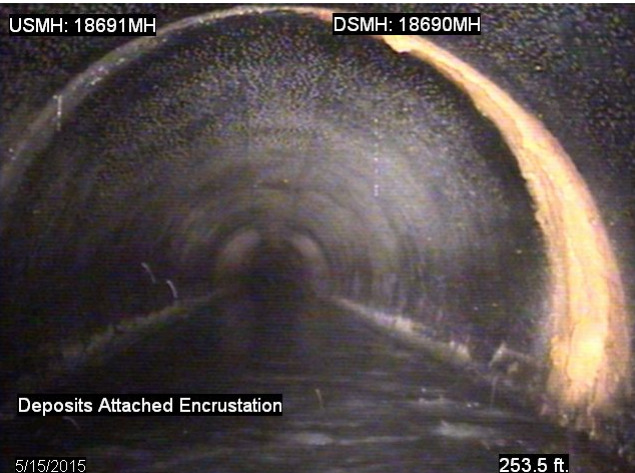
<p>USMH: 18691MH DSMH: 18690MH</p> <p>Deposits Attached Encrustation</p> <p>5/15/2015 253.5 ft.</p>

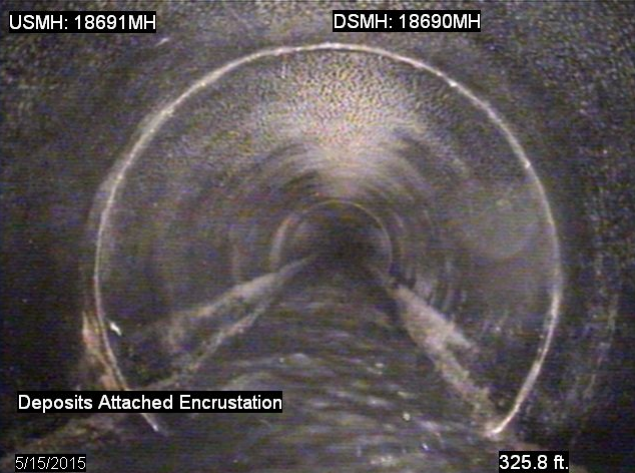
325.8	<b>Deposits Attached Encrustation</b> <b>Position: 8</b> <b>Severity: None</b> <b>Percent: 5</b> <b>Joint</b> <b>Attention Required</b> <b>Maint Weight: 2</b>	30:32

<p>USMH: 18691MH DSMH: 18690MH</p> <p>Deposits Attached Encrustation</p> <p>5/15/2015 325.8 ft.</p>

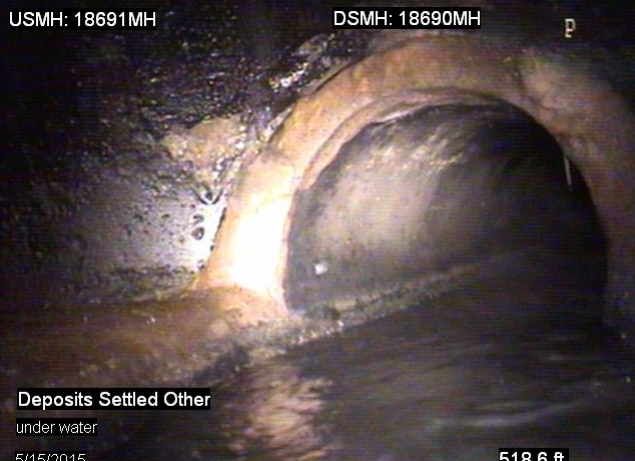
518.6	<p><b>Deposits Settled Other</b>  <b>Position: 6</b>  <b>Severity: None</b>  <b>Cont Defect: F02</b>  <b>Percent: 10</b>  <b>Attention Required</b>  <b>Remarks: under water</b>  <b>Maint Weight: 2</b></p>	44:33

<p>USMH: 18691MH DSMH: 18690MH P</p> <p>Deposits Settled Other under water 5/15/2015 518.6 ft.</p>

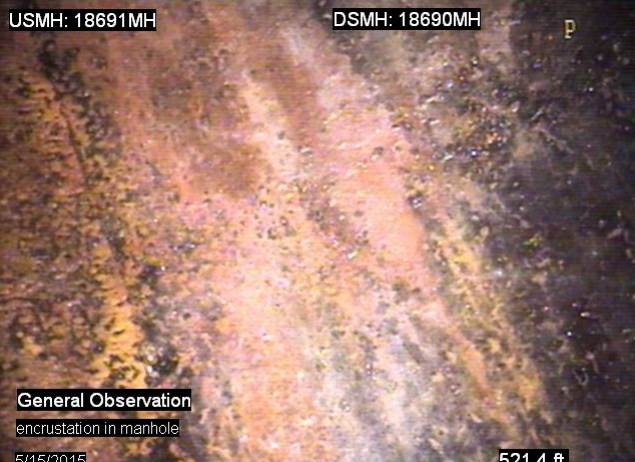
521.4	<p><b>General Observation</b>  <b>Severity: None</b>  <b>Percent: 0</b>  <b>Attention Required</b>  <b>Remarks: encrustation in manhole</b></p>	47:04

<p>USMH: 18691MH DSMH: 18690MH P</p> <p>General Observation encrustation in manhole 5/15/2015 521.4 ft.</p>

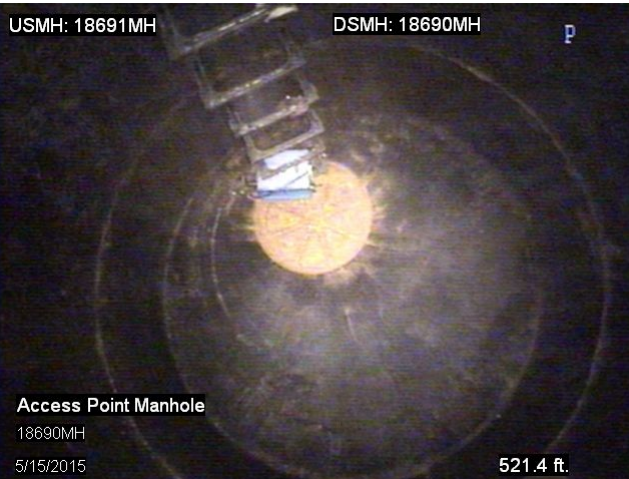
<p>USMH: 18691MH      DSMH: 18690MH      P</p> <p>Access Point Manhole 18690MH 5/15/2015</p> <p align="right">521.4 ft.</p>

Distance	Fault Observation	Time	Picture
521.4	<p align="center"> <b>Manhole</b>  <b>Severity: None</b>  <b>Percent: 0</b>  <b>Attention Required</b>  <b>Remarks: 18690MH</b> </p>	47:18

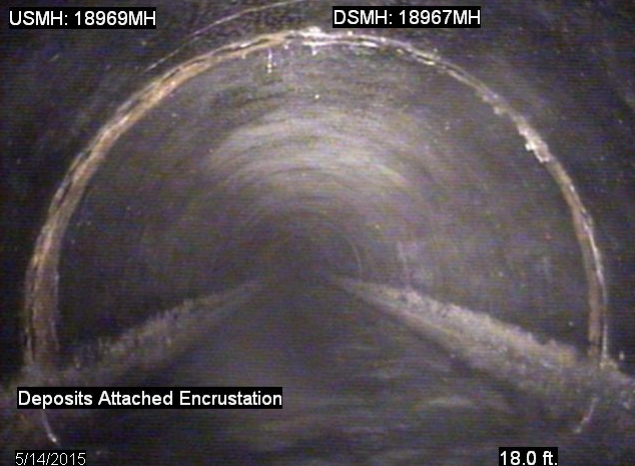
Distance	Fault Observation	Time	Picture
18.0	<b>Deposits Attached Encrustation</b> <b>Position: 8 To 4</b> <b>Severity: None</b> <b>Percent: 5</b> <b>Joint</b> <b>Attention Required</b> <b>Maint Weight: 2</b>	06:51

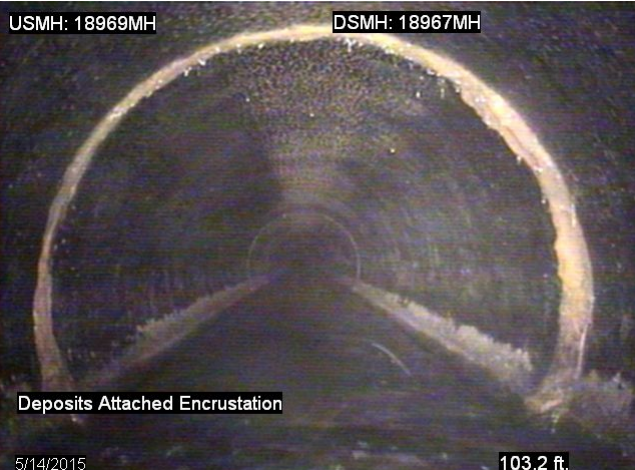
103.2	<b>Deposits Attached Encrustation</b> <b>Position: 7 To 4</b> <b>Severity: None</b> <b>Percent: 5</b> <b>Joint</b> <b>Attention Required</b> <b>Maint Weight: 2</b>	11:59

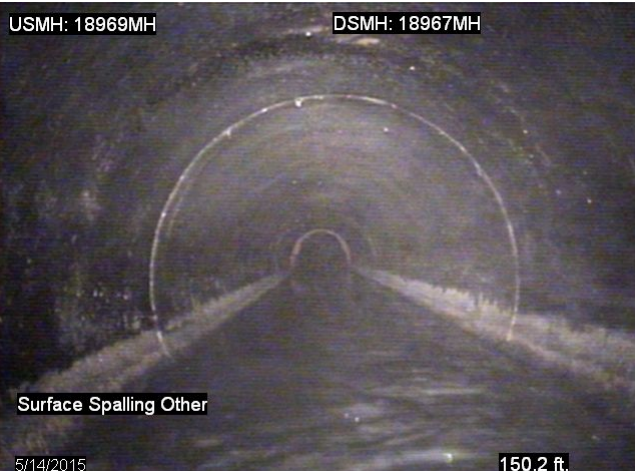
150.2	<b>Surface Spalling Other</b> <b>Position: 12</b> <b>Severity: None</b> <b>Percent: 0</b> <b>Attention Required</b> <b>Struct Weight: 2</b>	15:39

(150.2) SSSZ - Surface Spalling Other - Position: 12

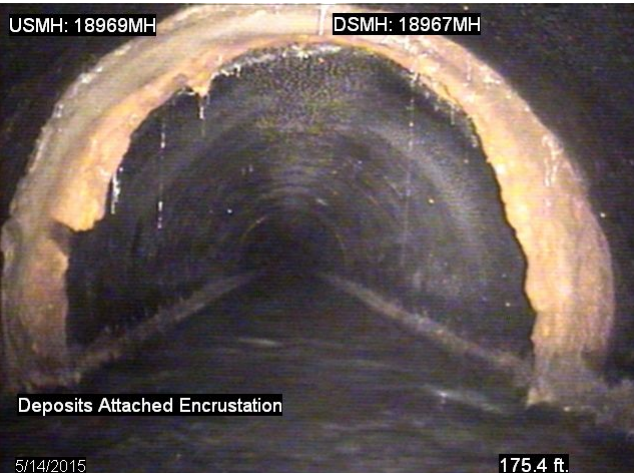
Distance	Fault Observation	Time	Picture
175.4	<p><b>Deposits Attached Encrustation</b>  <b>Position: 7 To 5</b>  <b>Severity: None</b>  <b>Percent: 15</b>  <b>Joint</b>  <b>Attention Required</b>  <b>Maint Weight: 3</b></p>	18:22

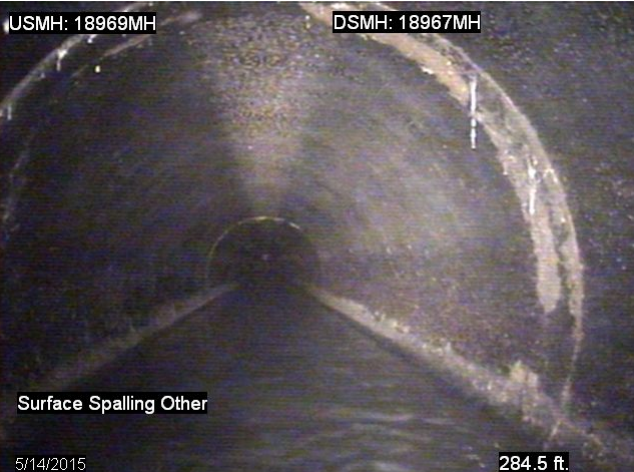
<p>USMH: 18969MH DSMH: 18967MH</p> <p>Deposits Attached Encrustation</p> <p>5/14/2015 175.4 ft.</p>
284.5	<p><b>Surface Spalling Other</b>  <b>Position: 12 To 2</b>  <b>Severity: None</b>  <b>Percent: 0</b>  <b>Joint</b>  <b>Attention Required</b>  <b>Struct Weight: 2</b></p>	25:22

(284.5) SSSZ - Surface Spalling Other - Position: 12 To 2

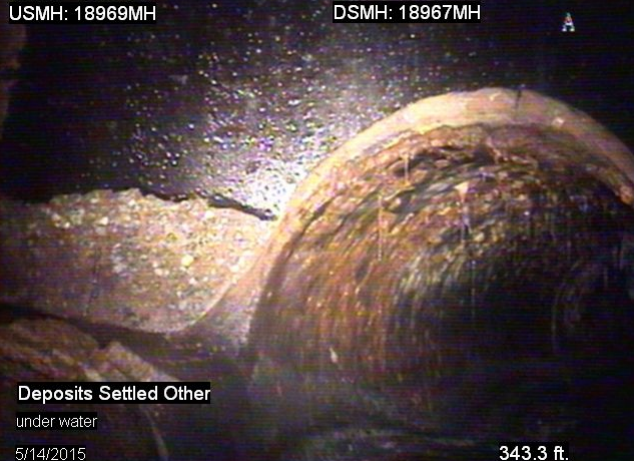
Distance	Fault Observation	Time	Picture
343.3	<p><b>Deposits Settled Other</b>  <b>Position: 6</b>  <b>Severity: None</b>  <b>Cont Defect: F02</b>  <b>Percent: 10</b>  <b>Attention Required</b>  <b>Remarks: under water</b>  <b>Maint Weight: 2</b></p>	29:41

<p>USMH: 18969MH DSMH: 18967MH</p> <p><b>Deposits Settled Other</b>  under water  5/14/2015 343.3 ft.</p>

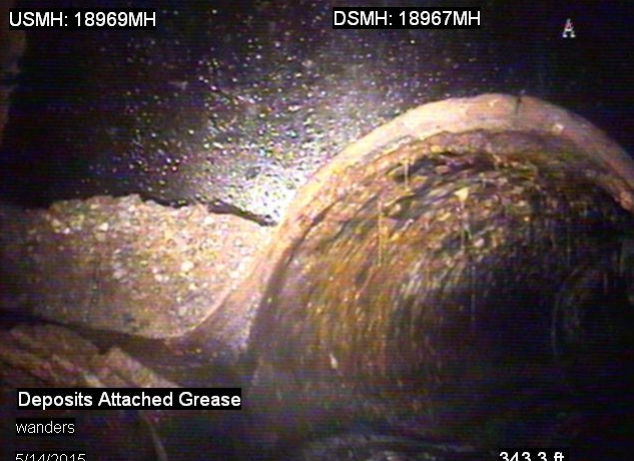
343.3	<p><b>Deposits Attached Grease</b>  <b>Position: 8 To 4</b>  <b>Severity: None</b>  <b>Cont Defect: F01</b>  <b>Percent: 5</b>  <b>Attention Required</b>  <b>Remarks: wanders</b>  <b>Maint Weight: 2</b></p>	29:51

<p>USMH: 18969MH DSMH: 18967MH</p> <p><b>Deposits Attached Grease</b>  wanders  5/14/2015 343.3 ft.</p>

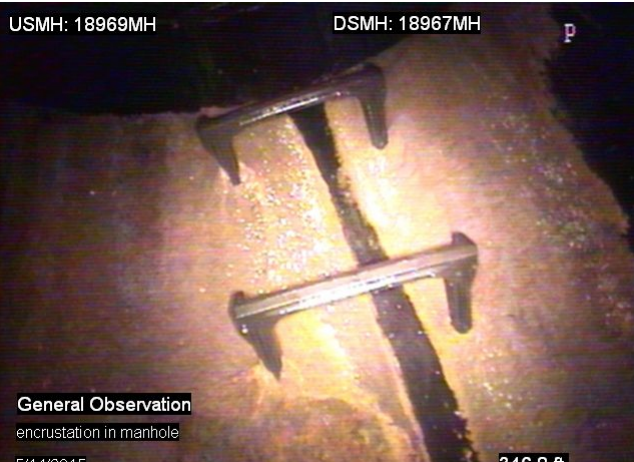
346.8	<p><b>General Observation</b>  <b>Severity: None</b>  <b>Percent: 0</b>  <b>Attention Required</b>  <b>Remarks: encrustation in manhole</b></p>	32:55

<p>USMH: 18969MH DSMH: 18967MH</p> <p><b>General Observation</b>  encrustation in manhole  5/14/2015 346.8 ft.</p>

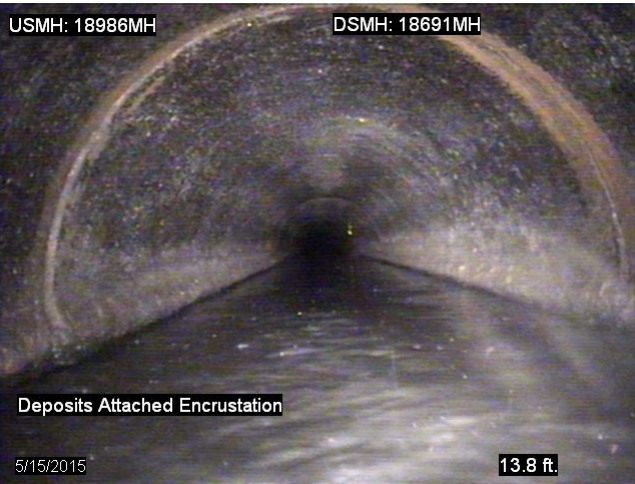
Distance	Fault Observation	Time	Picture
13.8	<b>Deposits Attached Encrustation</b> <b>Position: 8 To 4</b> <b>Severity: None</b> <b>Percent: 5</b> <b>Joint</b> <b>Attention Required</b> <b>Maint Weight: 2</b>	04:12

<p>USMH: 18986MH DSMH: 18691MH</p> <p>Deposits Attached Encrustation</p> <p>5/15/2015 13.8 ft.</p>

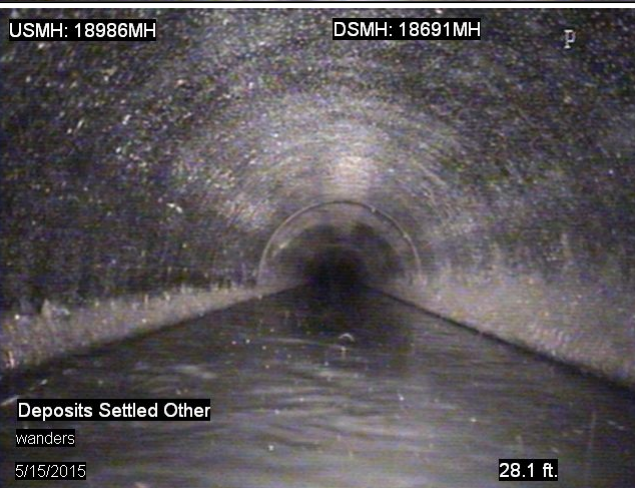
28.1	<b>Deposits Settled Other</b> <b>Position: 6</b> <b>Severity: None</b> <b>Cont Defect: S02</b> <b>Percent: 5</b> <b>Attention Required</b> <b>Remarks: under water</b> <b>Maint Weight: 2</b>	05:33

<p>USMH: 18986MH DSMH: 18691MH</p> <p>Deposits Settled Other</p> <p>wanders</p> <p>5/15/2015 28.1 ft.</p>

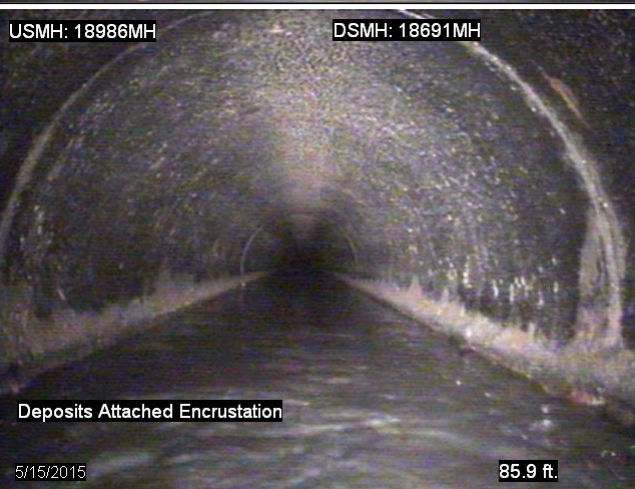
85.9	<b>Deposits Attached Encrustation</b> <b>Position: 2</b> <b>Severity: None</b> <b>Percent: 5</b> <b>Joint</b> <b>Attention Required</b> <b>Maint Weight: 2</b>	10:55

<p>USMH: 18986MH DSMH: 18691MH</p> <p>Deposits Attached Encrustation</p> <p>5/15/2015 85.9 ft.</p>

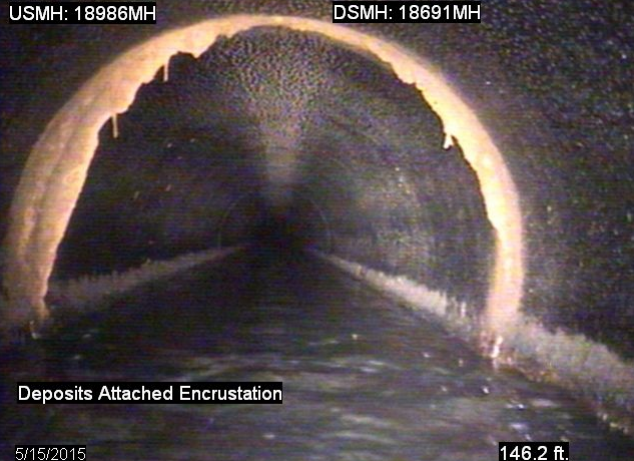
Distance	Fault Observation	Time	Picture
146.2	<p><b>Deposits Attached Encrustation</b>  <b>Position: 7 To 5</b>  <b>Severity: None</b>  <b>Percent: 10</b>  <b>Joint</b>  <b>Attention Required</b>  <b>Maint Weight: 2</b></p>	15:29

<p>USMH: 18986MH DSMH: 18691MH</p> <p>Deposits Attached Encrustation</p> <p>5/15/2015 146.2 ft.</p>

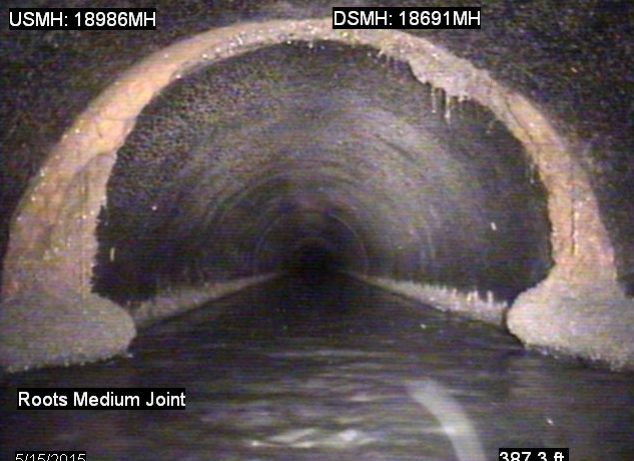
387.3	<p><b>Roots Medium Joint</b>  <b>Position: 8 To 4</b>  <b>Severity: None</b>  <b>Percent: 10</b>  <b>Joint</b>  <b>Attention Required</b>  <b>Maint Weight: 3</b></p>	34:20

<p>USMH: 18986MH DSMH: 18691MH</p> <p>Roots Medium Joint</p> <p>5/15/2015 387.3 ft.</p>

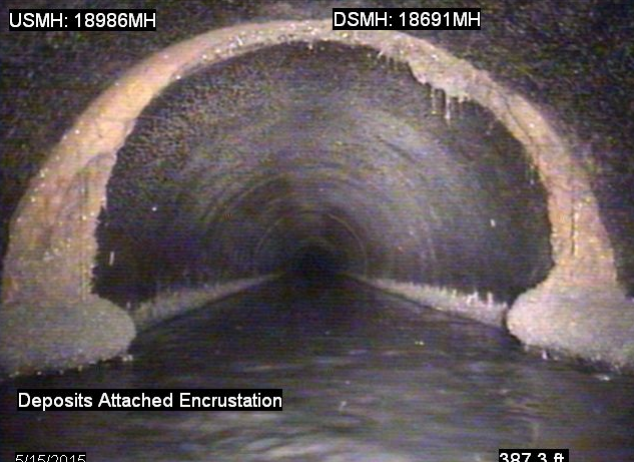
387.3	<p><b>Deposits Attached Encrustation</b>  <b>Position: 8 To 4</b>  <b>Severity: None</b>  <b>Percent: 5</b>  <b>Joint</b>  <b>Attention Required</b>  <b>Maint Weight: 2</b></p>	34:43

<p>USMH: 18986MH DSMH: 18691MH</p> <p>Deposits Attached Encrustation</p> <p>5/15/2015 387.3 ft.</p>

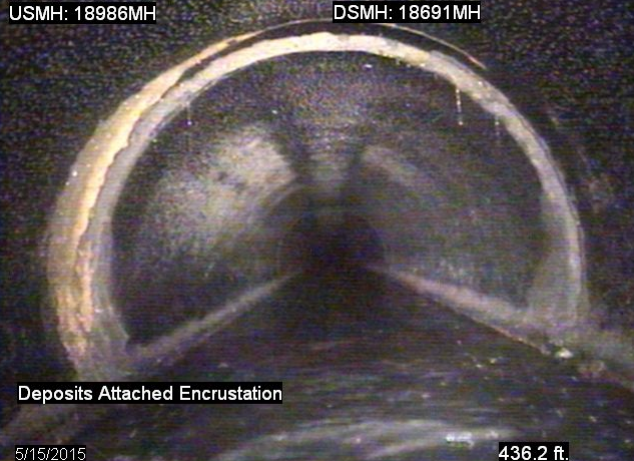
Distance	Fault Observation	Time	Picture
436.2	<b>Deposits Attached Encrustation</b> <b>Position: 8 To 2</b> <b>Severity: None</b> <b>Percent: 5</b> <b>Attention Required</b> <b>Maint Weight: 2</b>	40:27

<p>USMH: 18986MH DSMH: 18691MH</p> <p>Deposits Attached Encrustation</p> <p>5/15/2015 436.2 ft.</p>

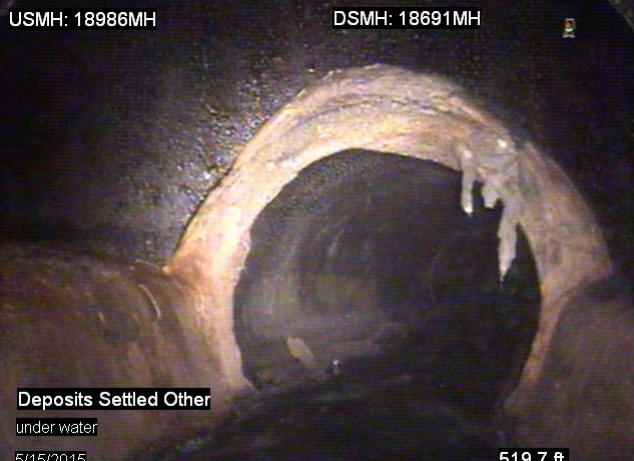
519.7	<b>Deposits Settled Other</b> <b>Position: 6</b> <b>Severity: None</b> <b>Cont Defect: F02</b> <b>Percent: 5</b> <b>Attention Required</b> <b>Remarks: under water</b> <b>Maint Weight: 2</b>	44:46

<p>USMH: 18986MH DSMH: 18691MH</p> <p>Deposits Settled Other</p> <p>under water</p> <p>5/15/2015 519.7 ft.</p>

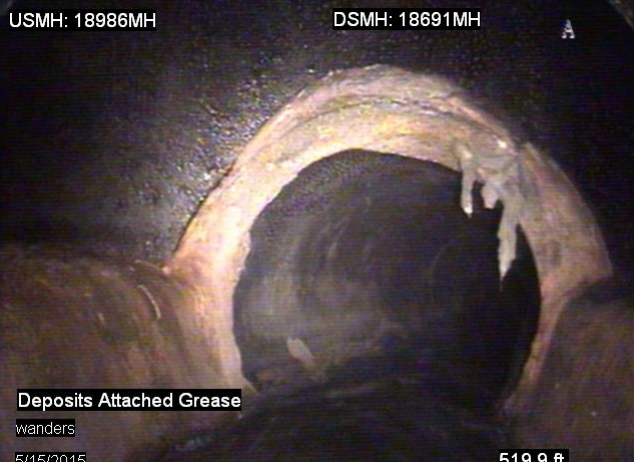
519.9	<b>Deposits Attached Grease</b> <b>Position: 7 To 5</b> <b>Severity: None</b> <b>Cont Defect: F01</b> <b>Percent: 5</b> <b>Attention Required</b> <b>Remarks: wanders</b> <b>Maint Weight: 2</b>	45:05

<p>USMH: 18986MH DSMH: 18691MH</p> <p>Deposits Attached Grease</p> <p>wanders</p> <p>5/15/2015 519.9 ft.</p>
