Addendum Number 3

Lake Peachtree Spillway Replacement Project

United Consulting is pleased to submit this report of the Ground Penetrating Radar Survey at the **Lake Peachtree Dam** located in Peachtree City, Fayette County, Georgia. This report includes a review of the scope of work and a summary of the subsurface conditions encountered.

CONSTRUCTION PLANS FOR LAKE PEACHTREE SPILLWAY REPLACEMENT PROJECT

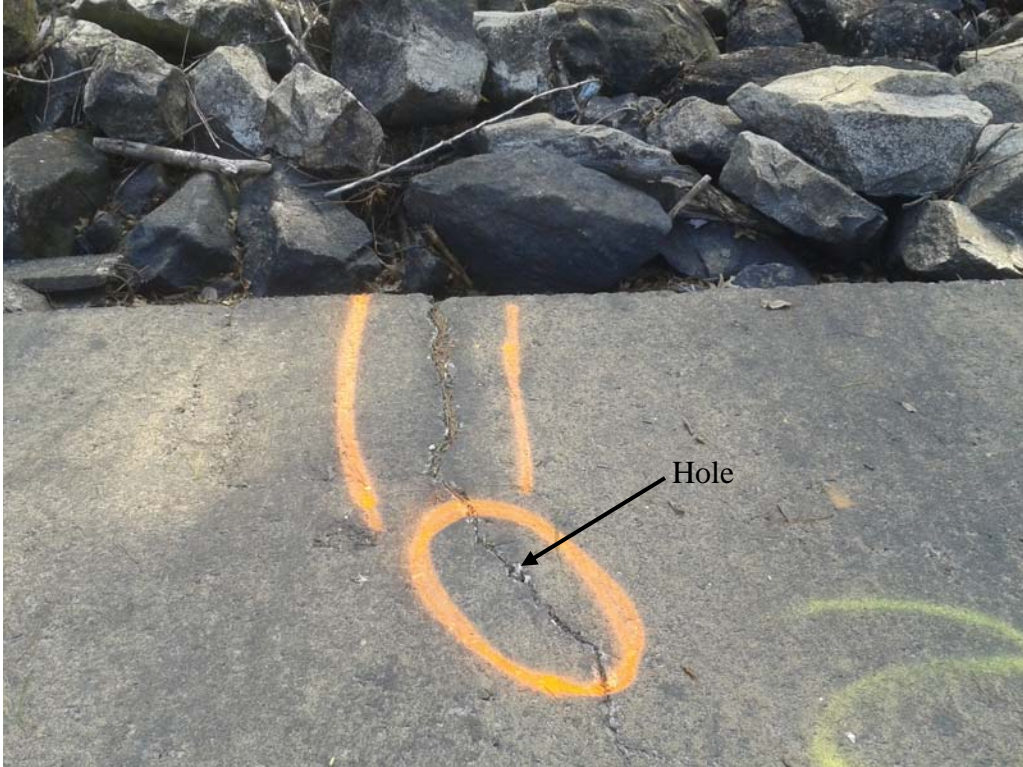
Figure 2: View of the hole found along a crack on the downstream face of the dam.

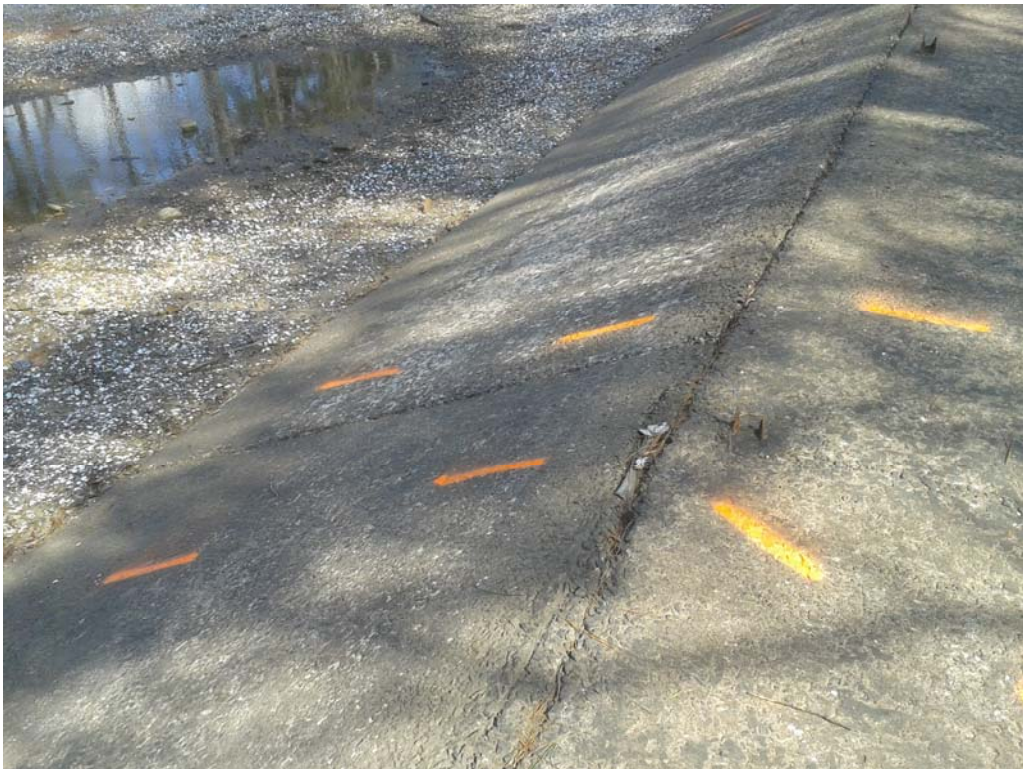
Figure 3: View of one of the anomalous areas on the lakeside of the dam.

anomalous GPR reflections consistent with soils that have been disturbed. These areas did not appear to contain major voids but it does appear that water has penetrated the joints and is affecting the soils below. Figure 3 is a photograph of one of these locations and Figure 10 is a sample GPR cross section from the lakeside face of the dam.

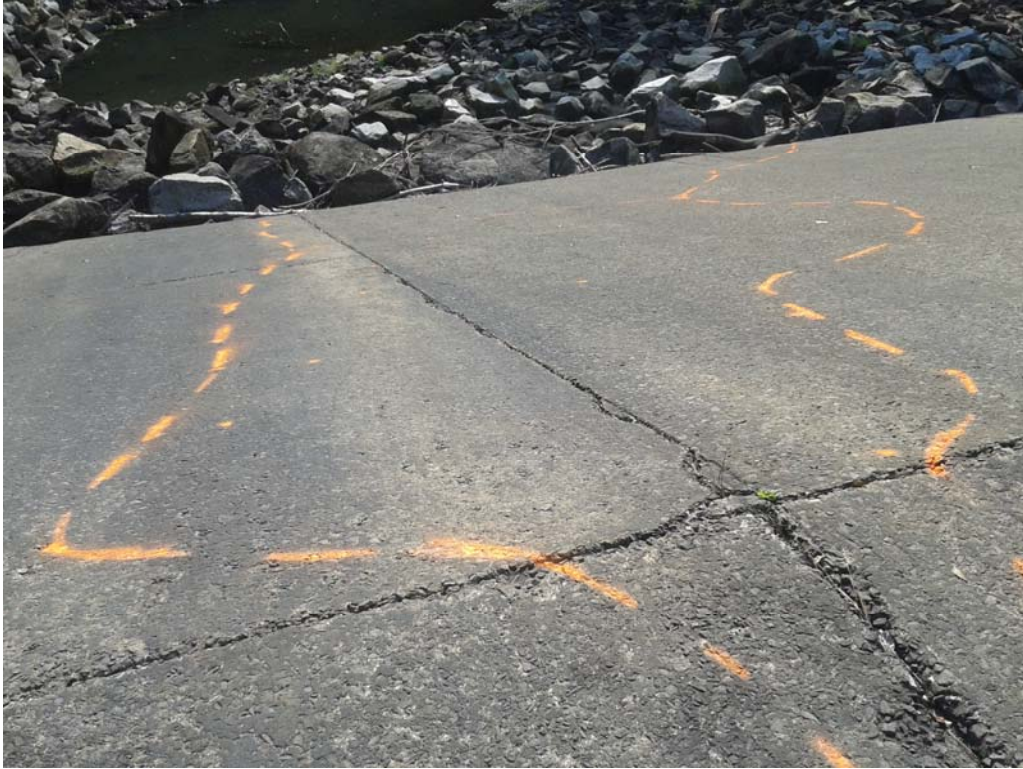
Figure 4: View the northeast anomalous area on the downstream face of the dam.

The area located on the northeast side of the downstream face continued along the joint across the top of the dam and can be seen in the photographs labeled as Figures 4 and 5. Sample GPR cross sections of this area are below as Figures 11 and 12. In the area shown on Figure 1 the GPR data contained anomalous GPR reflections consistent with voids and/or soils that have been substantially disturbed. As can be seen in the two GPR cross sections, marked between the white lines, the soils in the dam appear to be affected from just below the concrete to the extent of the testing depth of ten feet.

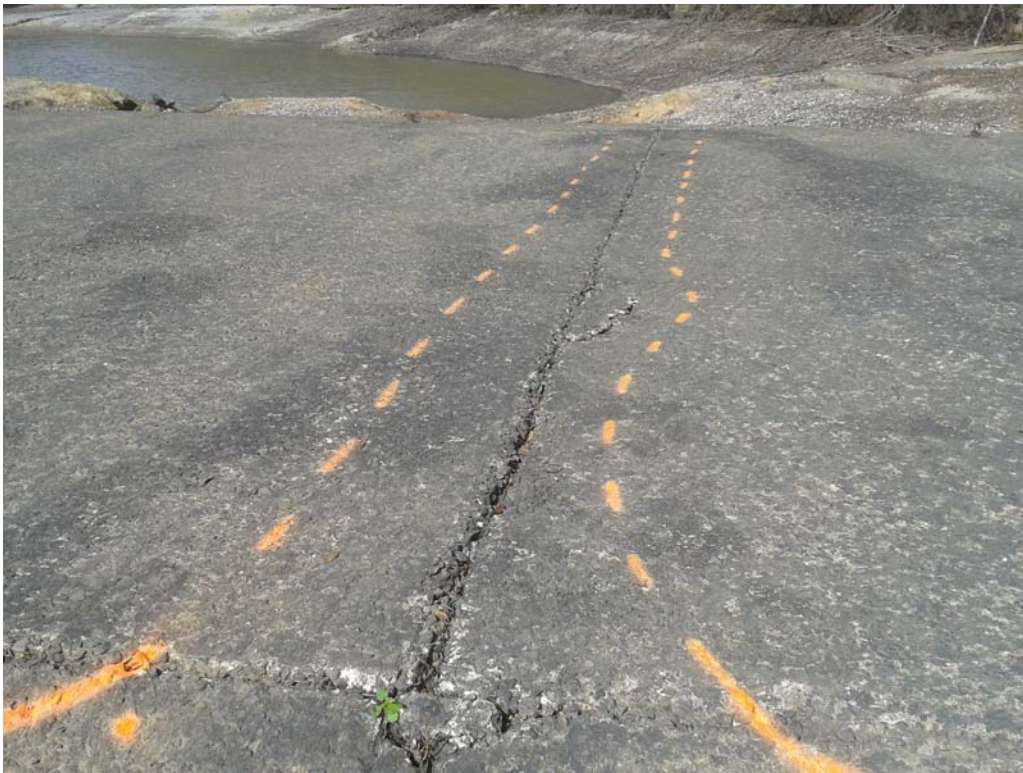
Figure 5: View the anomalous area to the northeast along the top of the dam.

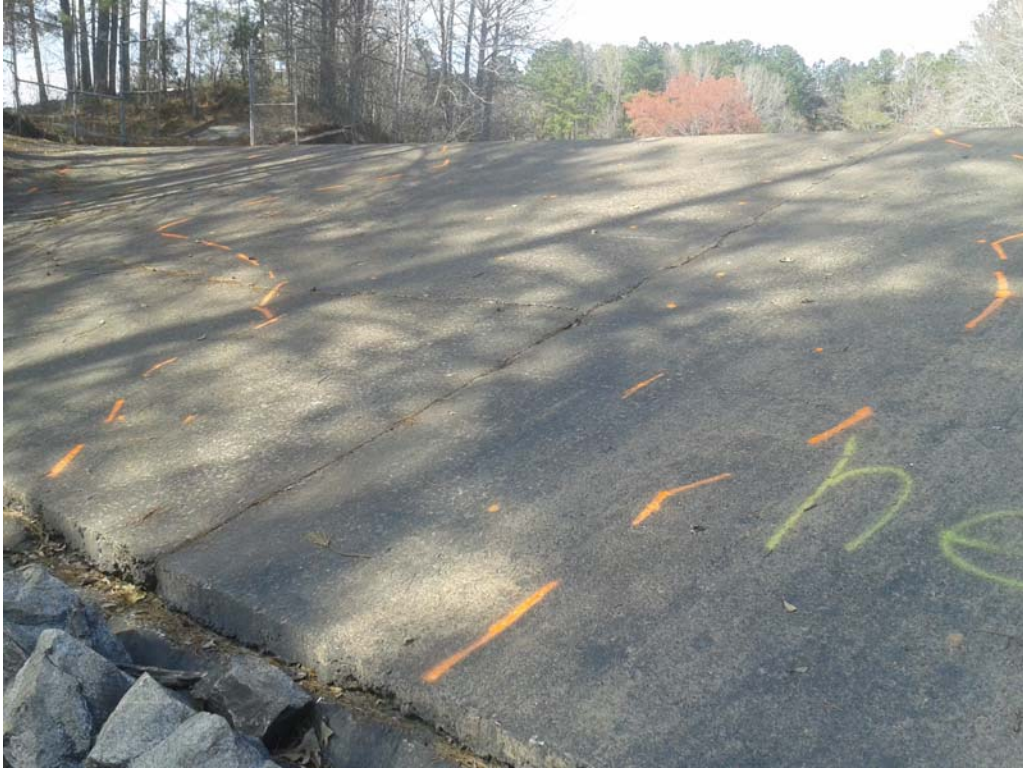
Figure 6: View the northwest anomalous area on the downstream face of the dam.

The area located on the northwest side of the downstream face can be seen in the photograph labeled as Figure 6. As with the northeast anomaly it continued along the joint across the top of the dam. Sample GPR cross sections of this area are below as Figures 13 and 14. In the area shown on Figure 1 the GPR data contained anomalous GPR reflections consistent with voids and/or soils that have been substantially disturbed. As can be seen in the two GPR cross sections, marked between the white lines, the soils in the dam appear to be affected from just below the concrete to the extent of the testing depth of ten feet.

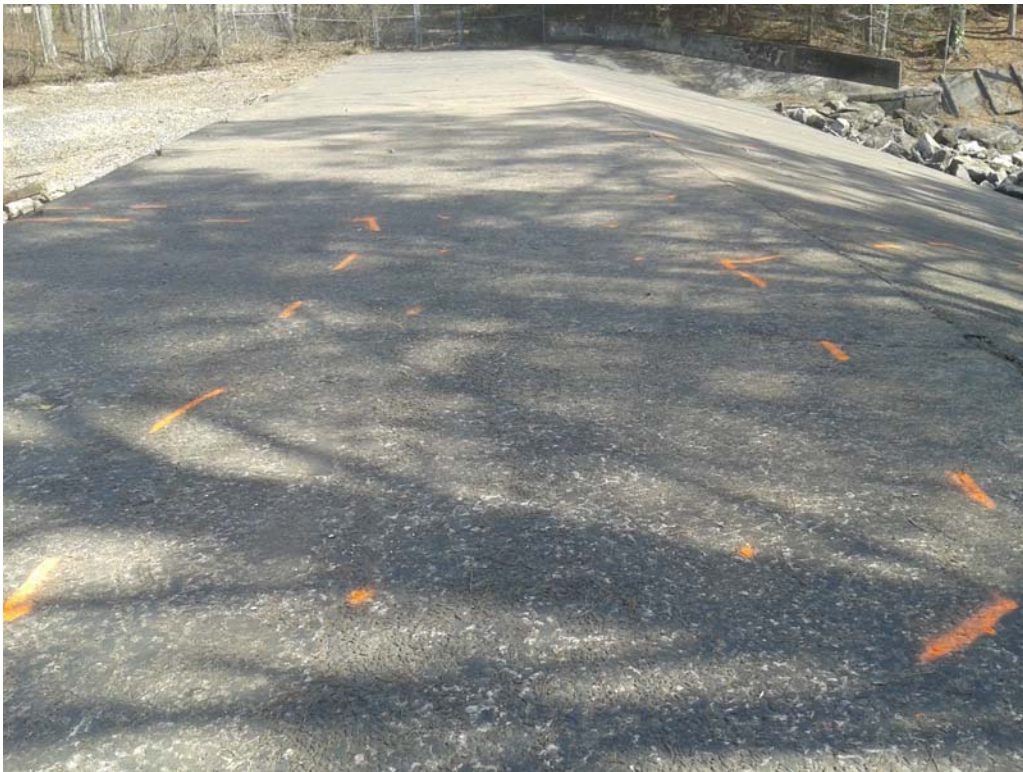
Figure 7: View the northwest anomalous area along the top of the dam.

The area located at the northwest side of the top of the dam on Figure 1 was determined to contain anomalous GPR reflections consistent with voids and/or soils that have been substantially disturbed. Figure 7 is a photograph of this area and Figure 15 is a sample GPR cross section of the area. Similar to the northeast and northwest anomalous areas in the GPR cross section, marked between the white lines, the soils in the dam appear to be affected from just below the concrete to the extent of the testing depth of ten feet.

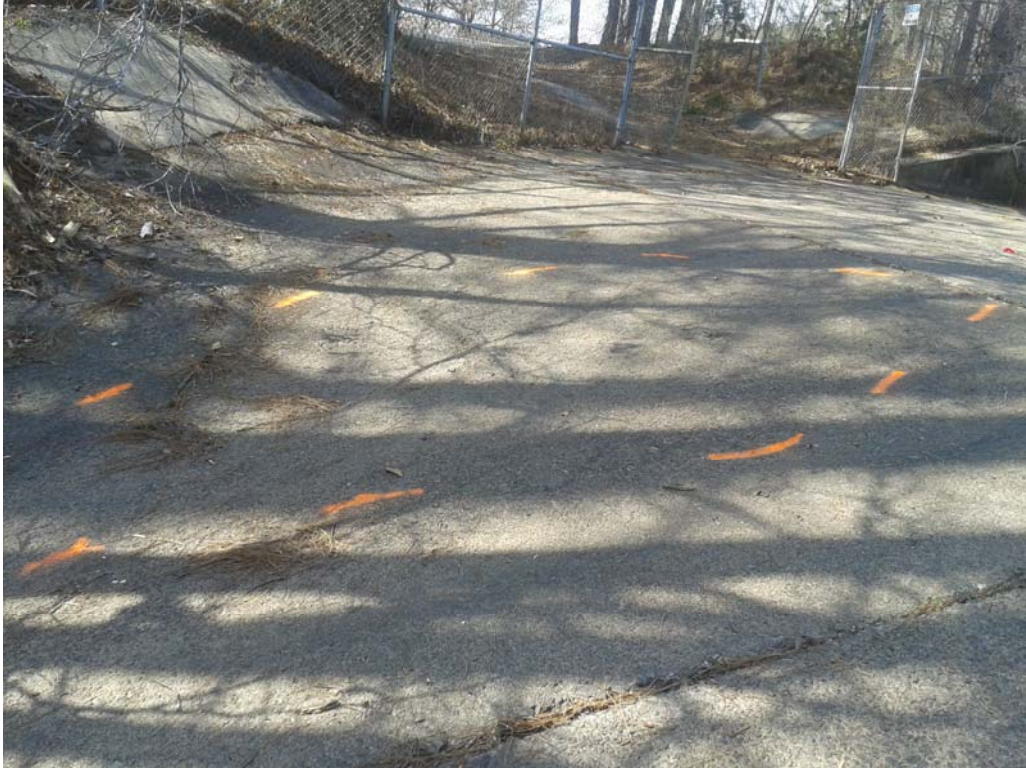
Figure 8: View the possibly anomalous area in the northwest corner of the dam.

The last area is located in the northwest apron of the downstream face. At this location the GPR data appeared to indicate the anomalous area that is shown on Figure 1. Figure 8 is a photograph of this area. However, due to the shape and topography of this area it was difficult to completely survey with the GPR. We were also unable to visually determine where the fill soils met the original ground surface. It is possible that the anomalous reflections in this area could be caused

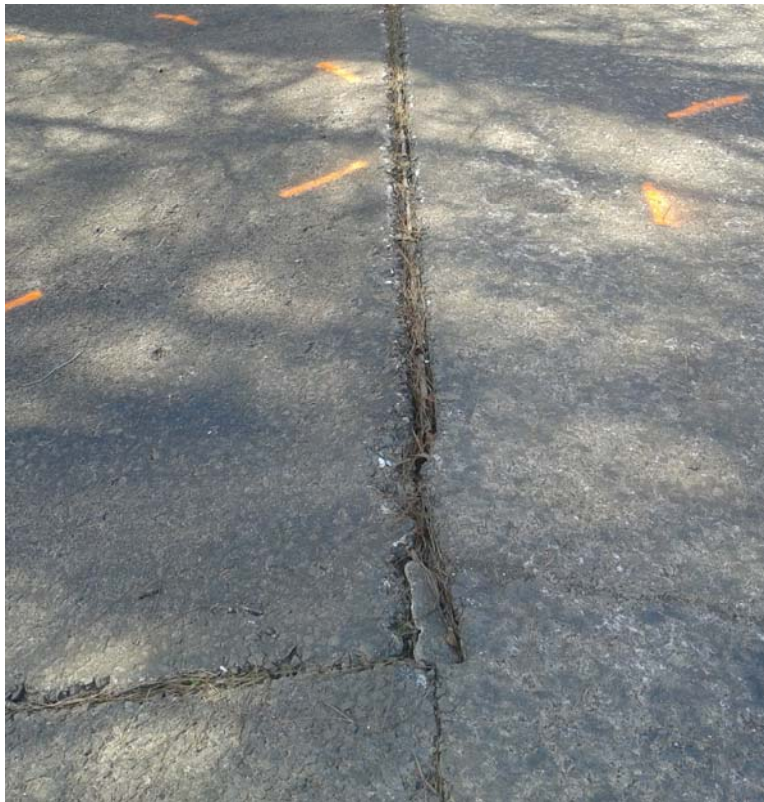
Figure 9: View the damaged control joint at the northwest end of the dam between the top and the downstream face of the dam.

by the dielectric difference between the residual soils and the soils placed during construction of the dam. We would suggest that if further investigation and/or if remediation is planned for the noted anomalous areas of the dam that this area be included as part of that plan. Additionally, in Figure 9 the control joint at the intersection of the top and downstream face can be seen. Since this joint is in poor condition and contains at least two repair points it is likely a water infiltration point.

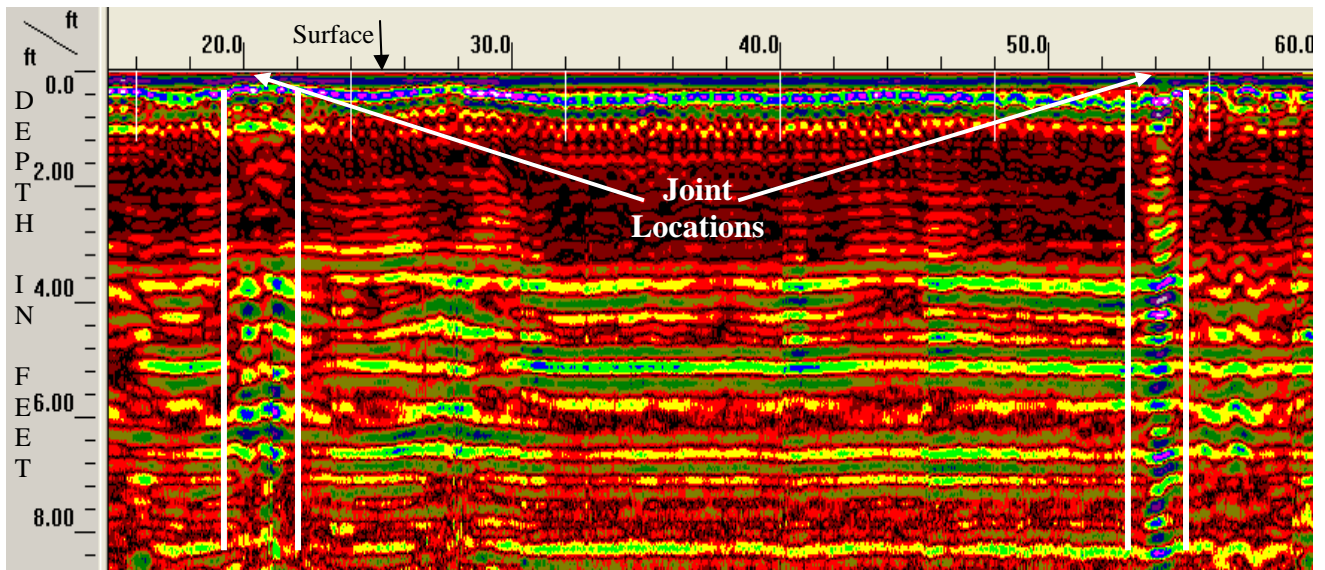
Figure 10: Sample GPR cross section of the anomalous areas located along the joints on the lakeside of the dam. Anomalous area is located between the white lines.

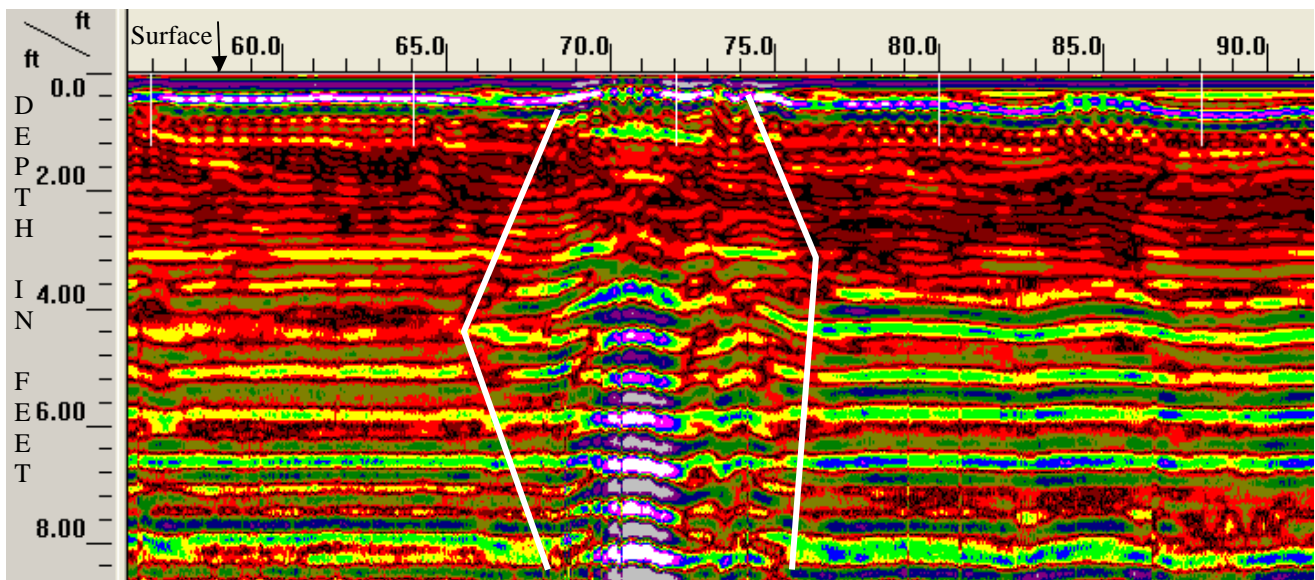
Figure 11: Sample GPR cross section of the conditions beneath the northeast anomalous area on the downstream face of the dam. Anomalous area is located between the white lines.

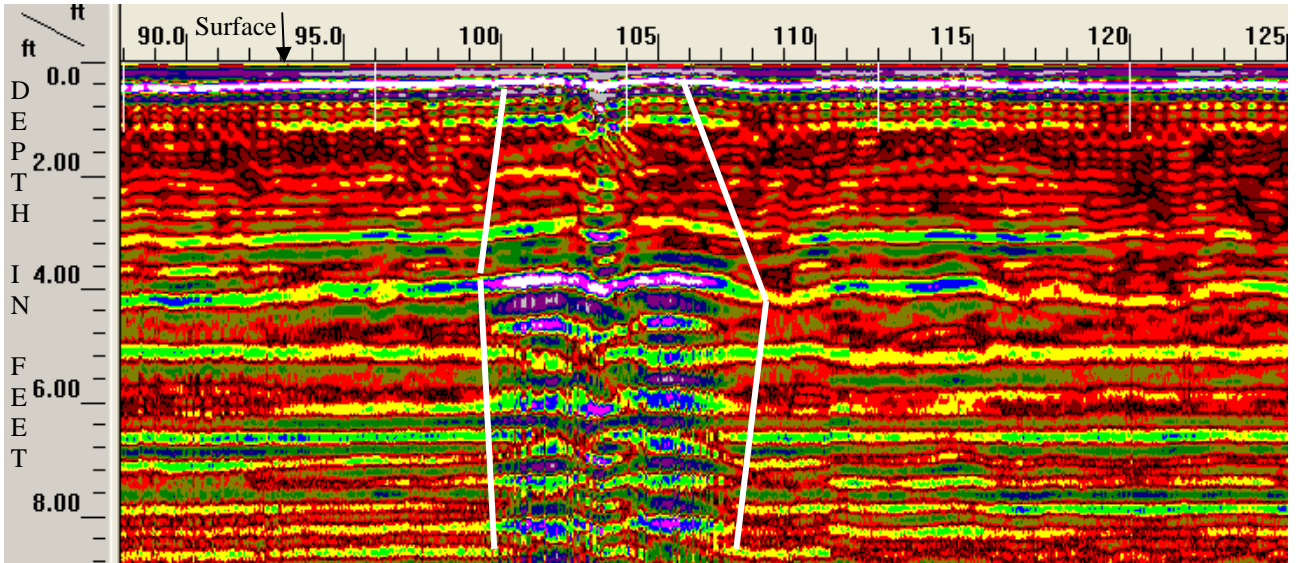
Figure 12: Sample GPR cross section of the conditions beneath the northeast anomalous area on the downstream face of the dam. Anomalous area is located between the white lines.

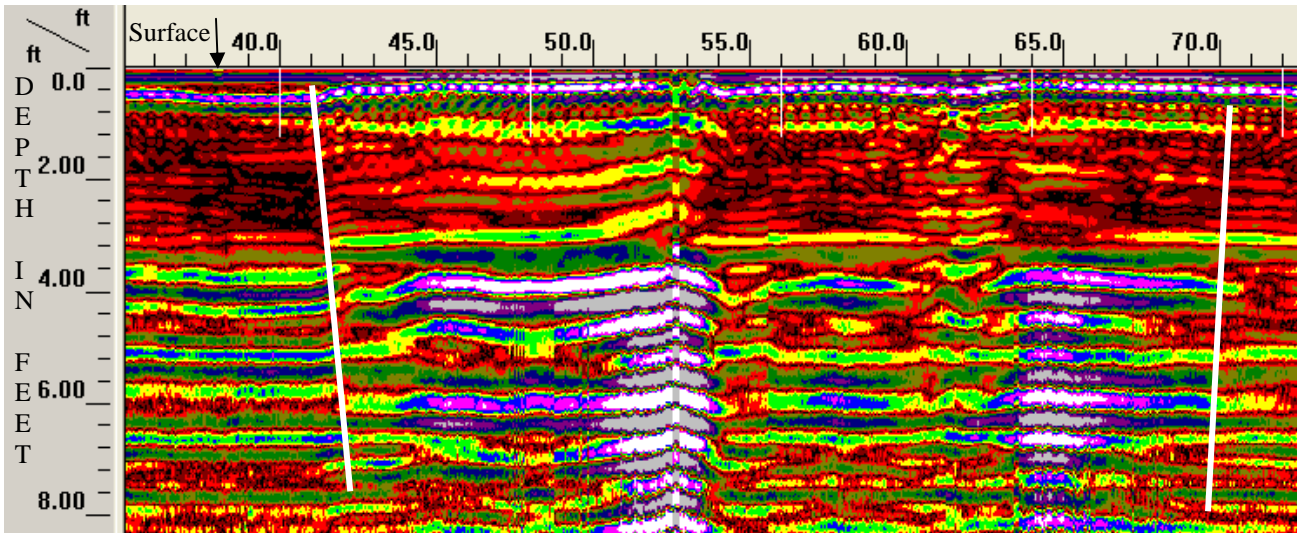
Figure 13: Sample GPR cross section of the conditions beneath the northwest anomalous area on the downstream face of the dam. Anomalous area is located between the white lines.

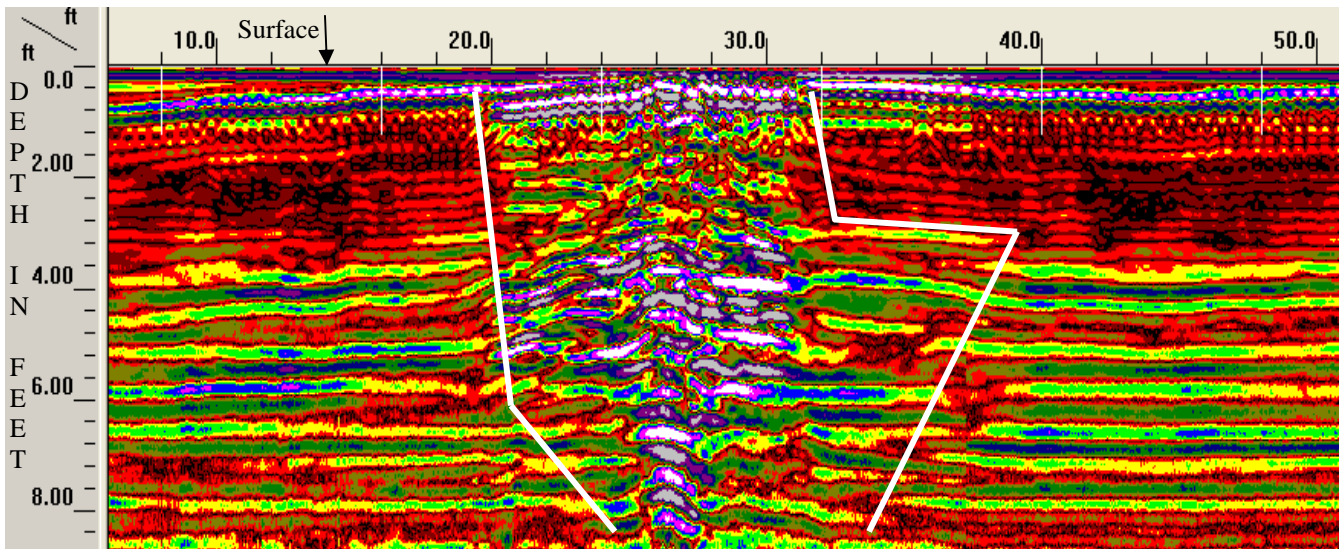
Figure 14: Sample GPR cross section of the conditions beneath the northwest anomalous area on the downstream face of the dam. Anomalous area is located between the white lines.

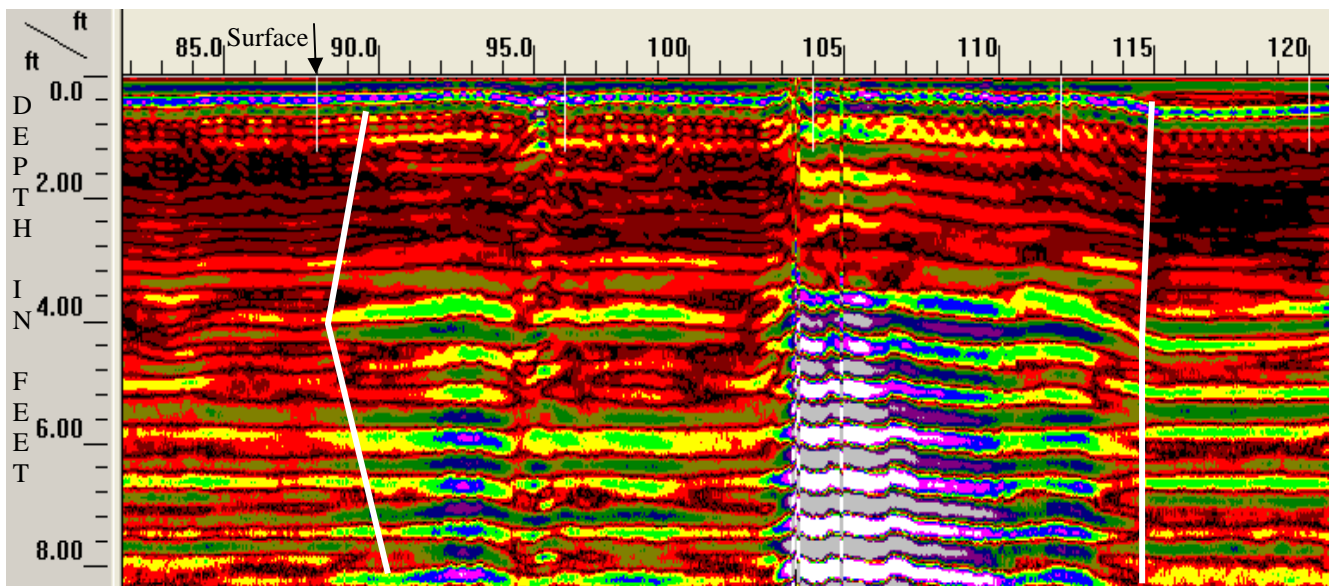
Figure 15: Sample GPR cross section of the conditions beneath the anomalous area along the top of the dam. Anomalous area is located between the white lines.

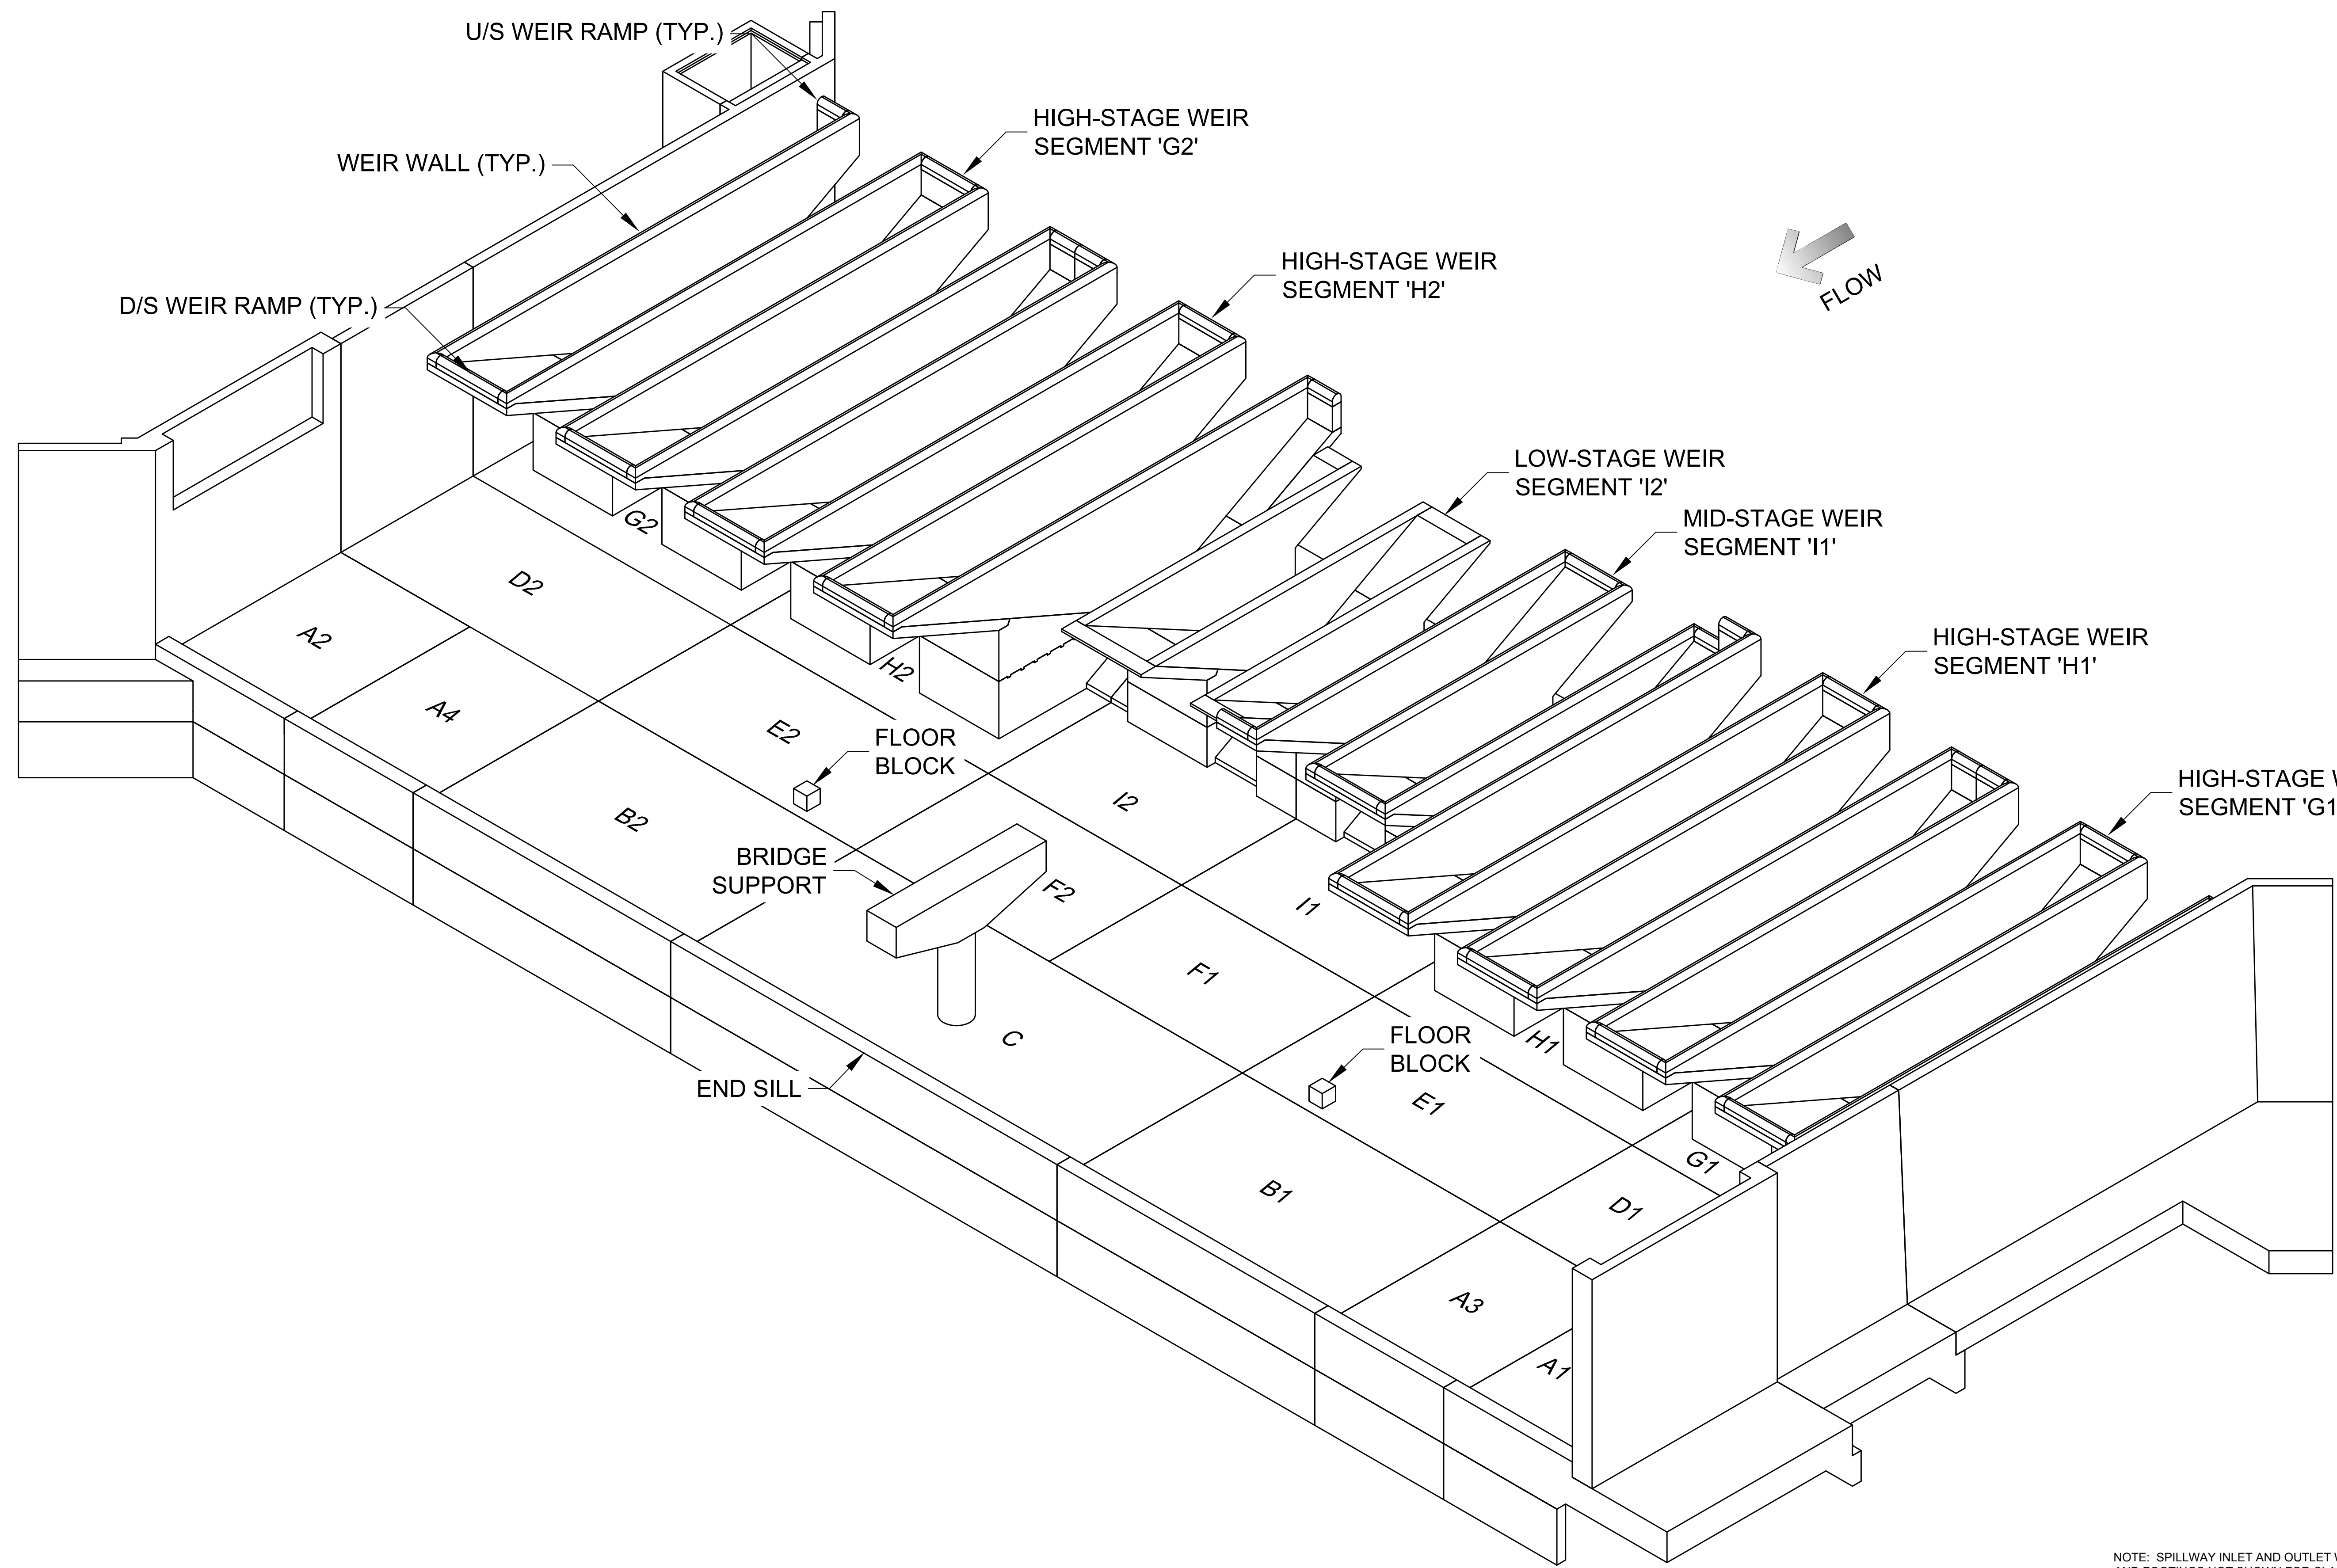
1 ISOMETRIC VIEW OF PIANO KEY WEIR
N.T.S.

NOTE: SPILLWAY INLET AND OUTLET WINGWALLS AND FOOTINGS NOT SHOWN FOR CLARITY. SEE SERVICE SPILLWAY LAYOUT PLAN SHEET 14 FOR ENTIRE SPILLWAY LAYOUT.
