Addendum Number 3

Lake Peachtree Spillway Replacement Project

United Consulting is pleased to submit this report of the Ground Penetrating Radar Survey at the **Lake Peachtree Dam** located in Peachtree City, Fayette County, Georgia. This report includes a review of the scope of work and a summary of the subsurface conditions encountered.

CONSTRUCTION PLANS FOR LAKE PEACHTREE SPILLWAY REPLACEMENT PROJECT

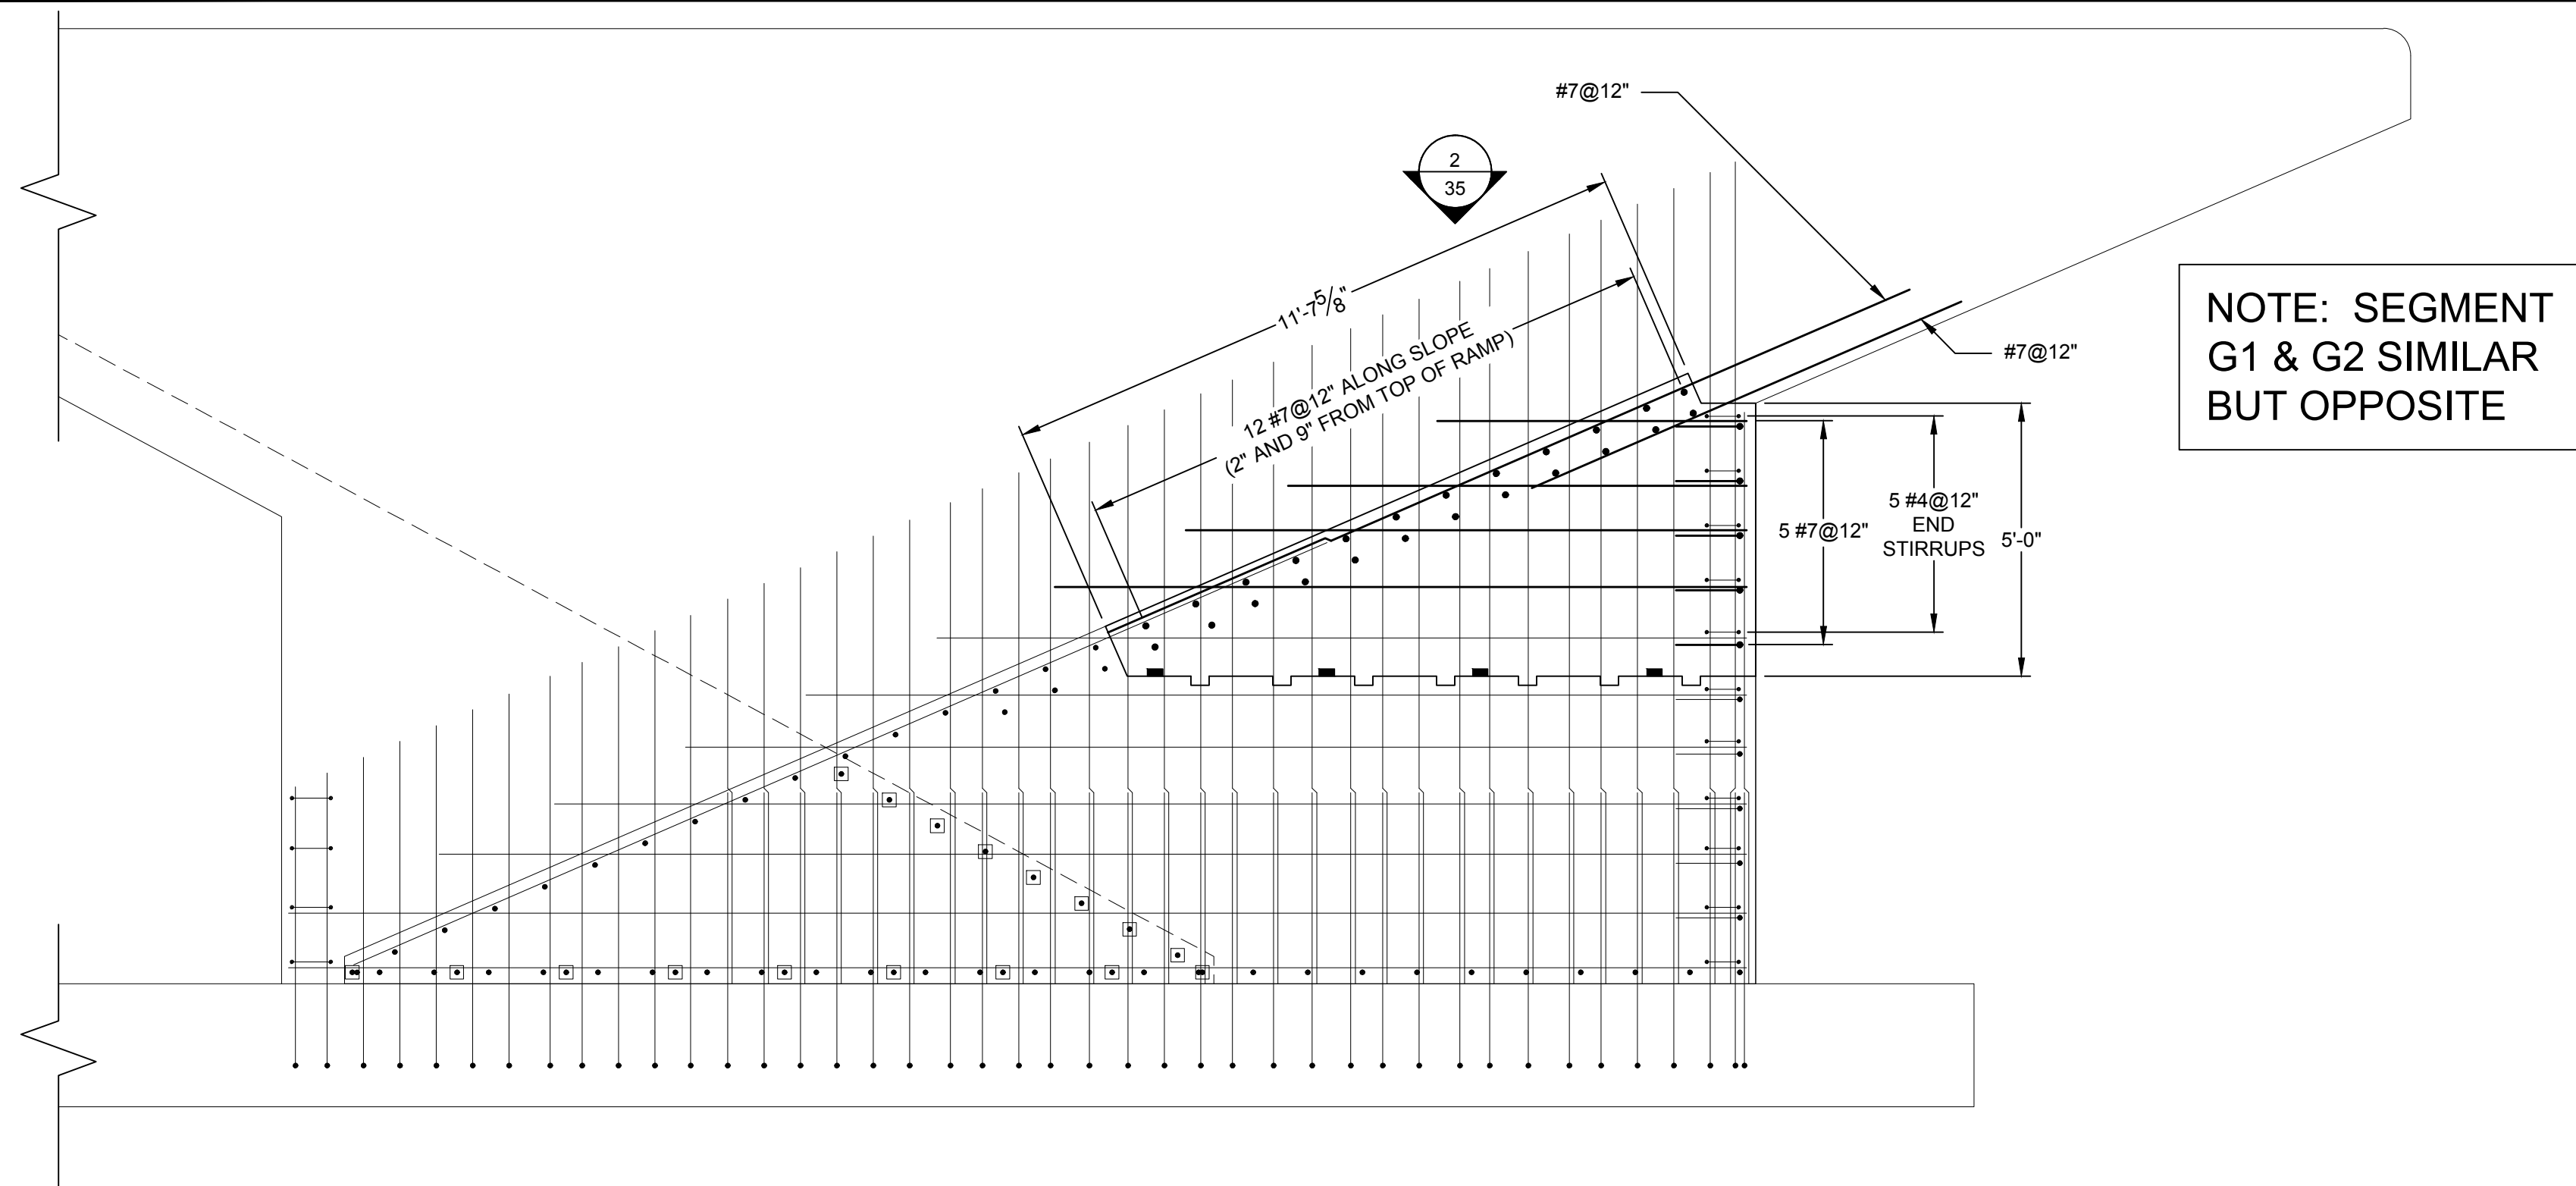
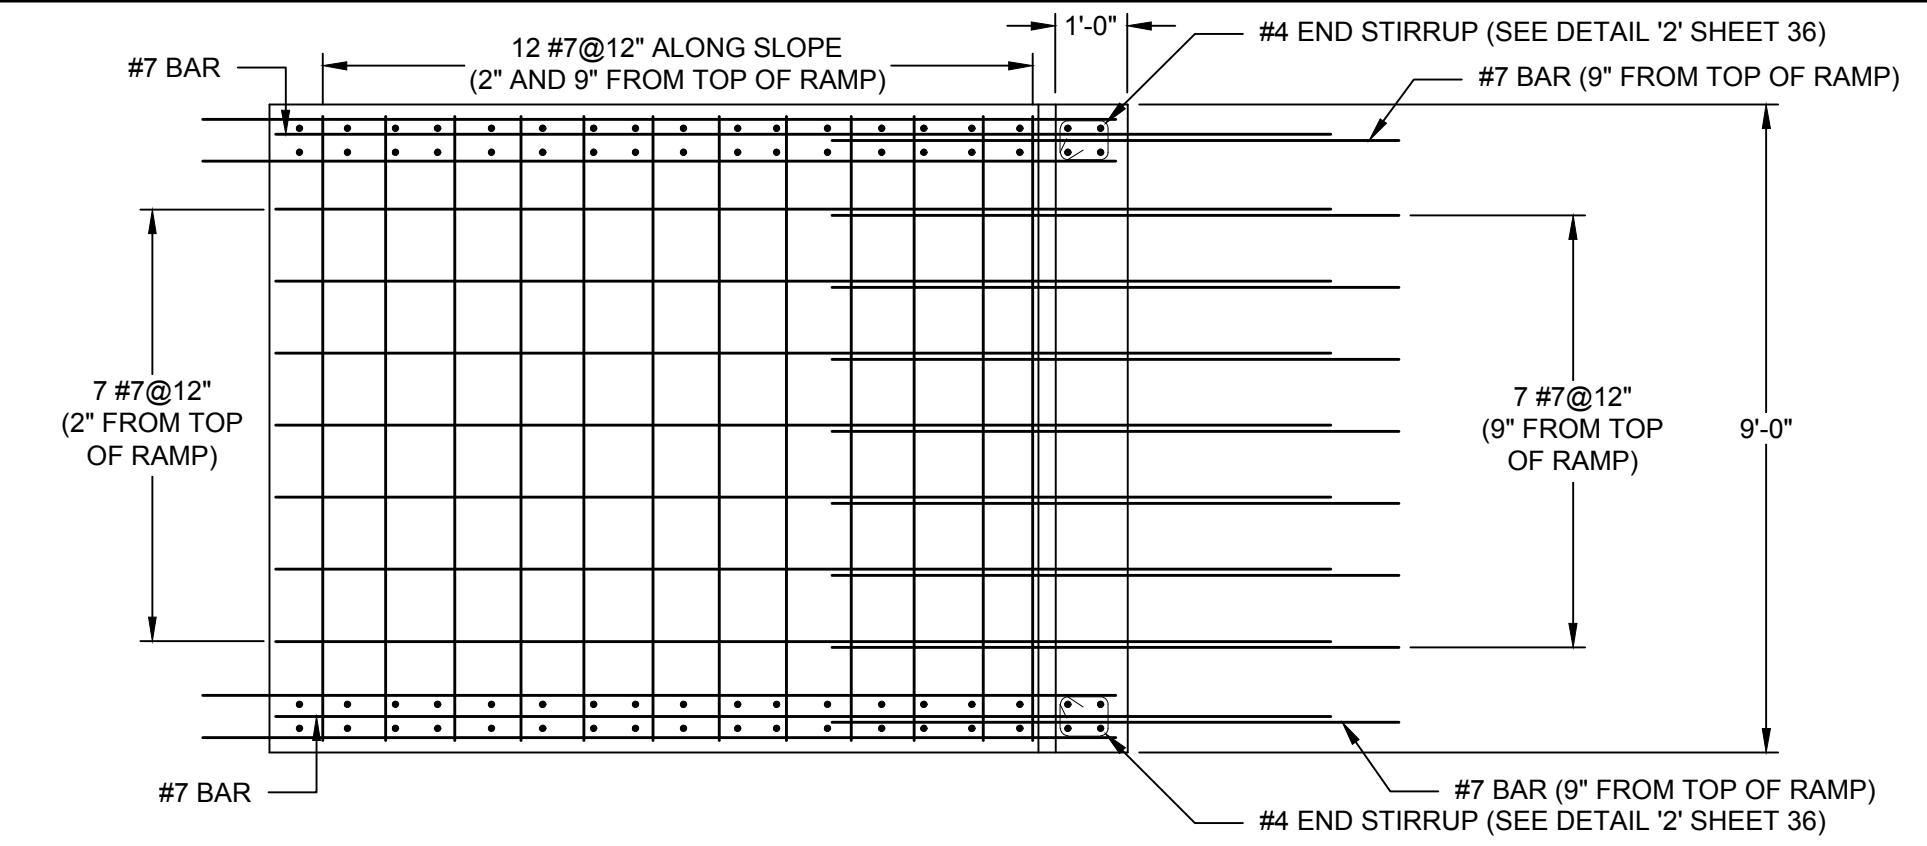
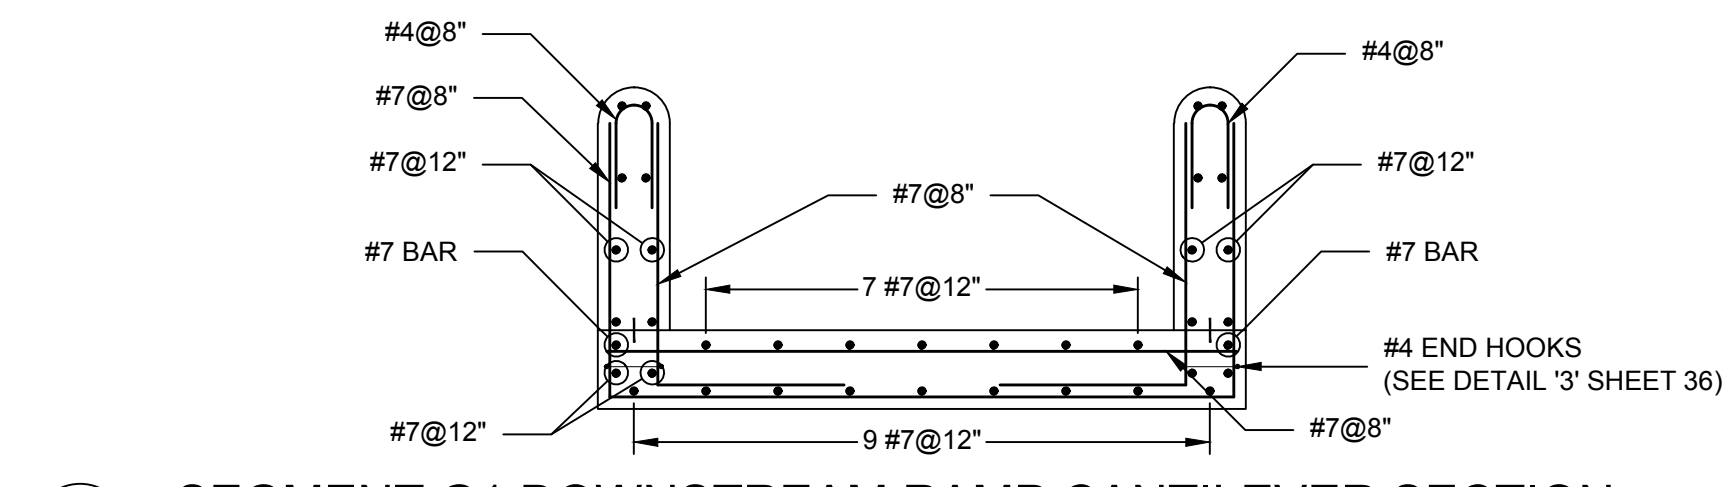
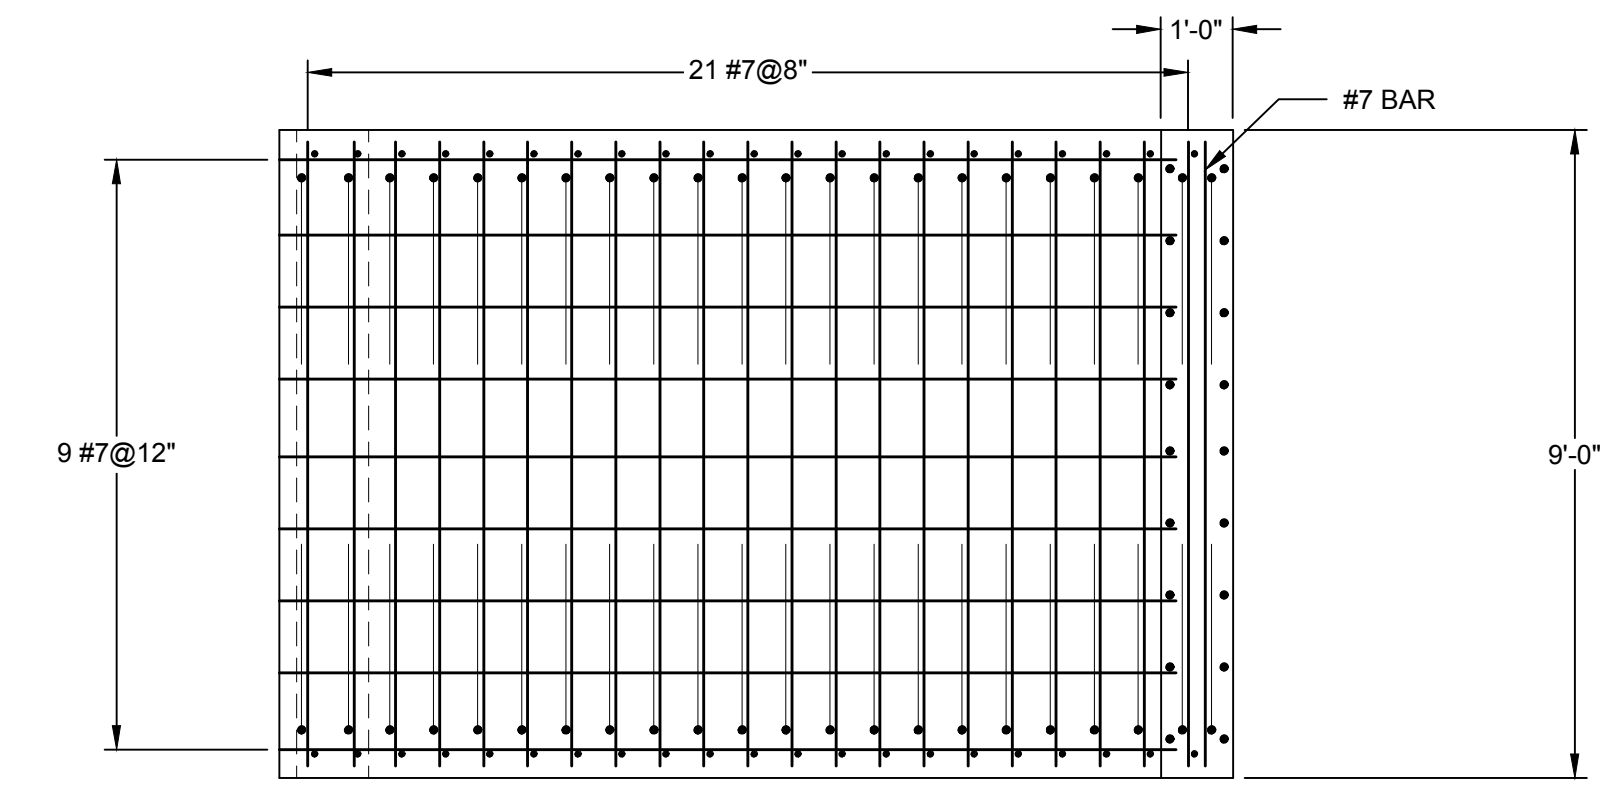
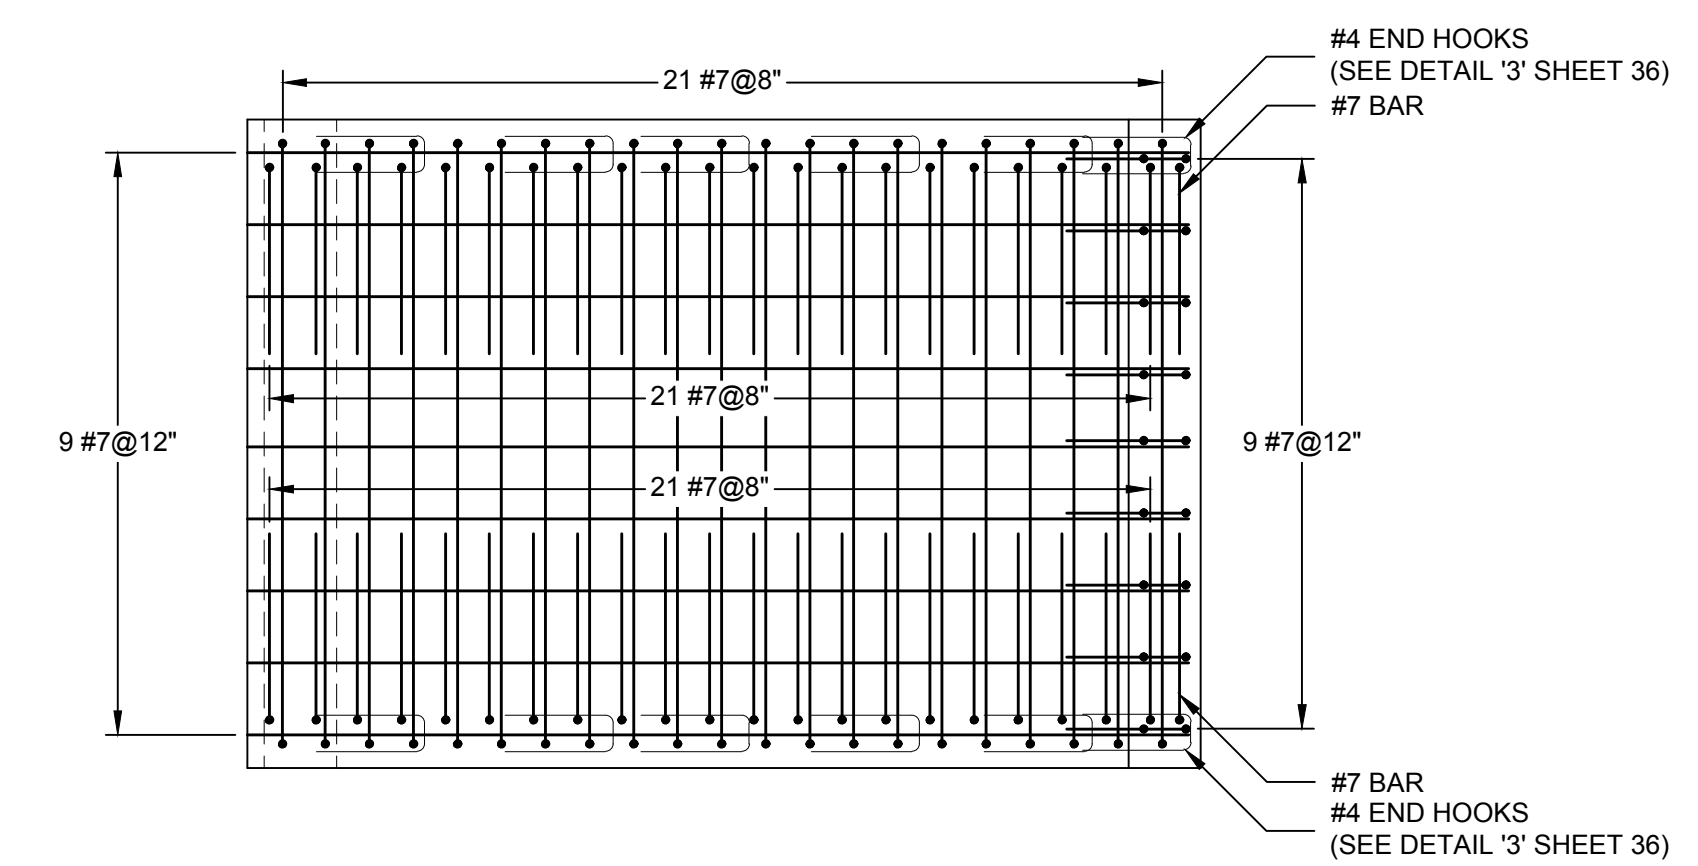
1 SEGMENT G1 DOWNSTREAM RAMP BASE 2
SCALE: 3/8"=1'0"
FLOW

3 SEGMENT G1 DOWNSTREAM RAMP CANTILEVER
SCALE: 3/8"=1'0"
FLOW

2 SEGMENT G1 DOWNSTREAM RAMP BASE 2 PLAN
SCALE: 3/8"=1'0"

4 SEGMENT G1 DOWNSTREAM RAMP CANTILEVER SECTION
SCALE: 3/8"=1'0"

5 SEGMENT G1 DOWNSTREAM RAMP CANTILEVER PLAN
REINFORCEMENT 2" FROM TOP OF CANTILEVER SLAB
SCALE: 3/8"=1'0"

5 SEGMENT G1 DOWNSTREAM RAMP CANTILEVER PLAN
REINFORCEMENT 2" FROM BOTTOM OF CANTILEVER SLAB
SCALE: 3/8"=1'0"

ADD: Attached Plan Sheets 1, 3, 11, 14, 15, 16, 29, 33, 34, 35, 36, 38, 39, 40, 43, 44, 45, 46, 47, 49, 50, 51, 52, 54, 65
Note: Additional temperature and shrinkage reinforcing steel was added in the ramp/infill sections of the piano key weirs. Sheets with material changes were notated as Revised per Addendum No. 3. Sheets that were inadvertently affected by the changes are included, but do not contain revision clouds/call-outs. The additional reinforcing typically includes the addition of #5@12" spacing, #7@12" spacing, and #4@24" spacing depending on the specific locations of reinforcing.

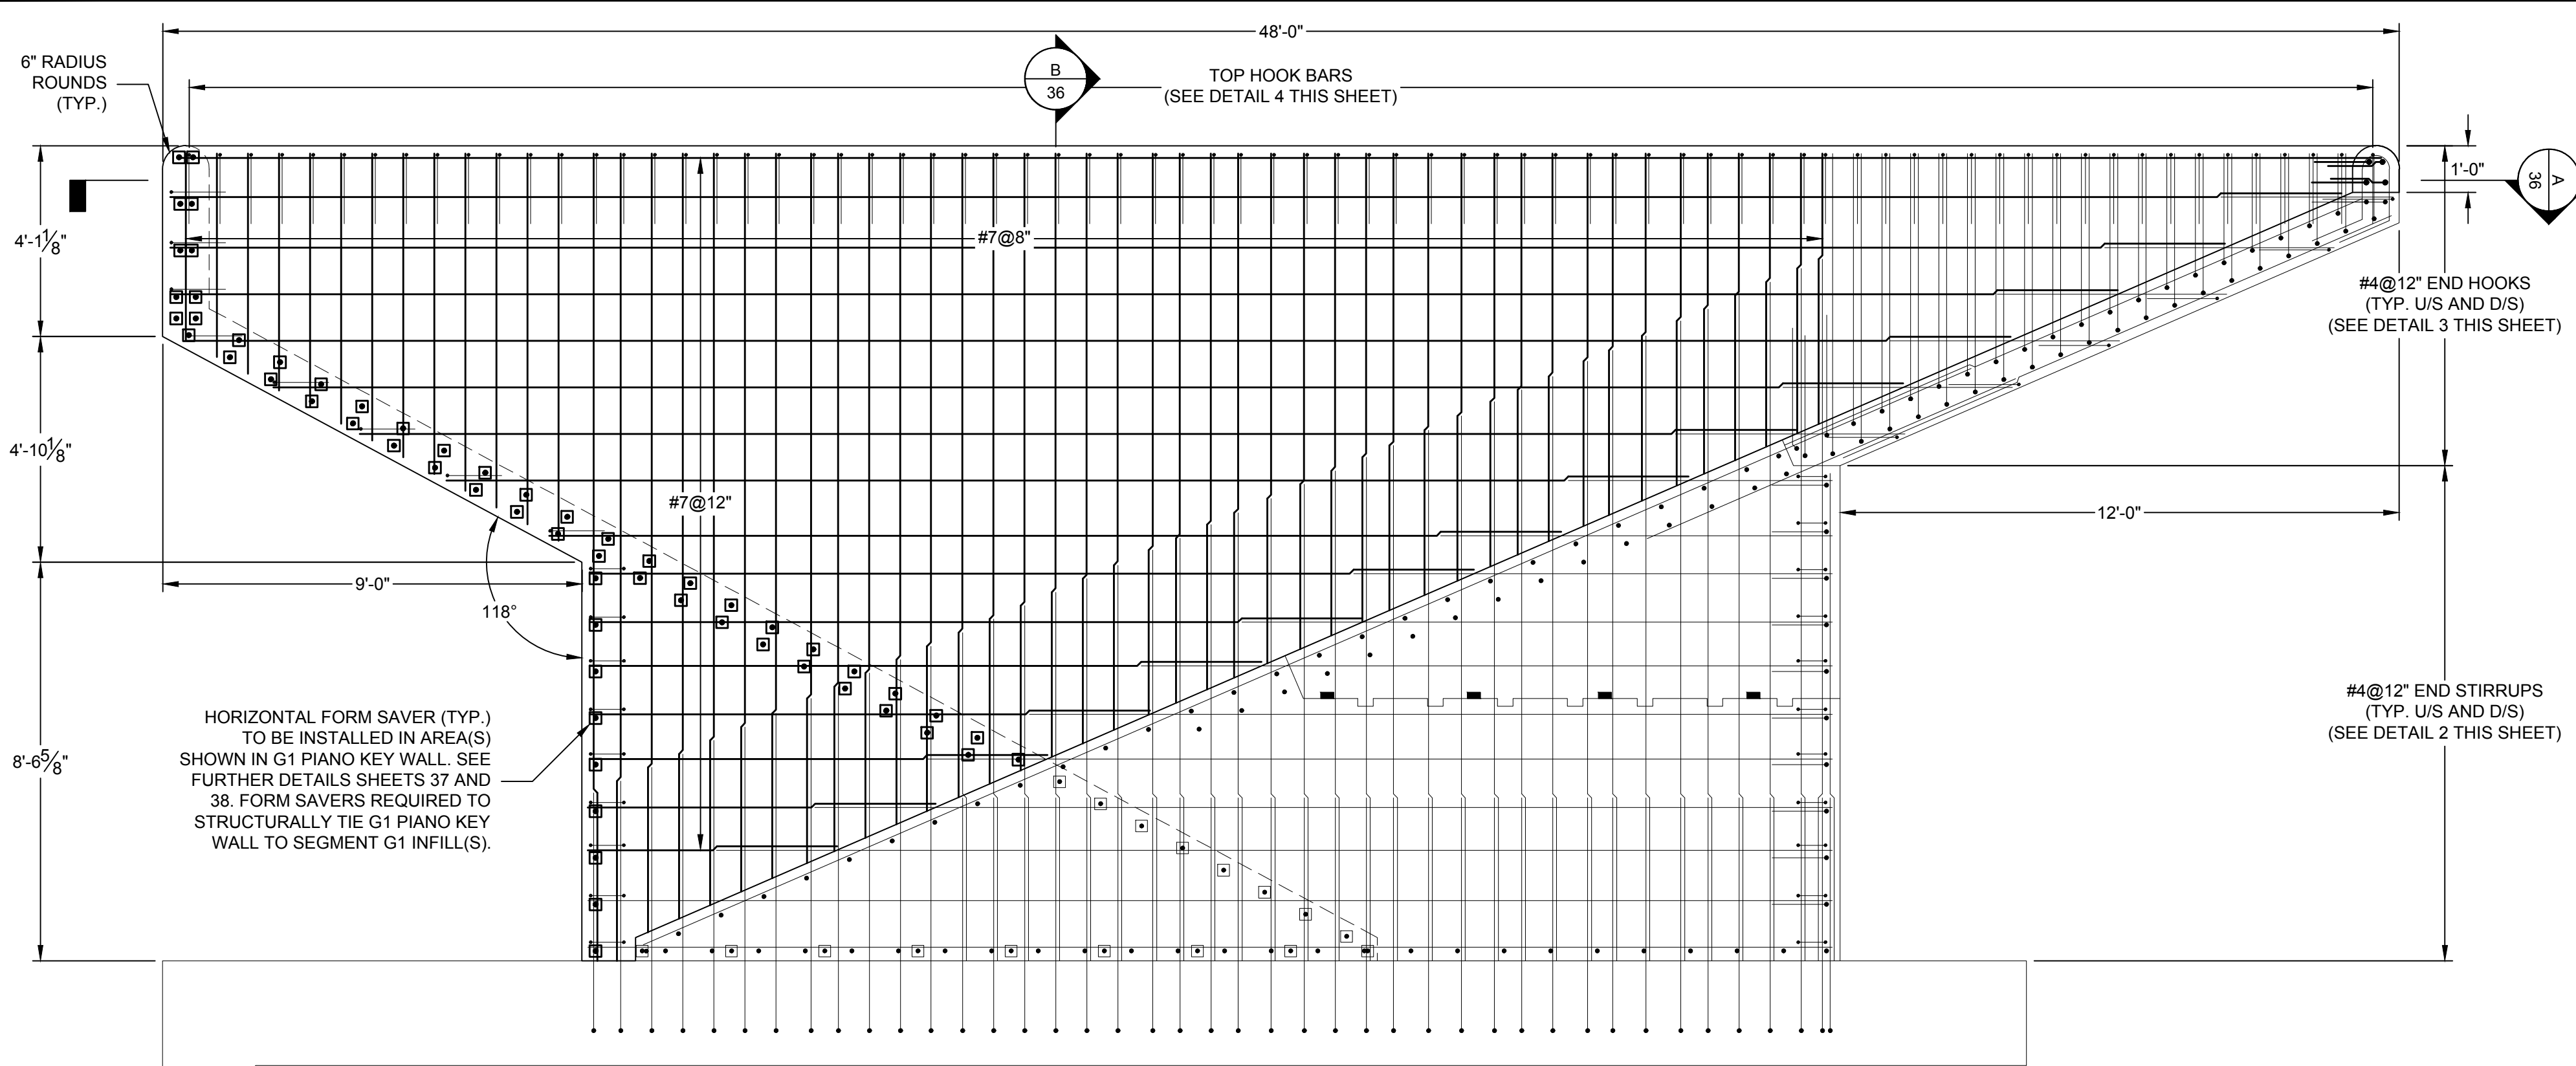
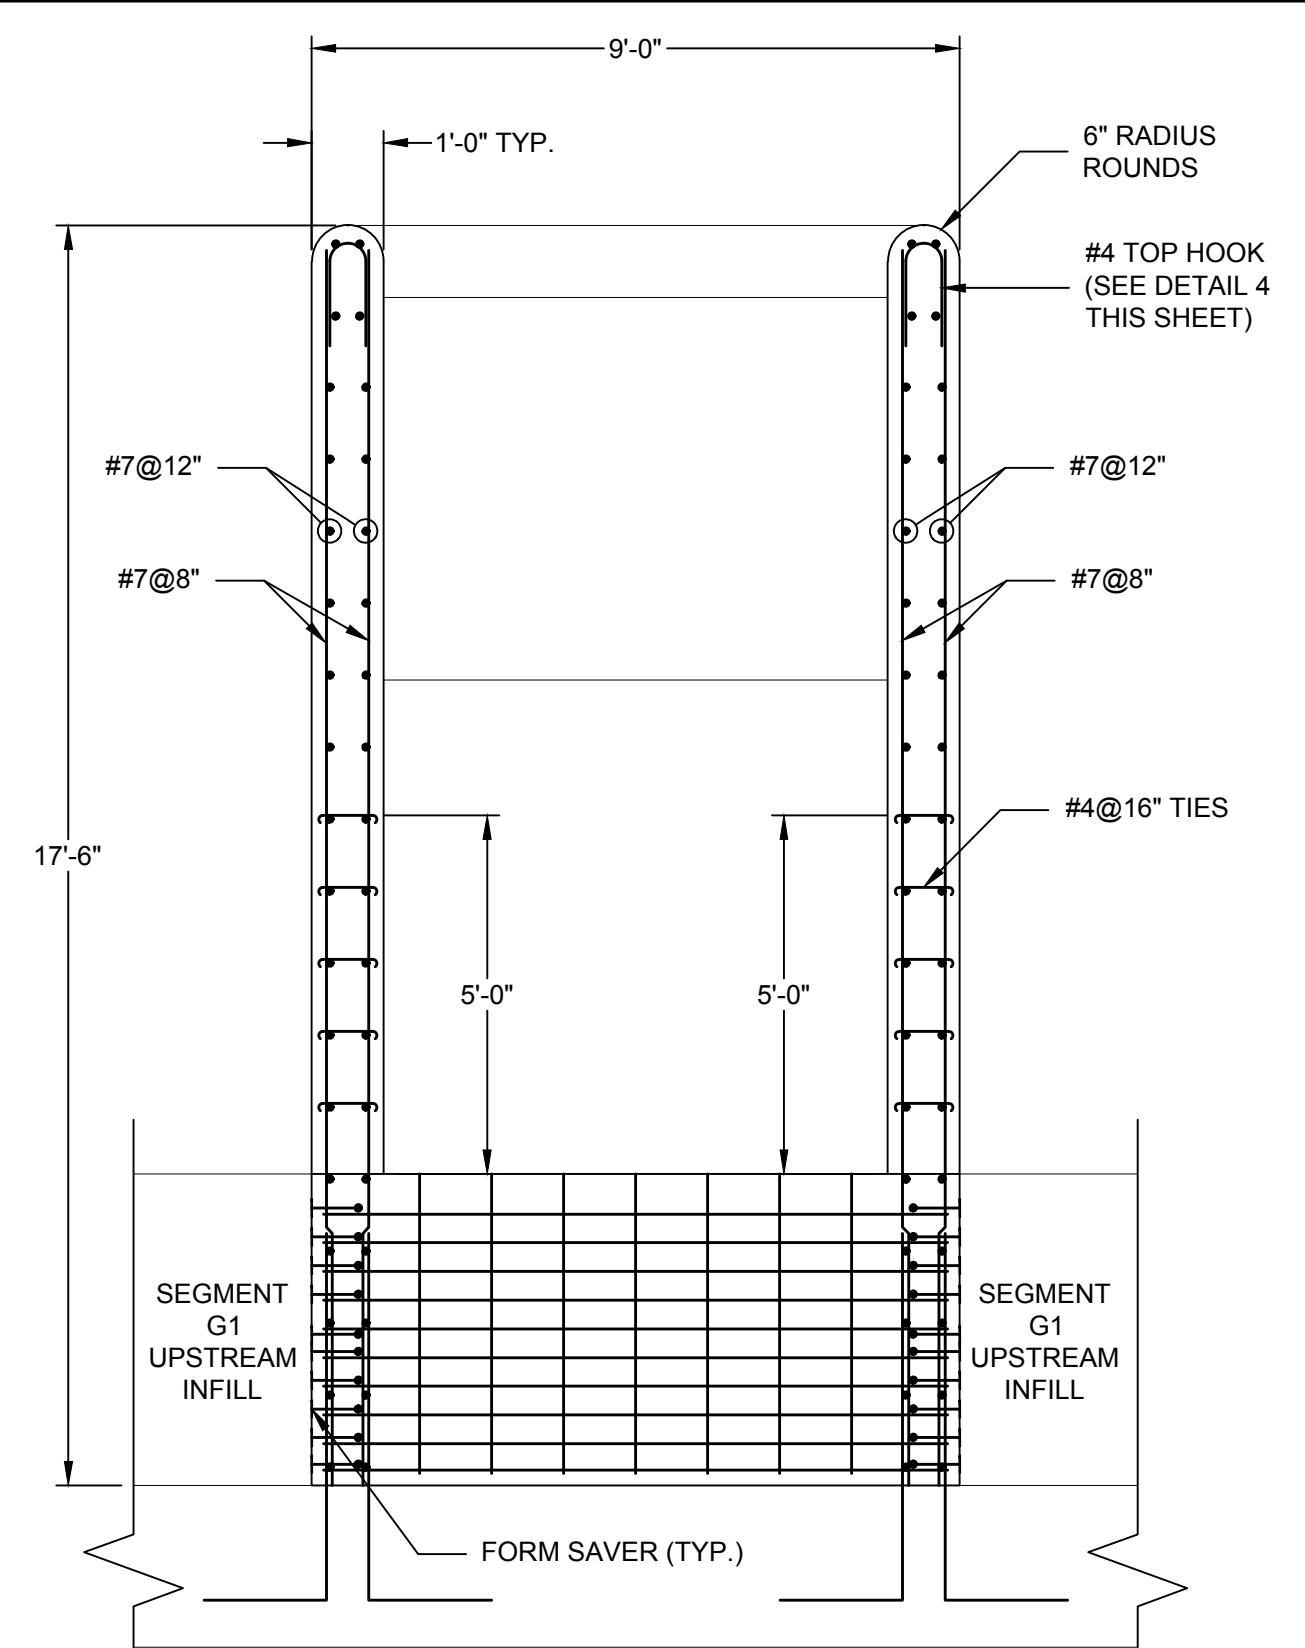
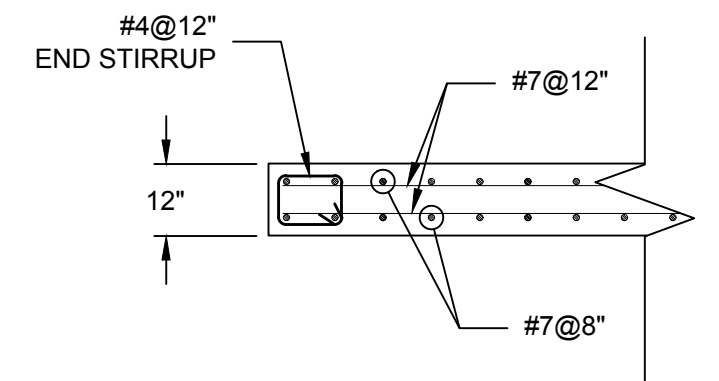
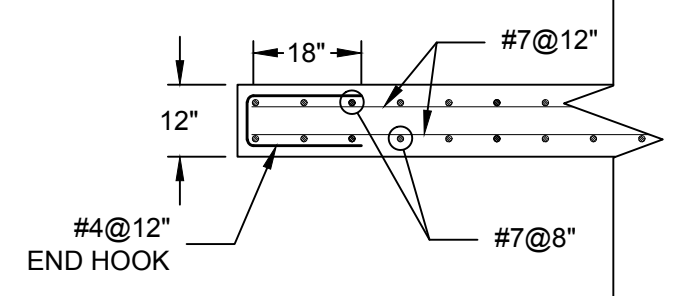
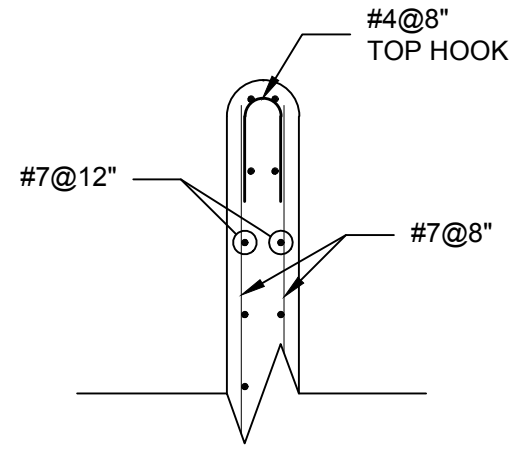
1 SEGMENT G1 PIANO KEY WEIR WALL

B SEGMENT G1 WALL SECTION

A SEGMENT G1 PIANO KEY WEIR WALL SECTION

2 END STIRRUP DETAIL

3 END HOOK DETAIL

4 TOP HOOK DETAIL
HIGH-STAGE AND MID-STAGE WEIR WALLS

NOTE: SEGMENT G1 & G2 SIMILAR BUT OPPOSITE
