Addendum Number 3

Lake Peachtree Spillway Replacement Project

United Consulting is pleased to submit this report of the Ground Penetrating Radar Survey at the **Lake Peachtree Dam** located in Peachtree City, Fayette County, Georgia. This report includes a review of the scope of work and a summary of the subsurface conditions encountered.

CONSTRUCTION PLANS FOR LAKE PEACHTREE SPILLWAY REPLACEMENT PROJECT

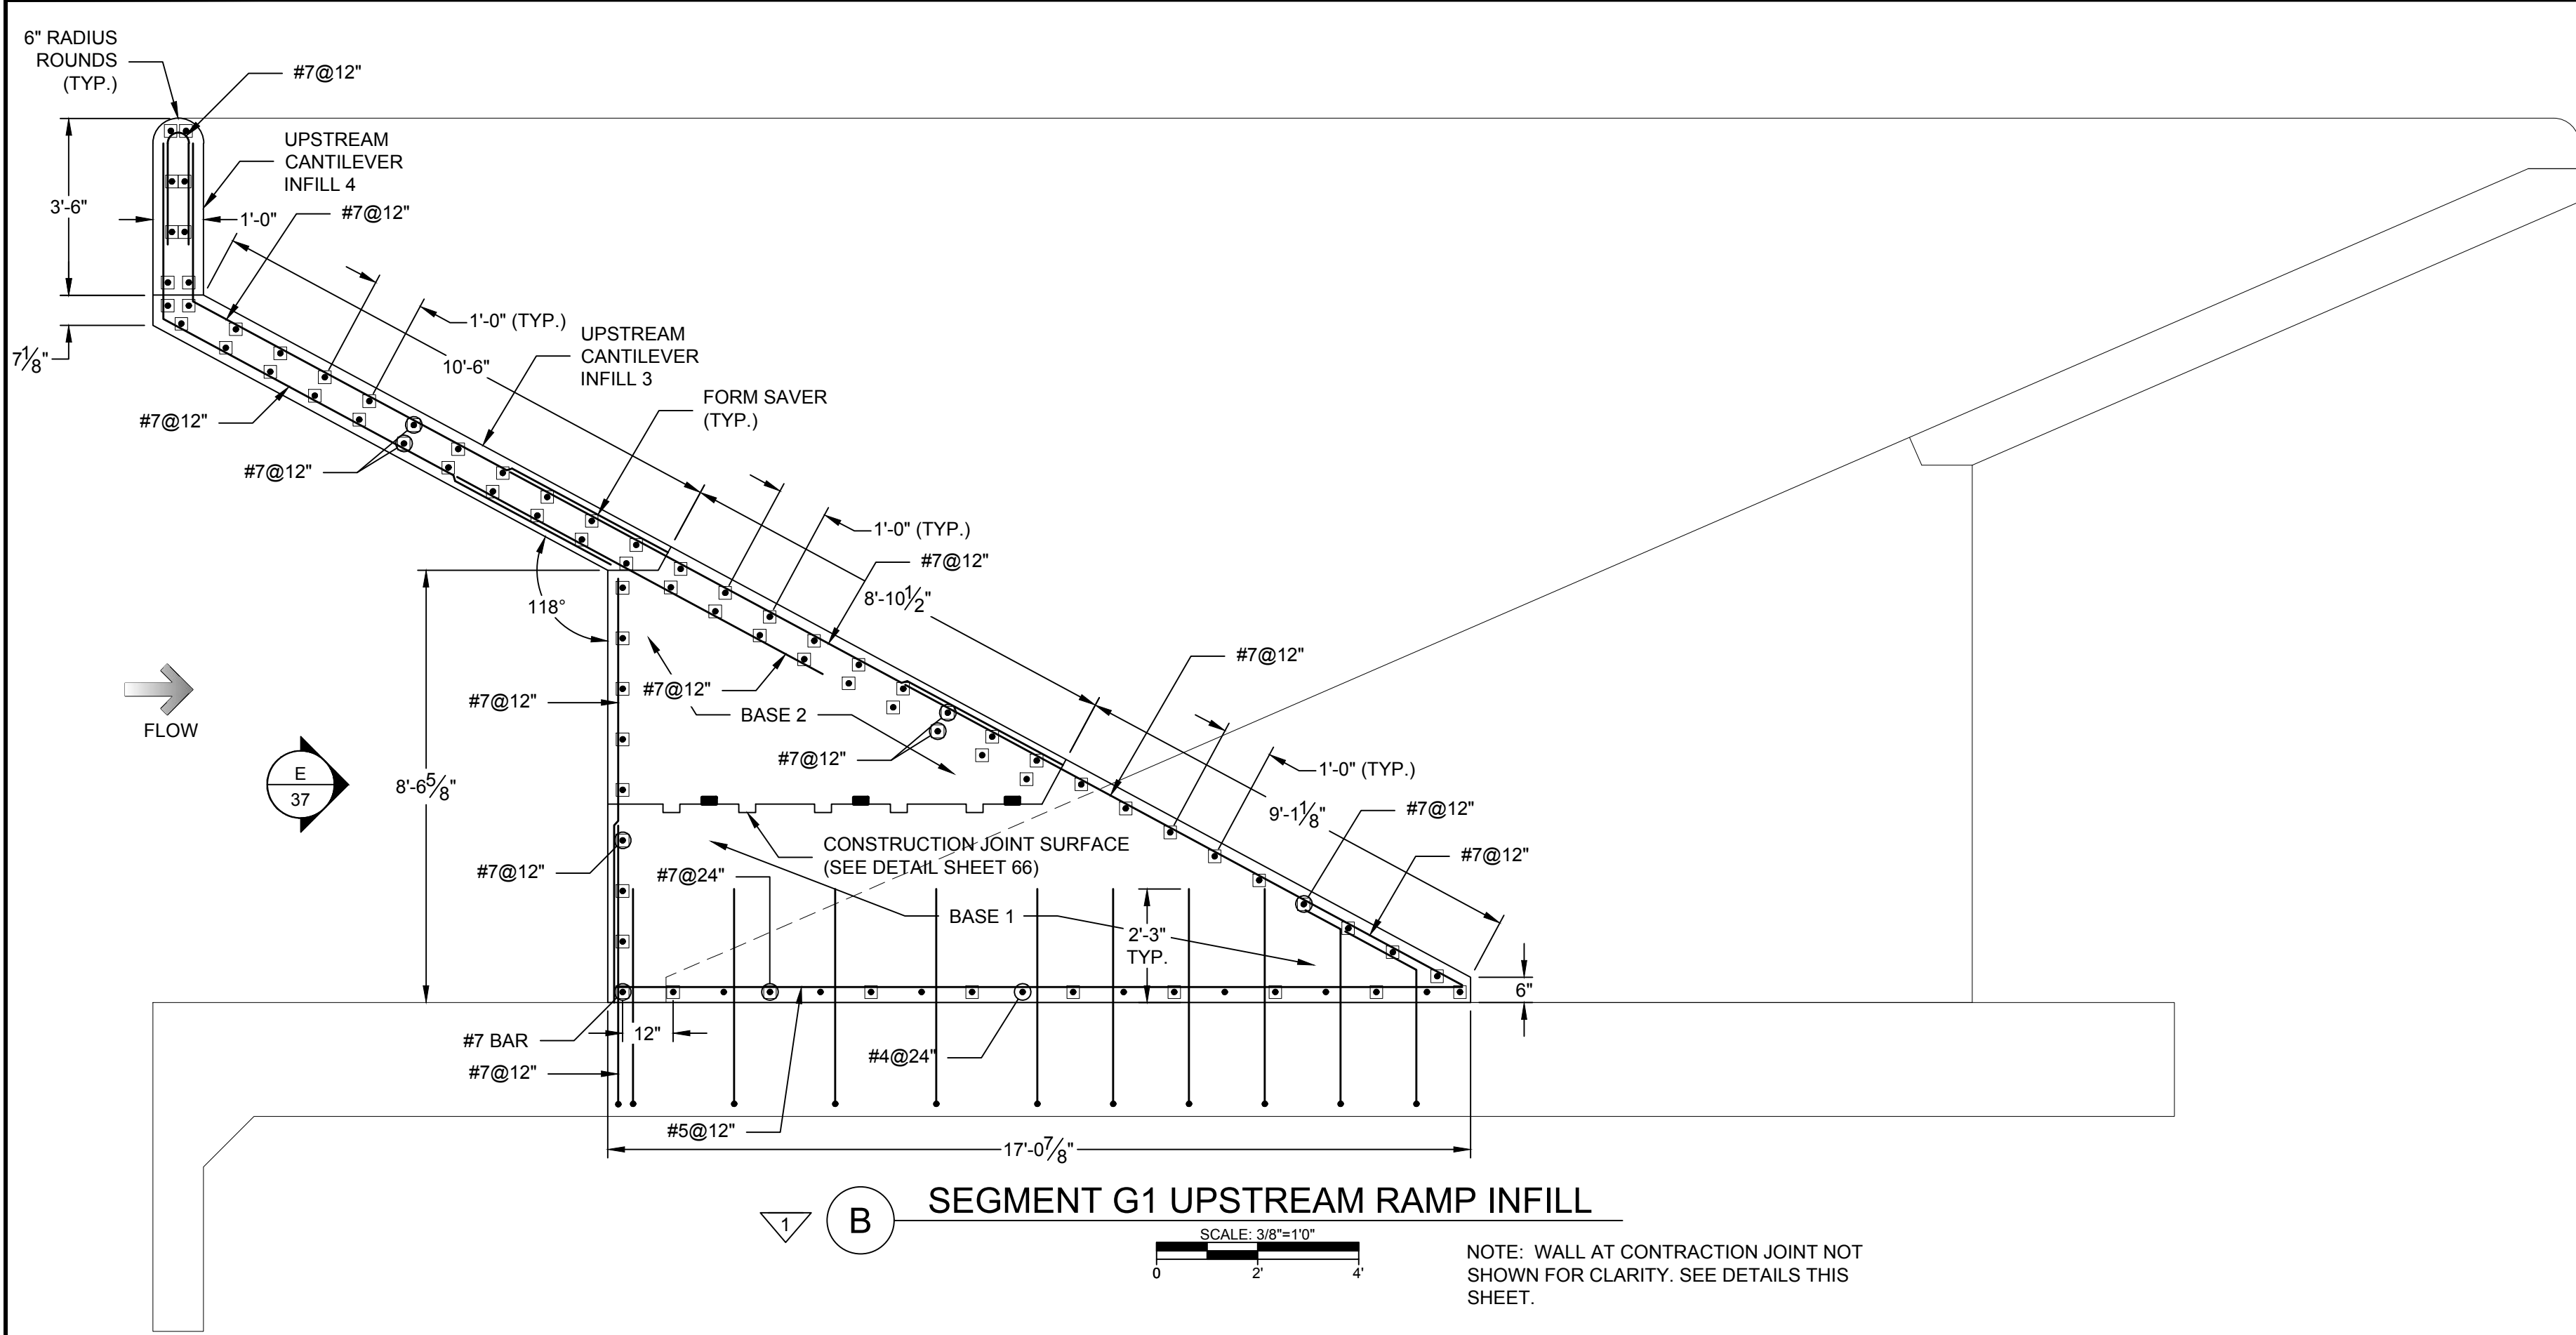
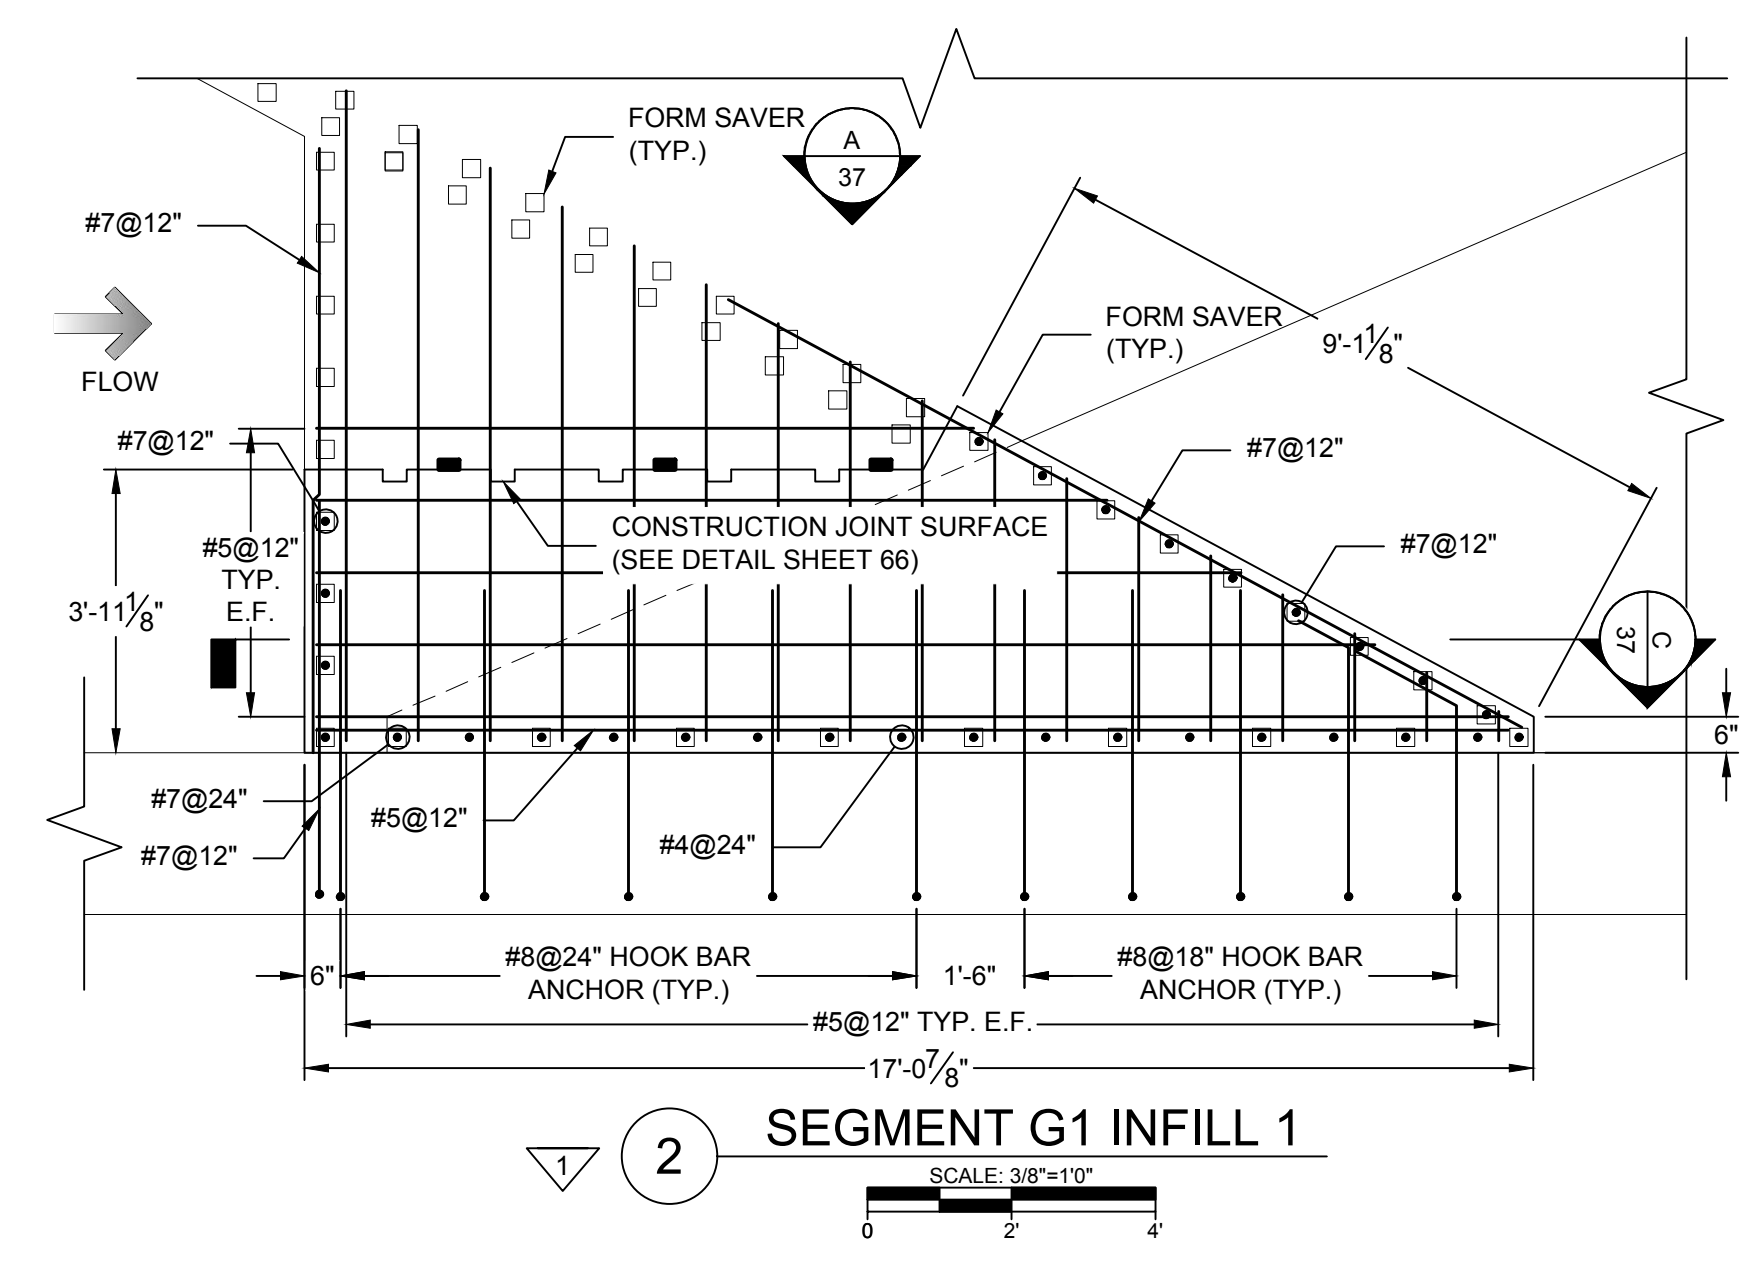
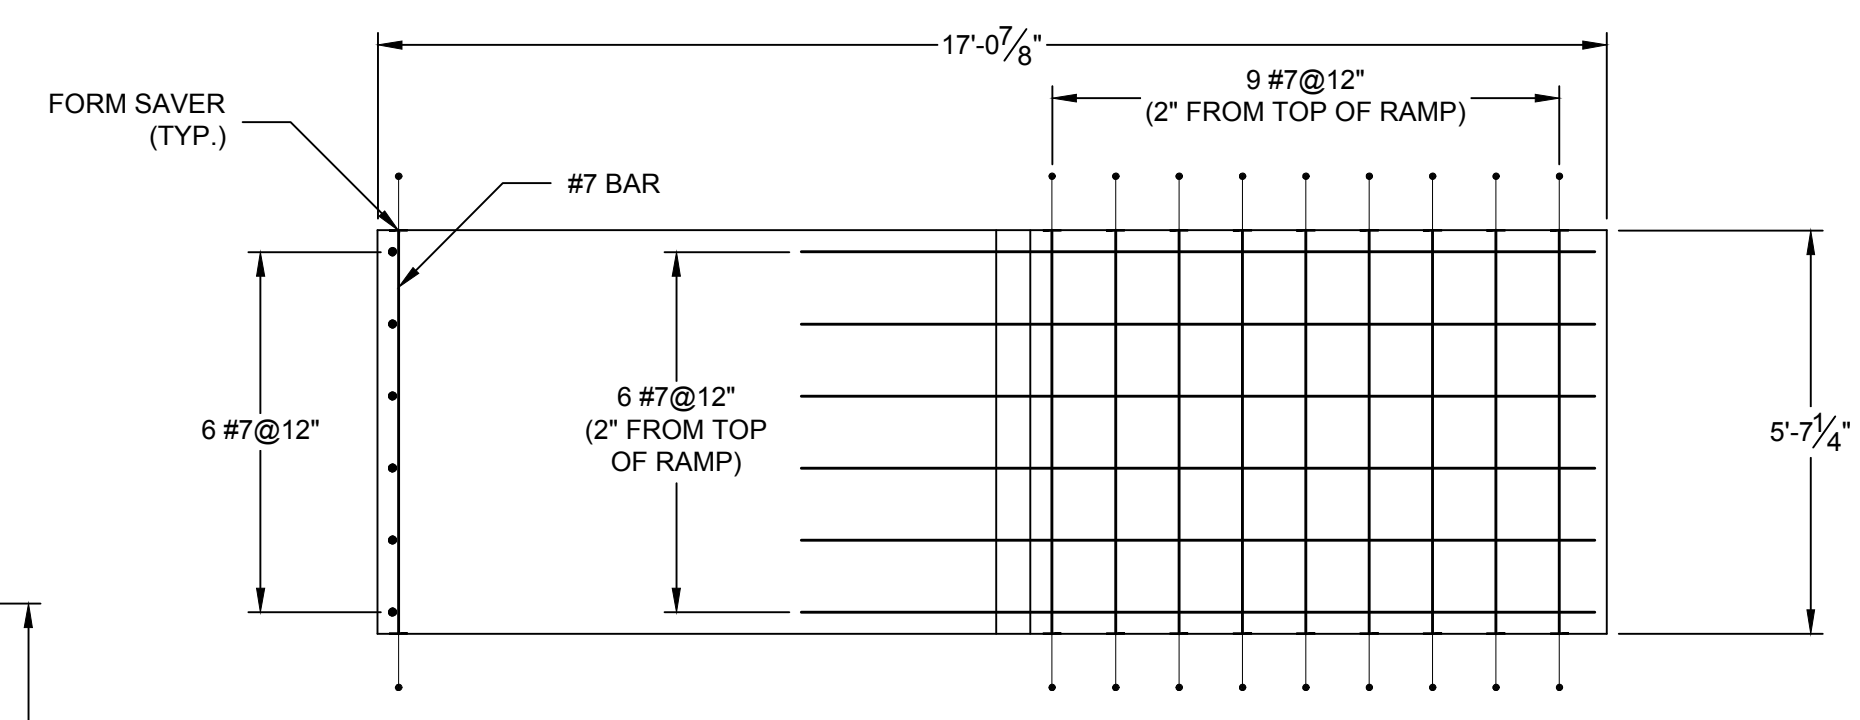
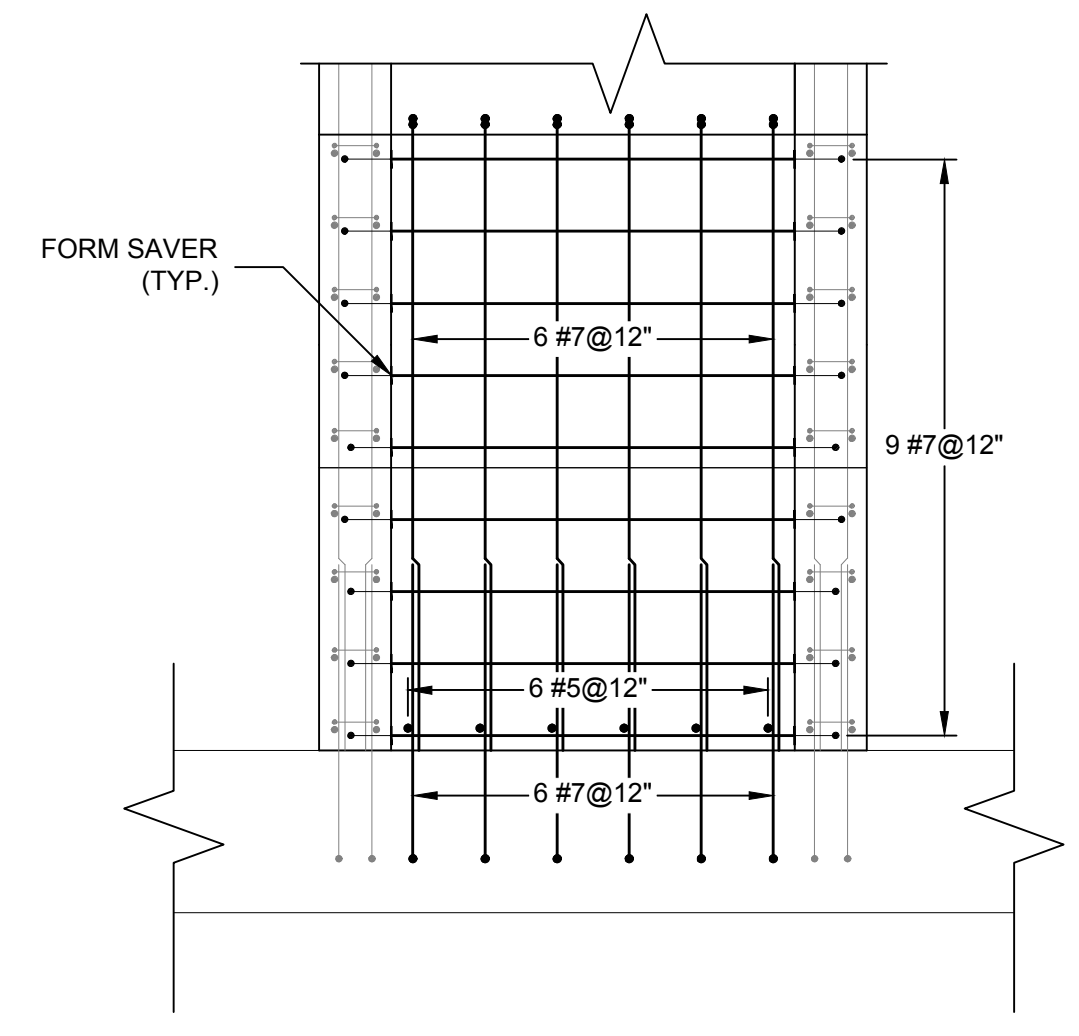
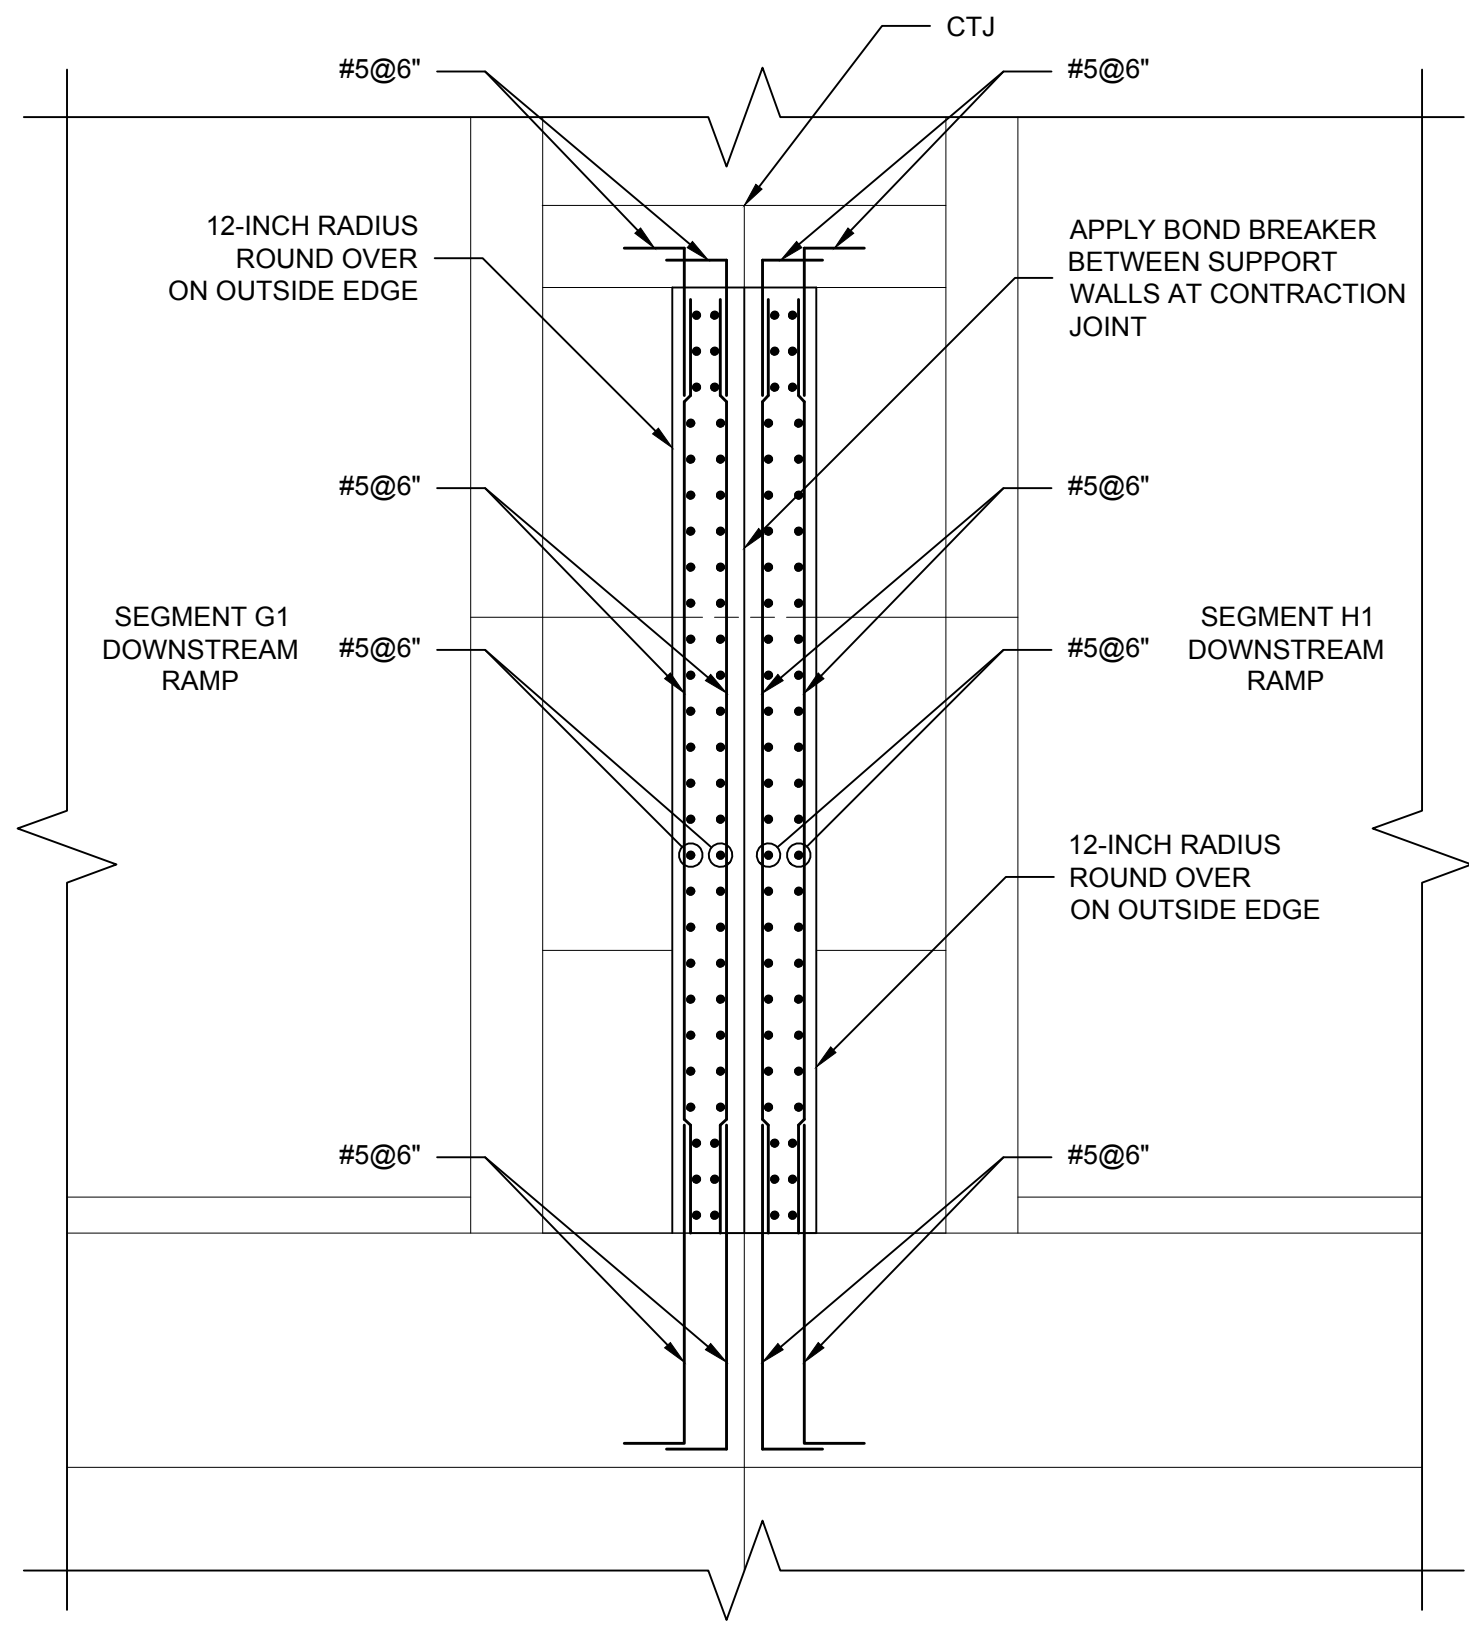
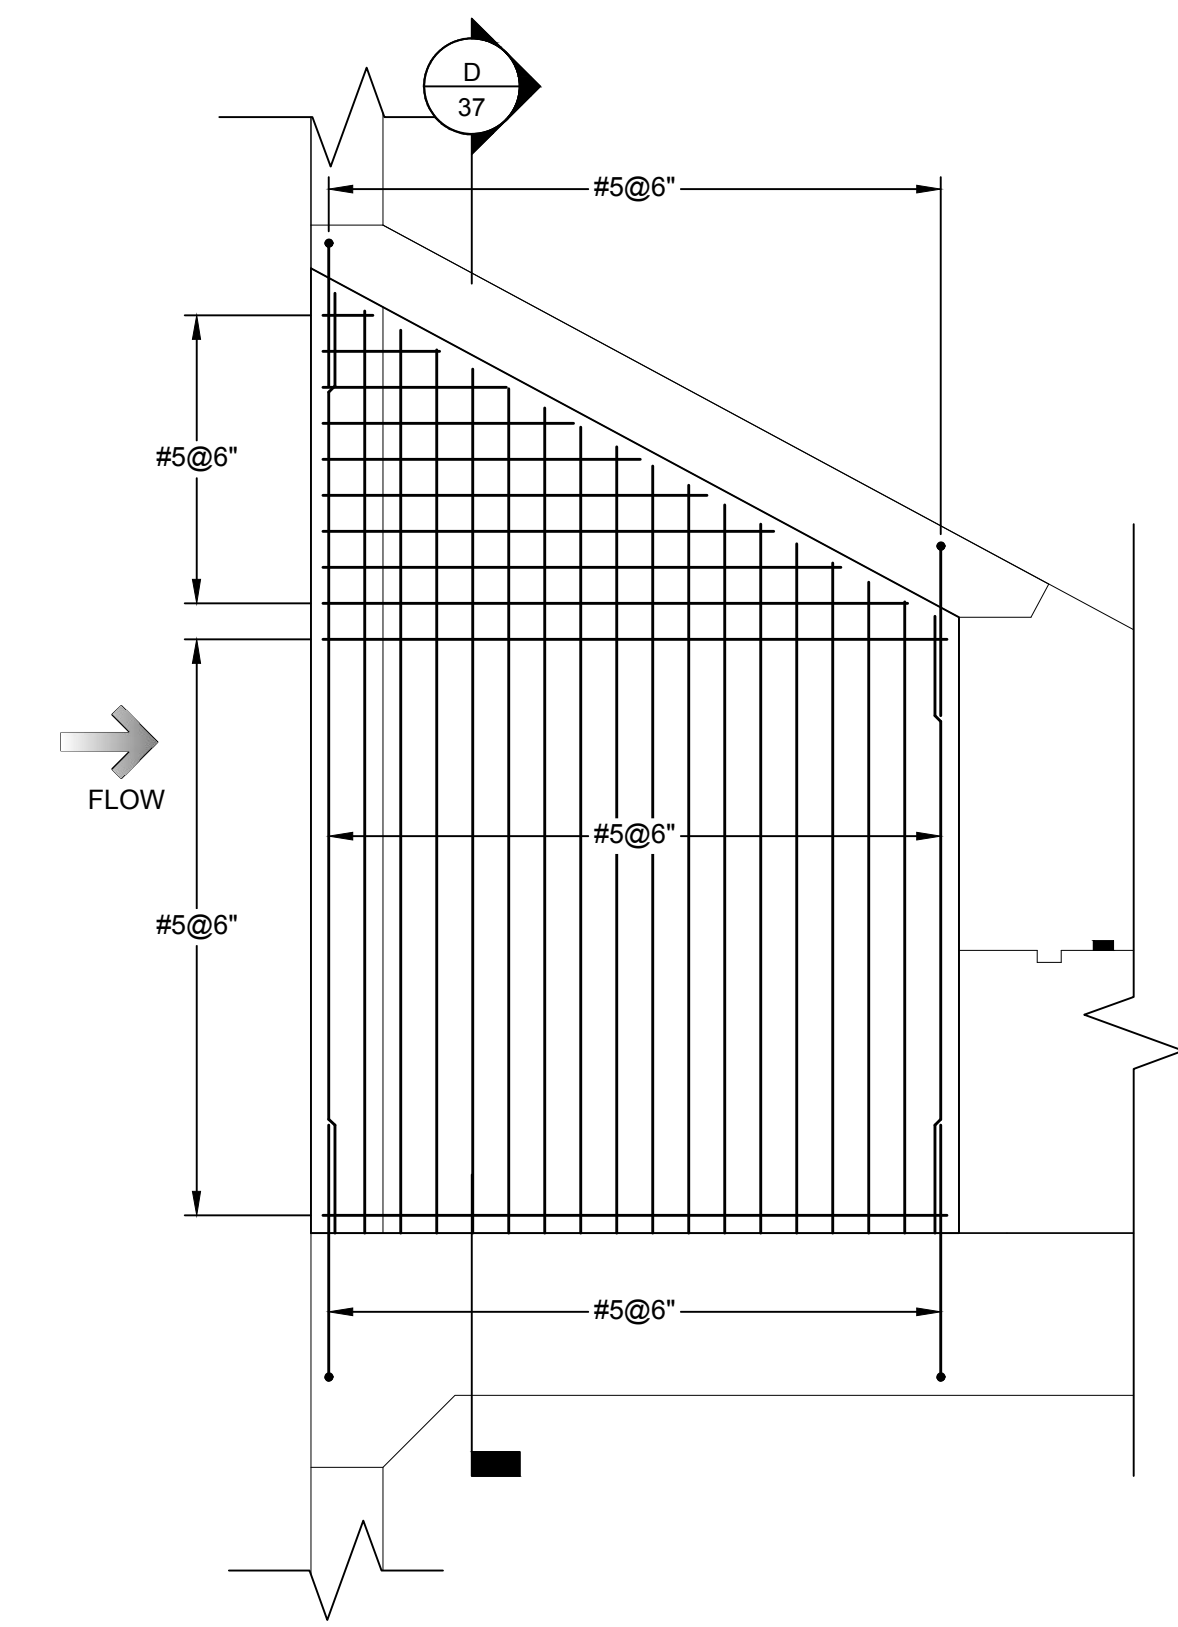
B SEGMENT G1 UPSTREAM RAMP INFILL
SCALE: 3/8"=1'0"
NOTE: WALL AT CONTRACTION JOINT NOT SHOWN FOR CLARITY. SEE DETAILS THIS SHEET.

2 SEGMENT G1 INFILL 1
SCALE: 3/8"=1'0"
0 2 4

A SEGMENT G1 INFILL BASE 1 PLAN
SCALE: 3/8"=1'0"
0 2 4

E SEGMENT G1 INFILL BASE ELEVATION
SCALE: 3/8"=1'0"
0 2 4

NOTE: FOR CONTRACTION JOINT BETWEEN PIANO KEY SEGMENTS G1 AND H1, PROVIDE 2-INCHES CLEARANCE FOR REINFORCEMENT EACH SIDE OF JOINT. (G2 AND H2 SIMILAR, BUT OPPOSITE)

D SEGMENT G1 SUPPORT WALL SECTION
SCALE: 3/8"=1'0"
0 2 4

1 SEGMENT G1 SUPPORT WALL AT CONTRACTION JOINT BETWEEN SEGMENTS G1 AND H1
SCALE: 3/8"=1'0"
0 2 4

ADD: Attached Plan Sheets 37, 48 and 53
Note: The upstream ramp support walls (Sheets 37, 48, 53) were revised to include a 12-inch radius to improve hydraulic efficiency on the upstream ends of those walls.

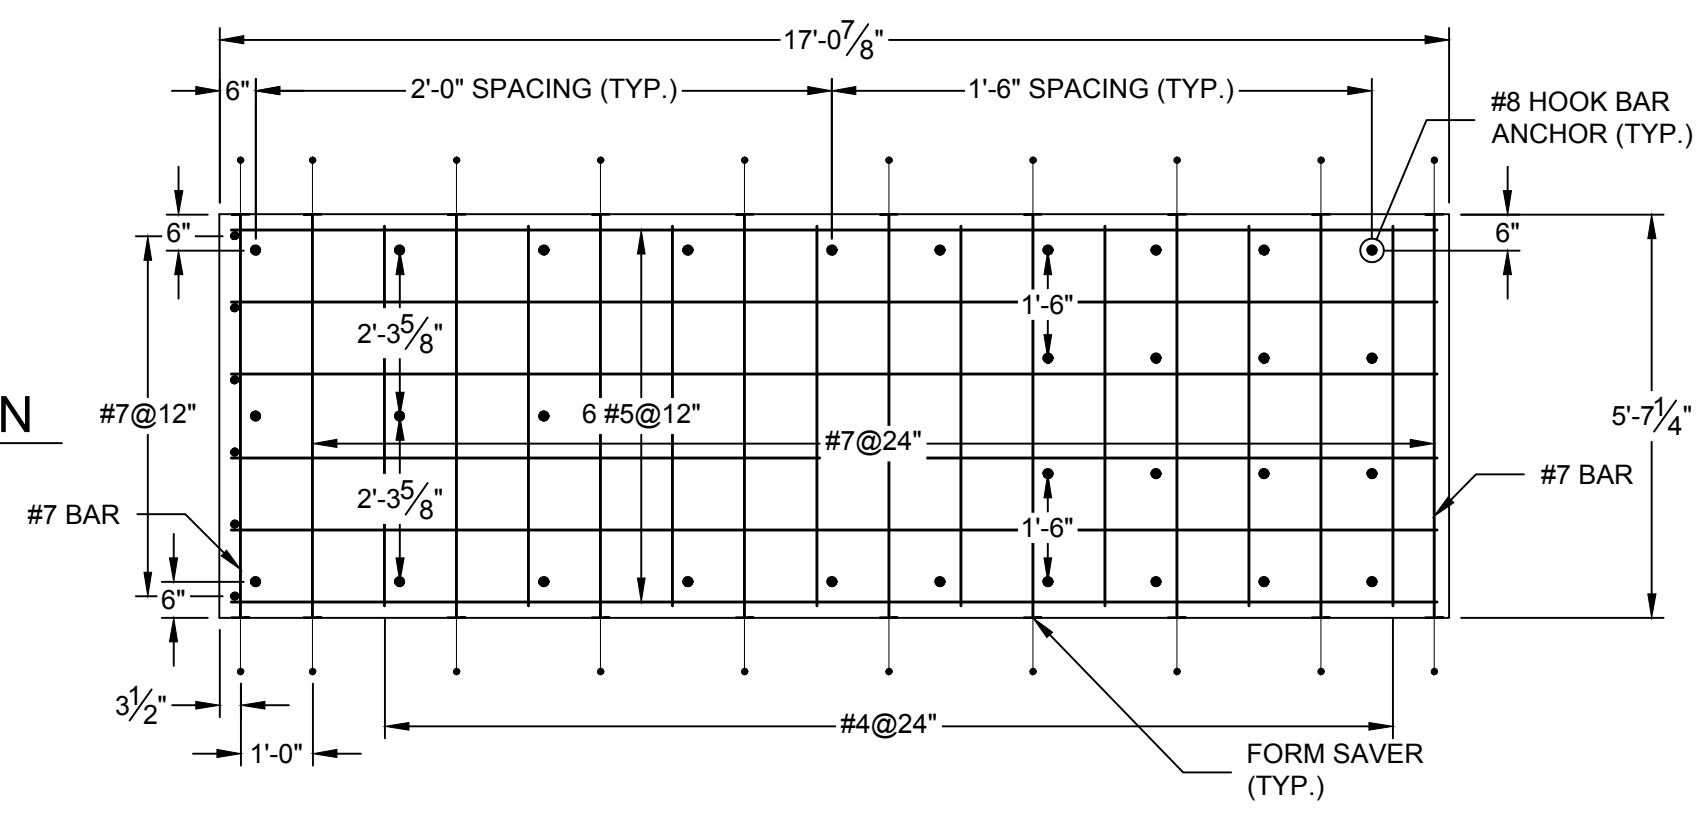
C SEGMENT G1 INFILL BASE 1 SECTION
SCALE: 3/8"=1'0"
0 2 4

NOTE: SEGMENT G1 & G2 SIMILAR BUT OPPOSITE

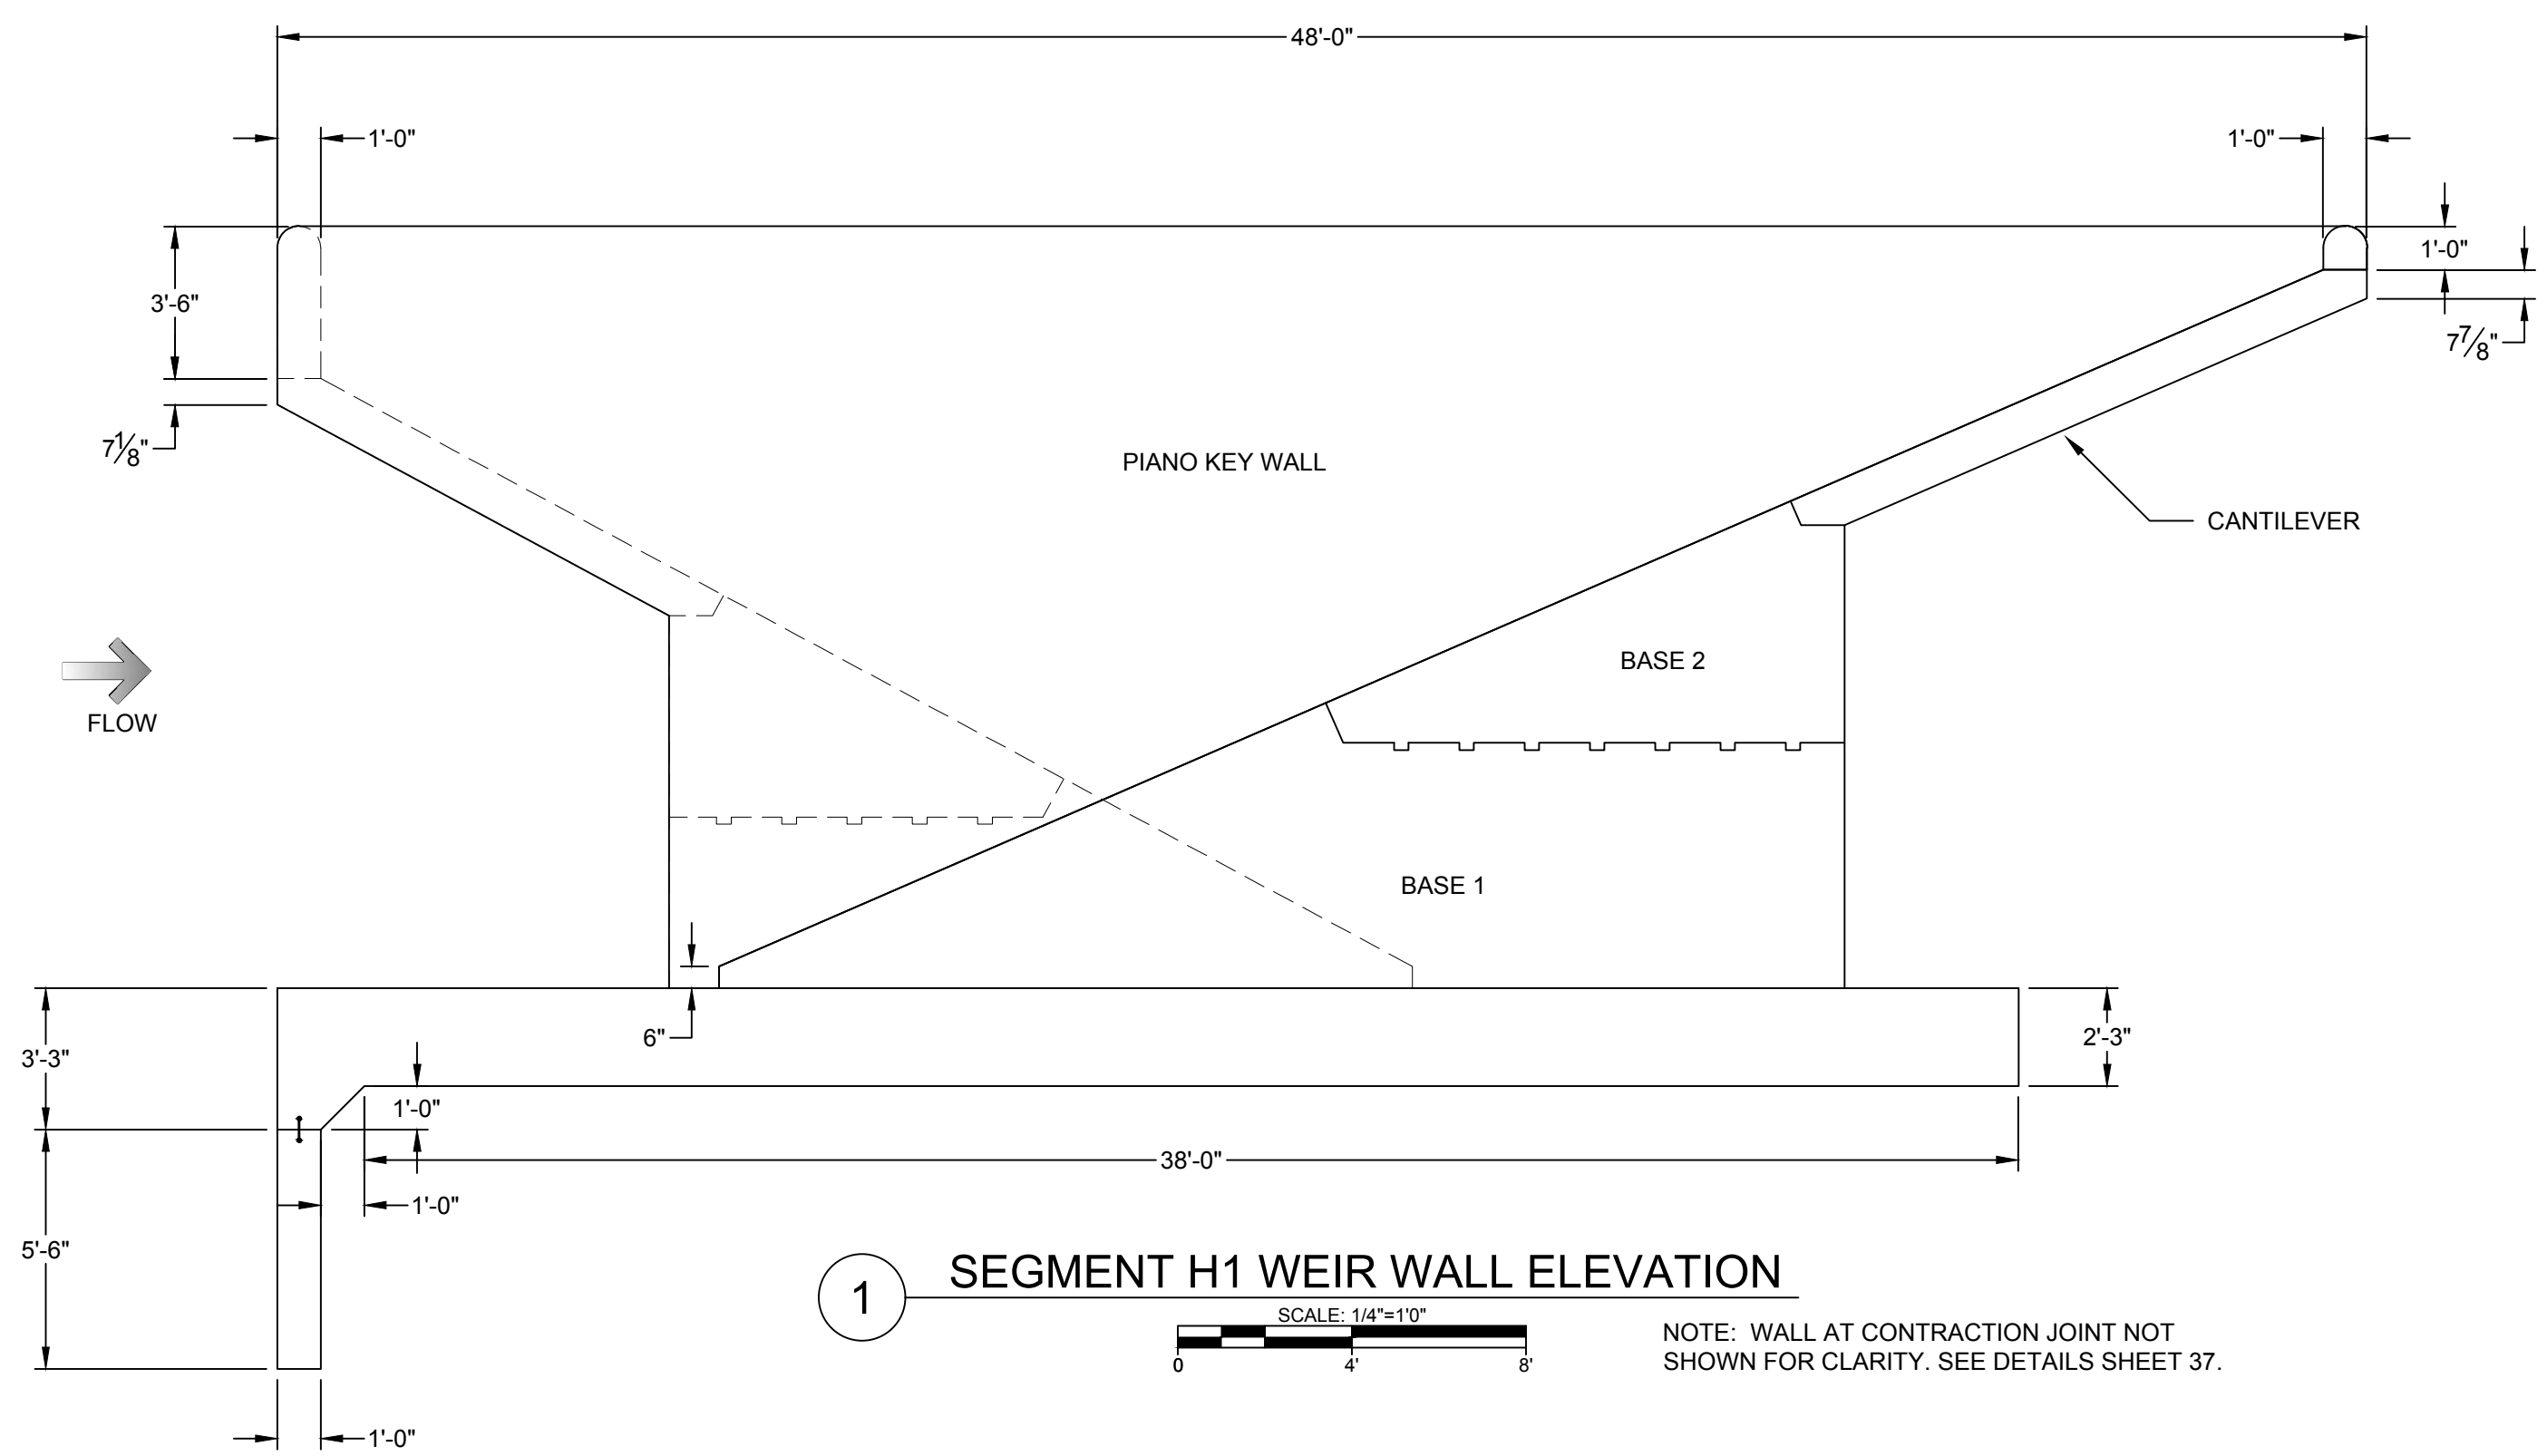
1 SEGMENT H1 WEIR WALL ELEVATION
 SCALE: 1/4"=1'-0"
 NOTE: WALL AT CONTRACTION JOINT NOT SHOWN FOR CLARITY. SEE DETAILS SHEET 37.

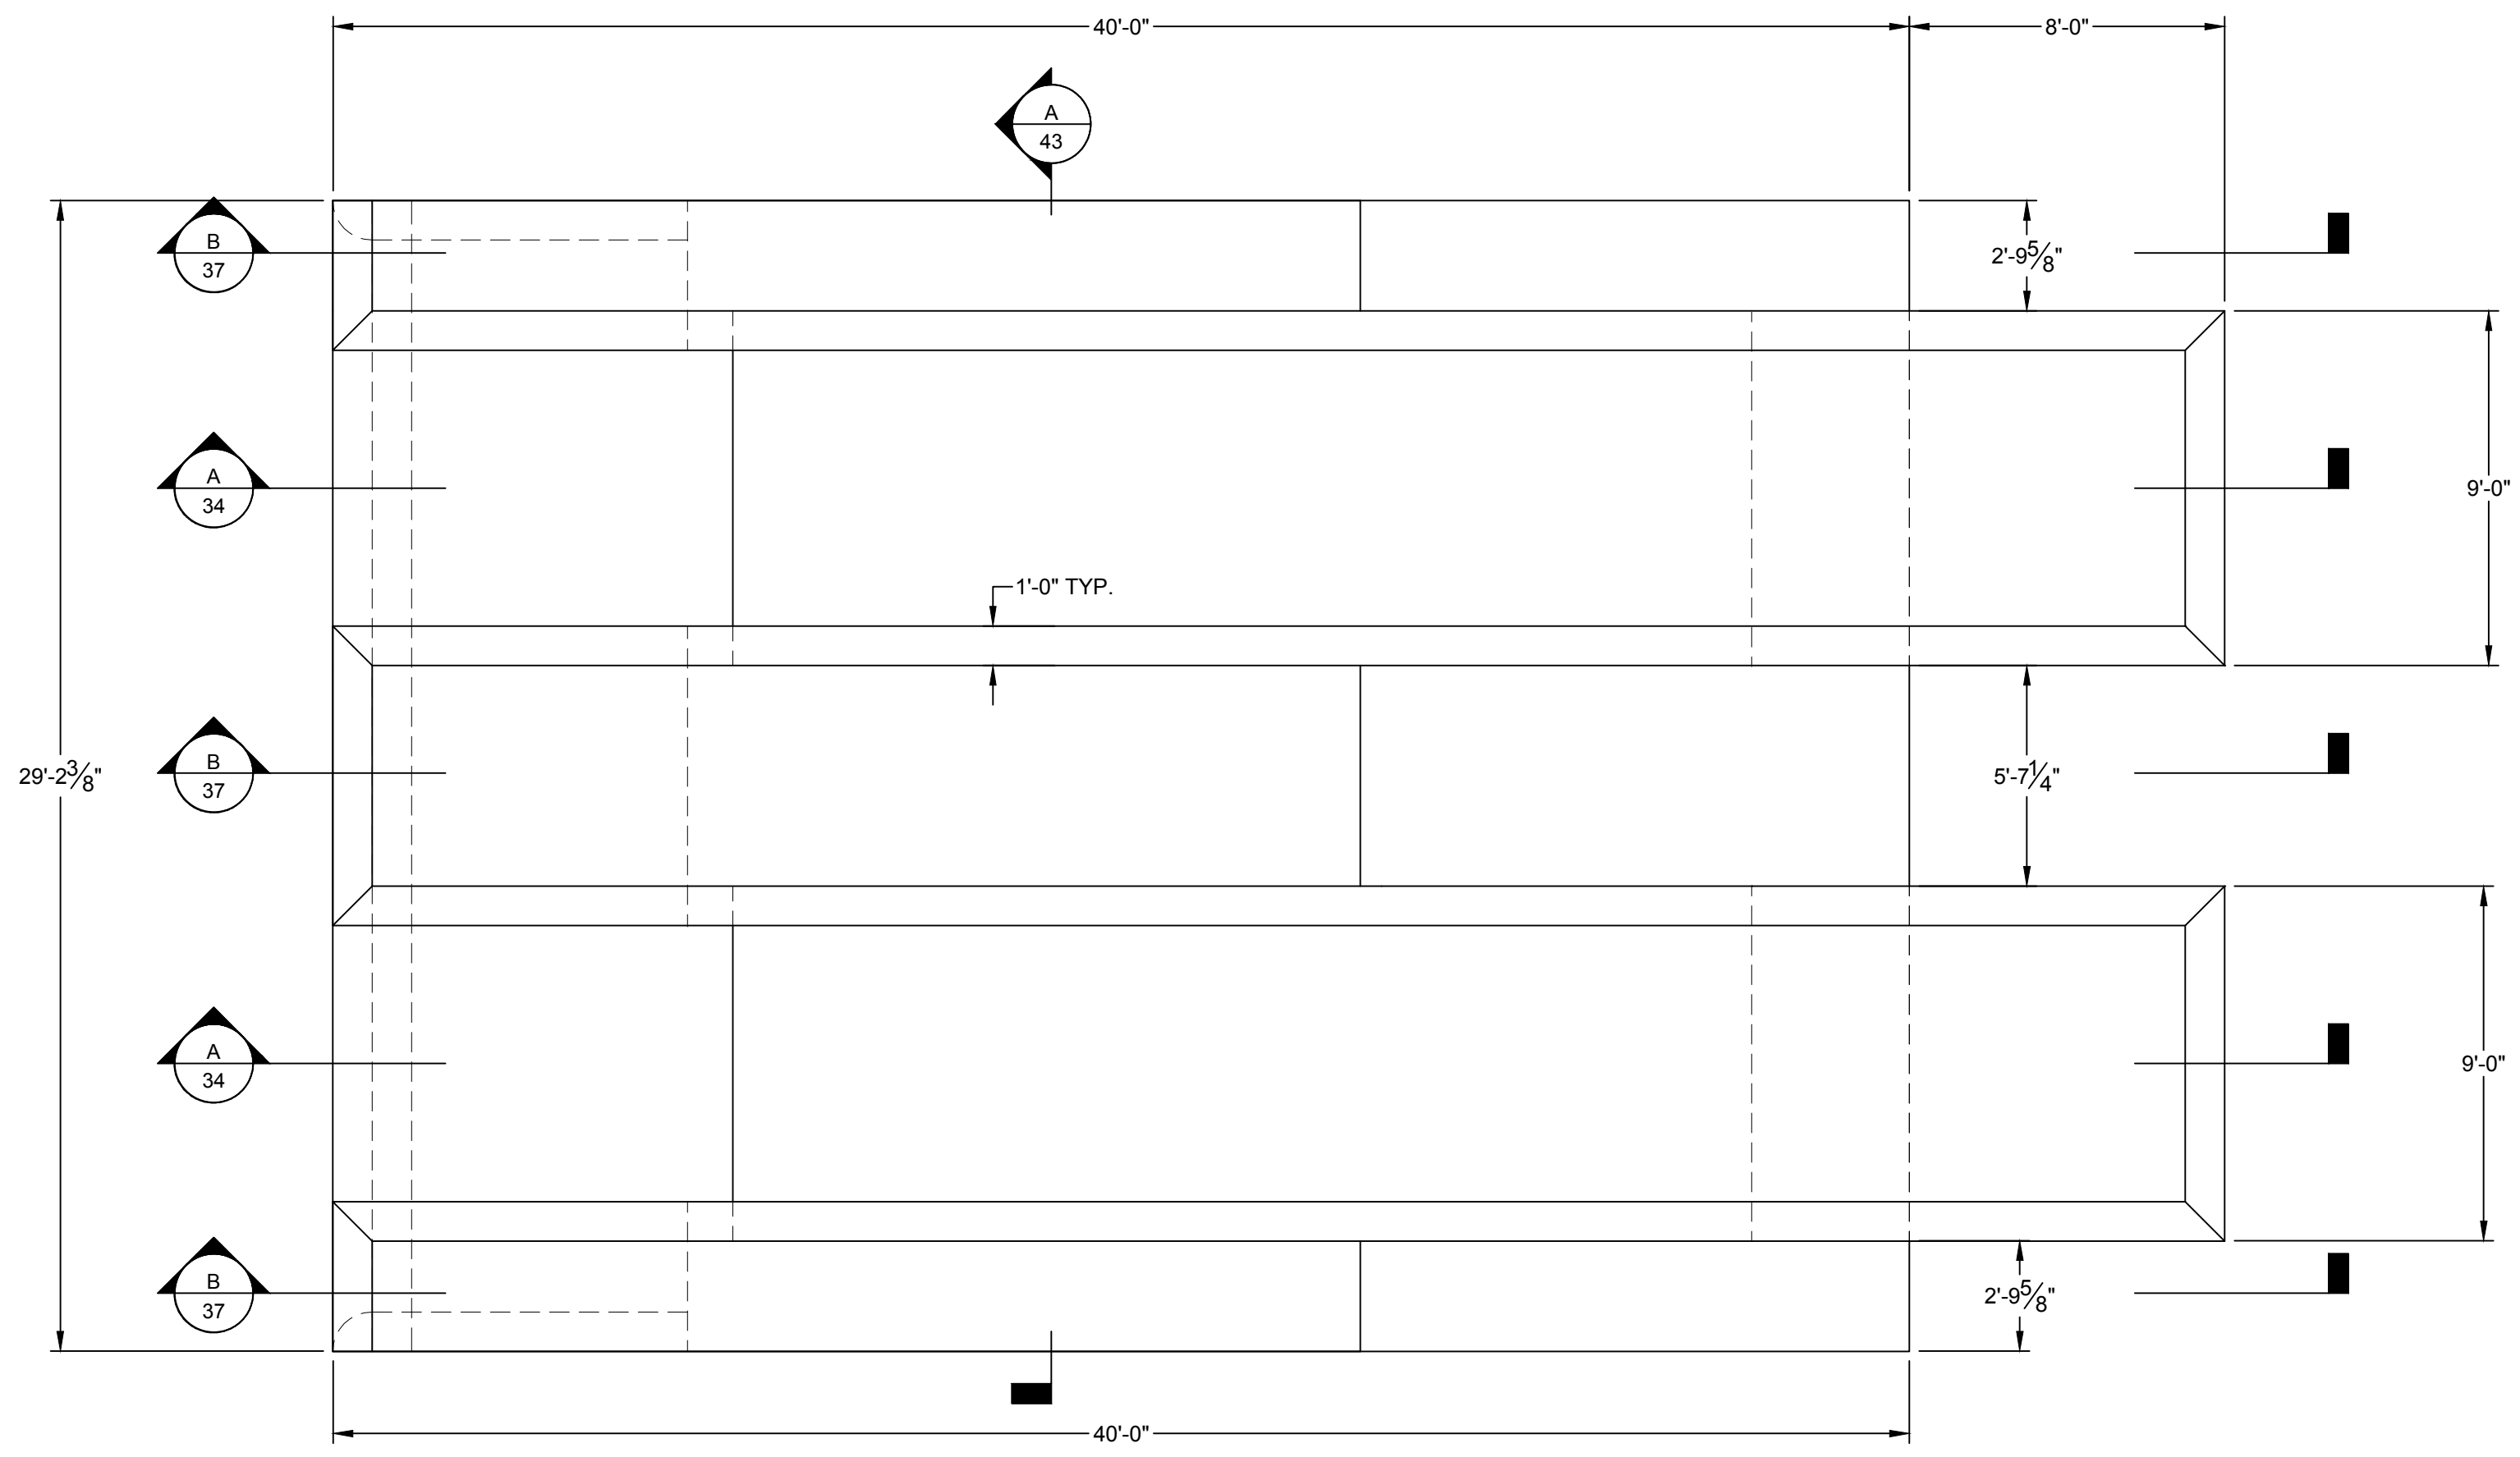
2 SEGMENT H1 SLAB PLAN
 SCALE: 1/4"=1'-0"

NOTE: SEGMENT H1 & H2 SIMILAR
