Addendum Number 3

Lake Peachtree Spillway Replacement Project

United Consulting is pleased to submit this report of the Ground Penetrating Radar Survey at the **Lake Peachtree Dam** located in Peachtree City, Fayette County, Georgia. This report includes a review of the scope of work and a summary of the subsurface conditions encountered.

CONSTRUCTION PLANS FOR LAKE PEACHTREE SPILLWAY REPLACEMENT PROJECT

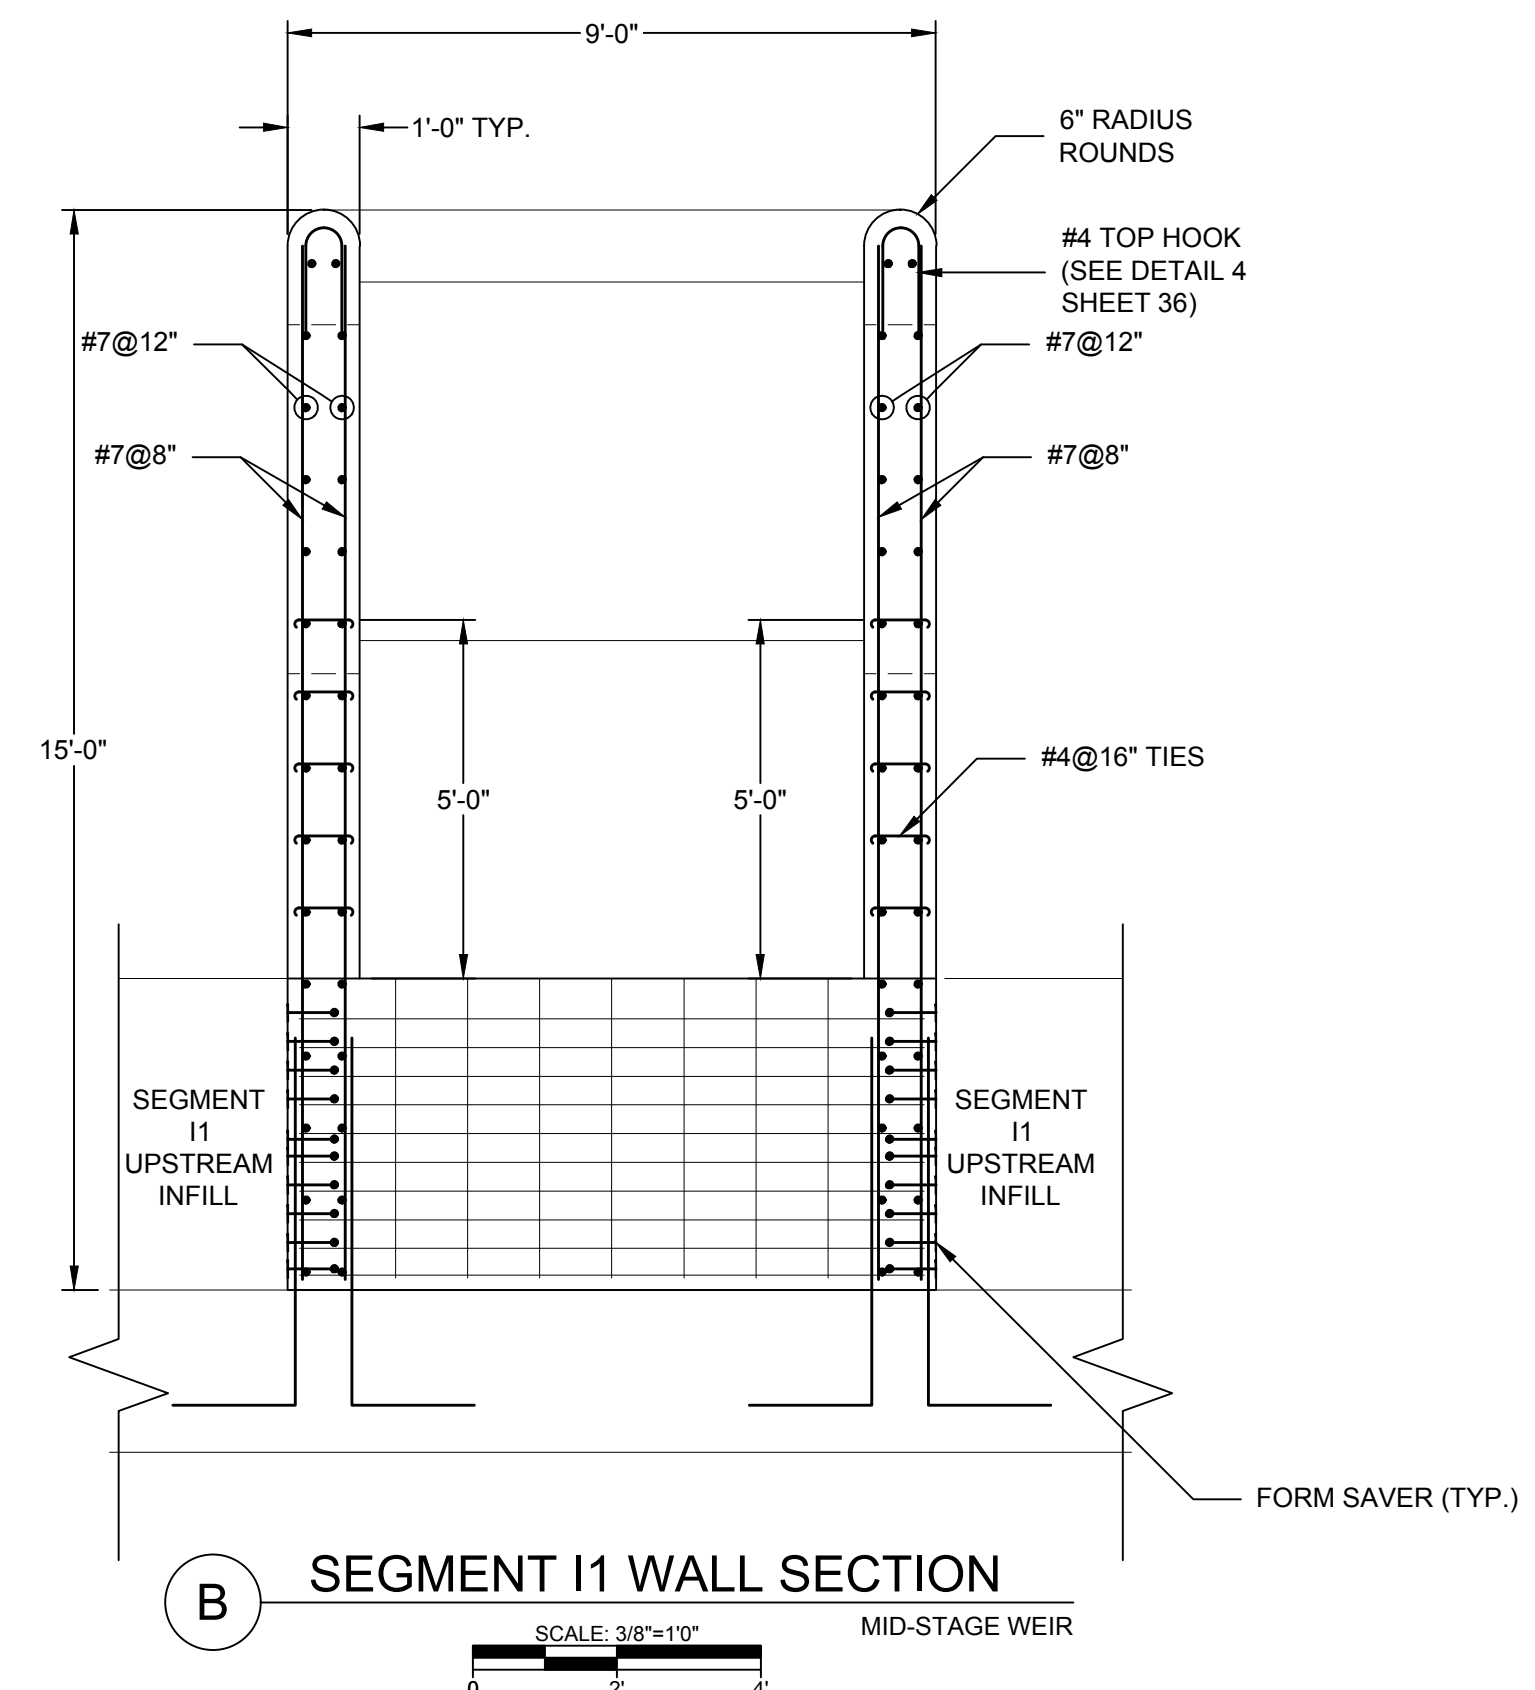
B SEGMENT I1 WALL SECTION
MID-STAGE WEIR
SCALE: 3/8"=1'0"
FORM SAVER (TYP.)

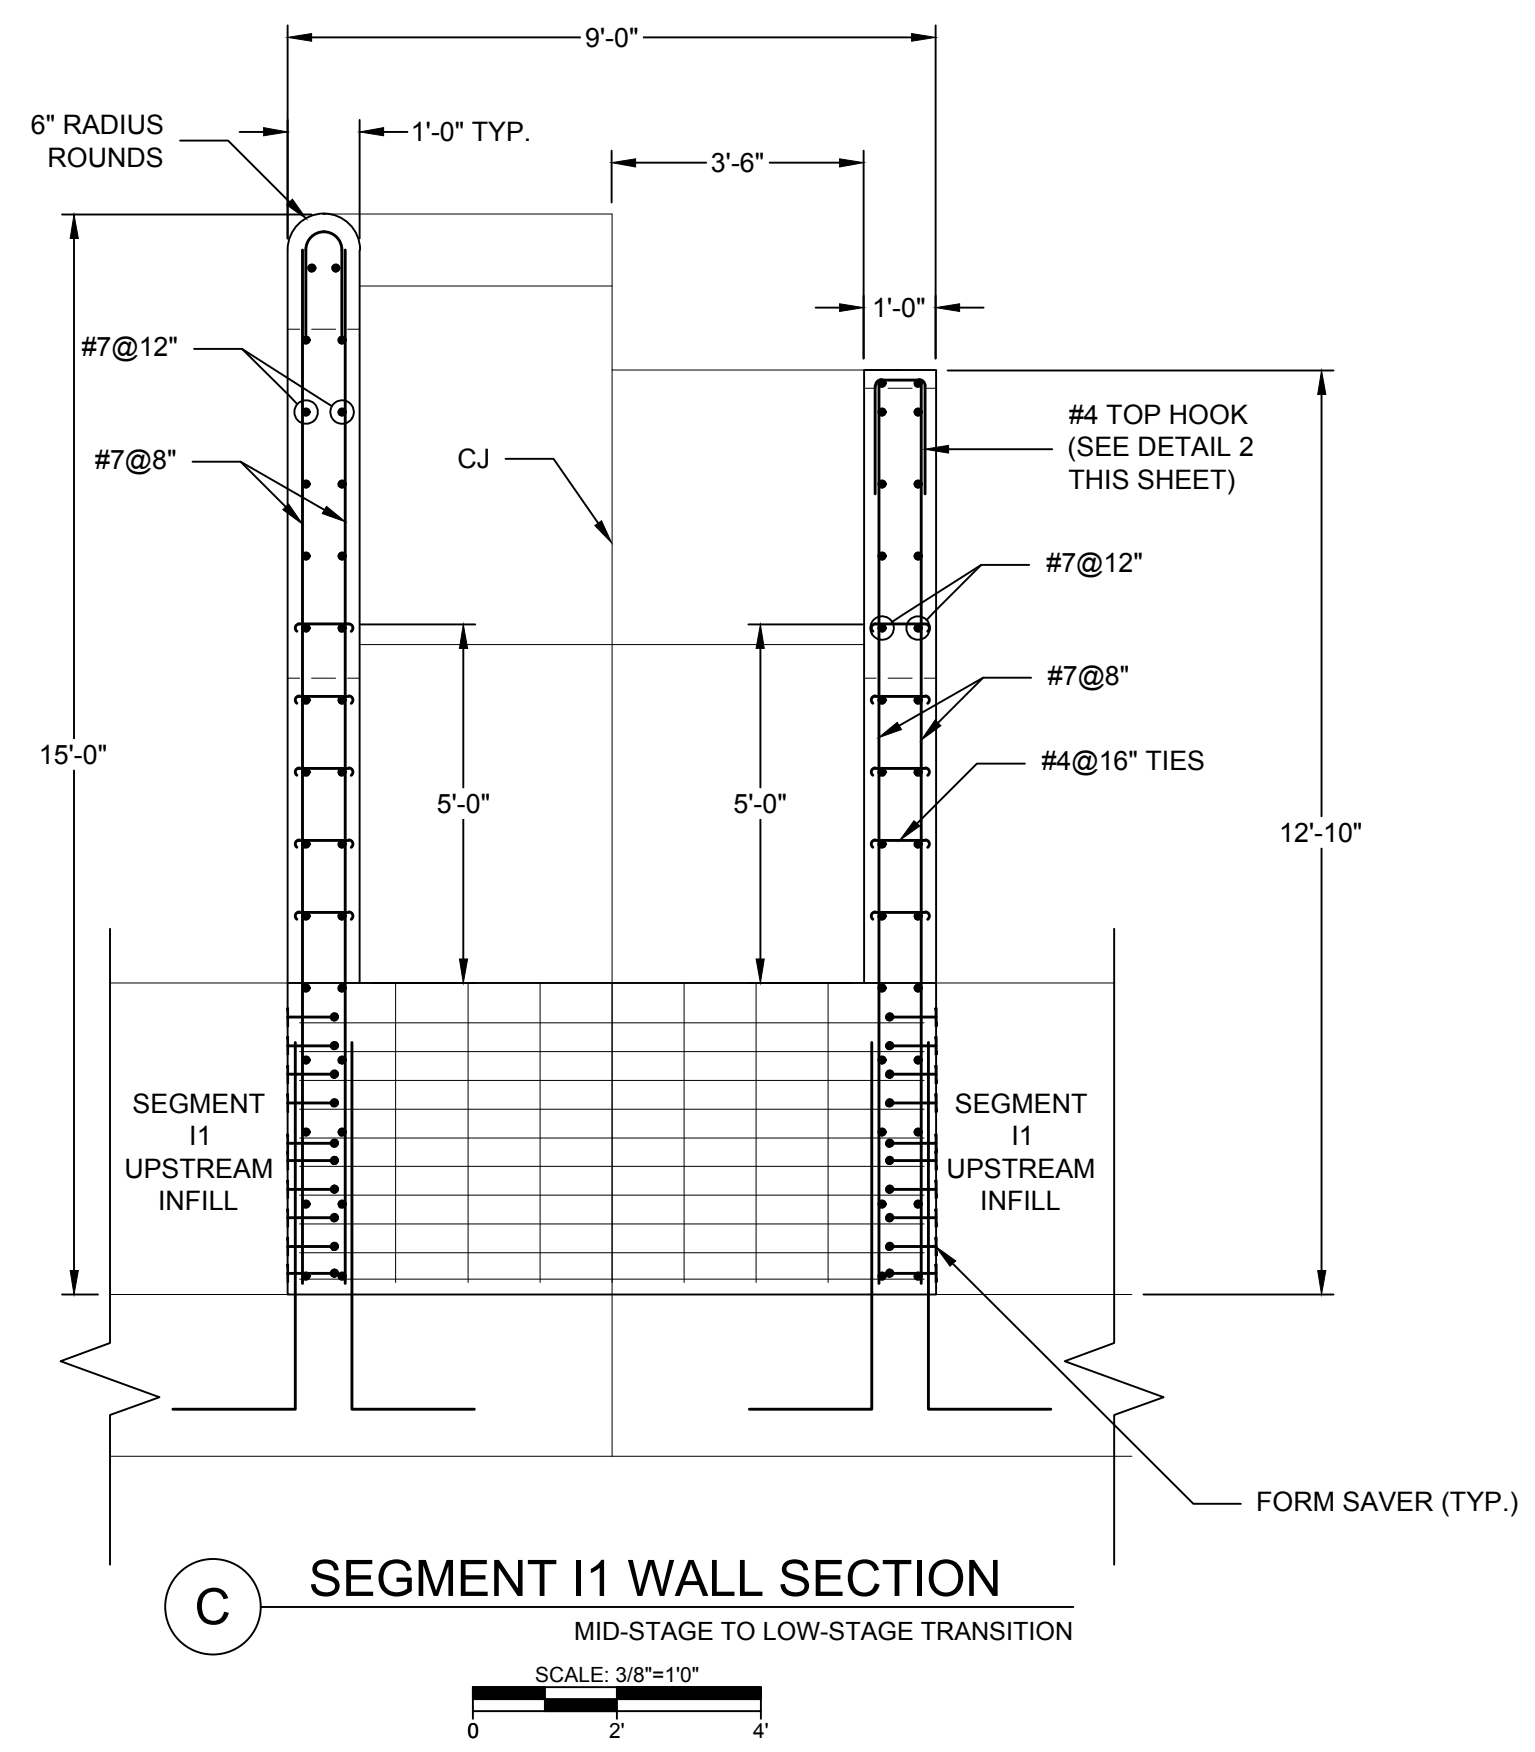
C SEGMENT I1 WALL SECTION
MID-STAGE TO LOW-STAGE TRANSITION
SCALE: 3/8"=1'0"
FORM SAVER (TYP.)

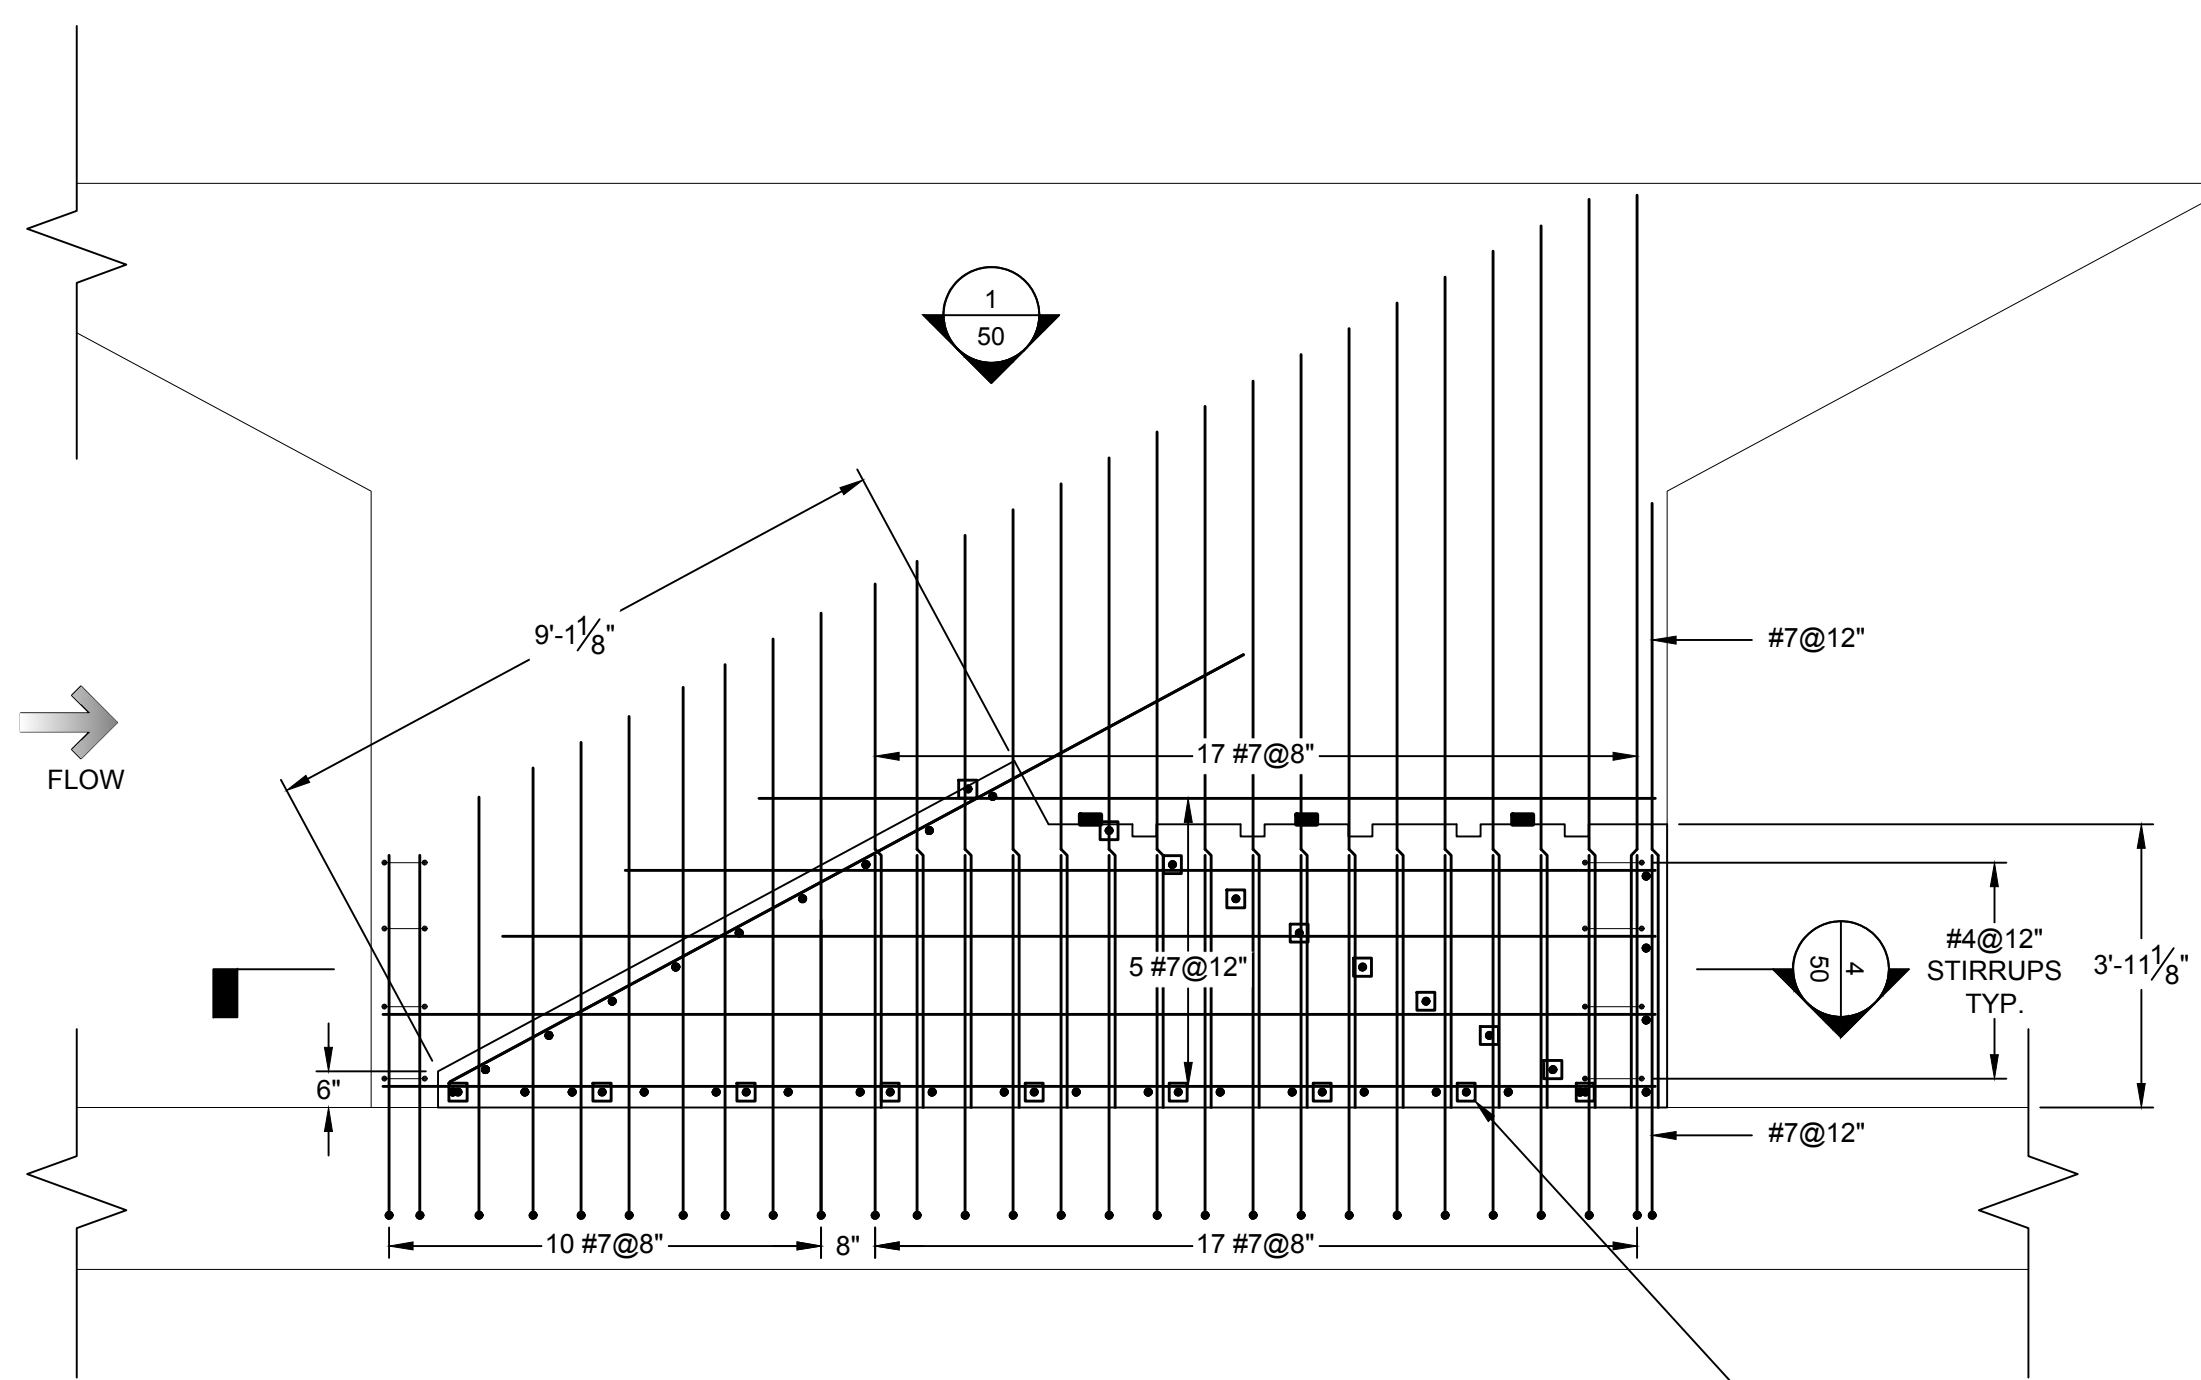
3 SEGMENT I1 DOWNSTREAM RAMP BASE 1 SECTION
SCALE: 3/8"=1'0"
0 2 4

HORIZONTAL FORM SAVER (TYP.) TO BE INSTALLED IN AREA(S) SHOWN IN SEGMENT G1 DOWNSTREAM RAMP BASE 1. SEE FURTHER DETAILS SHEETS 37 AND 38. FORM SAVERS REQUIRED TO STRUCTURALLY TIE SEGMENT G1 DOWNSTREAM RAMP BASE 1 TO SEGMENT G1 INFILL(S).

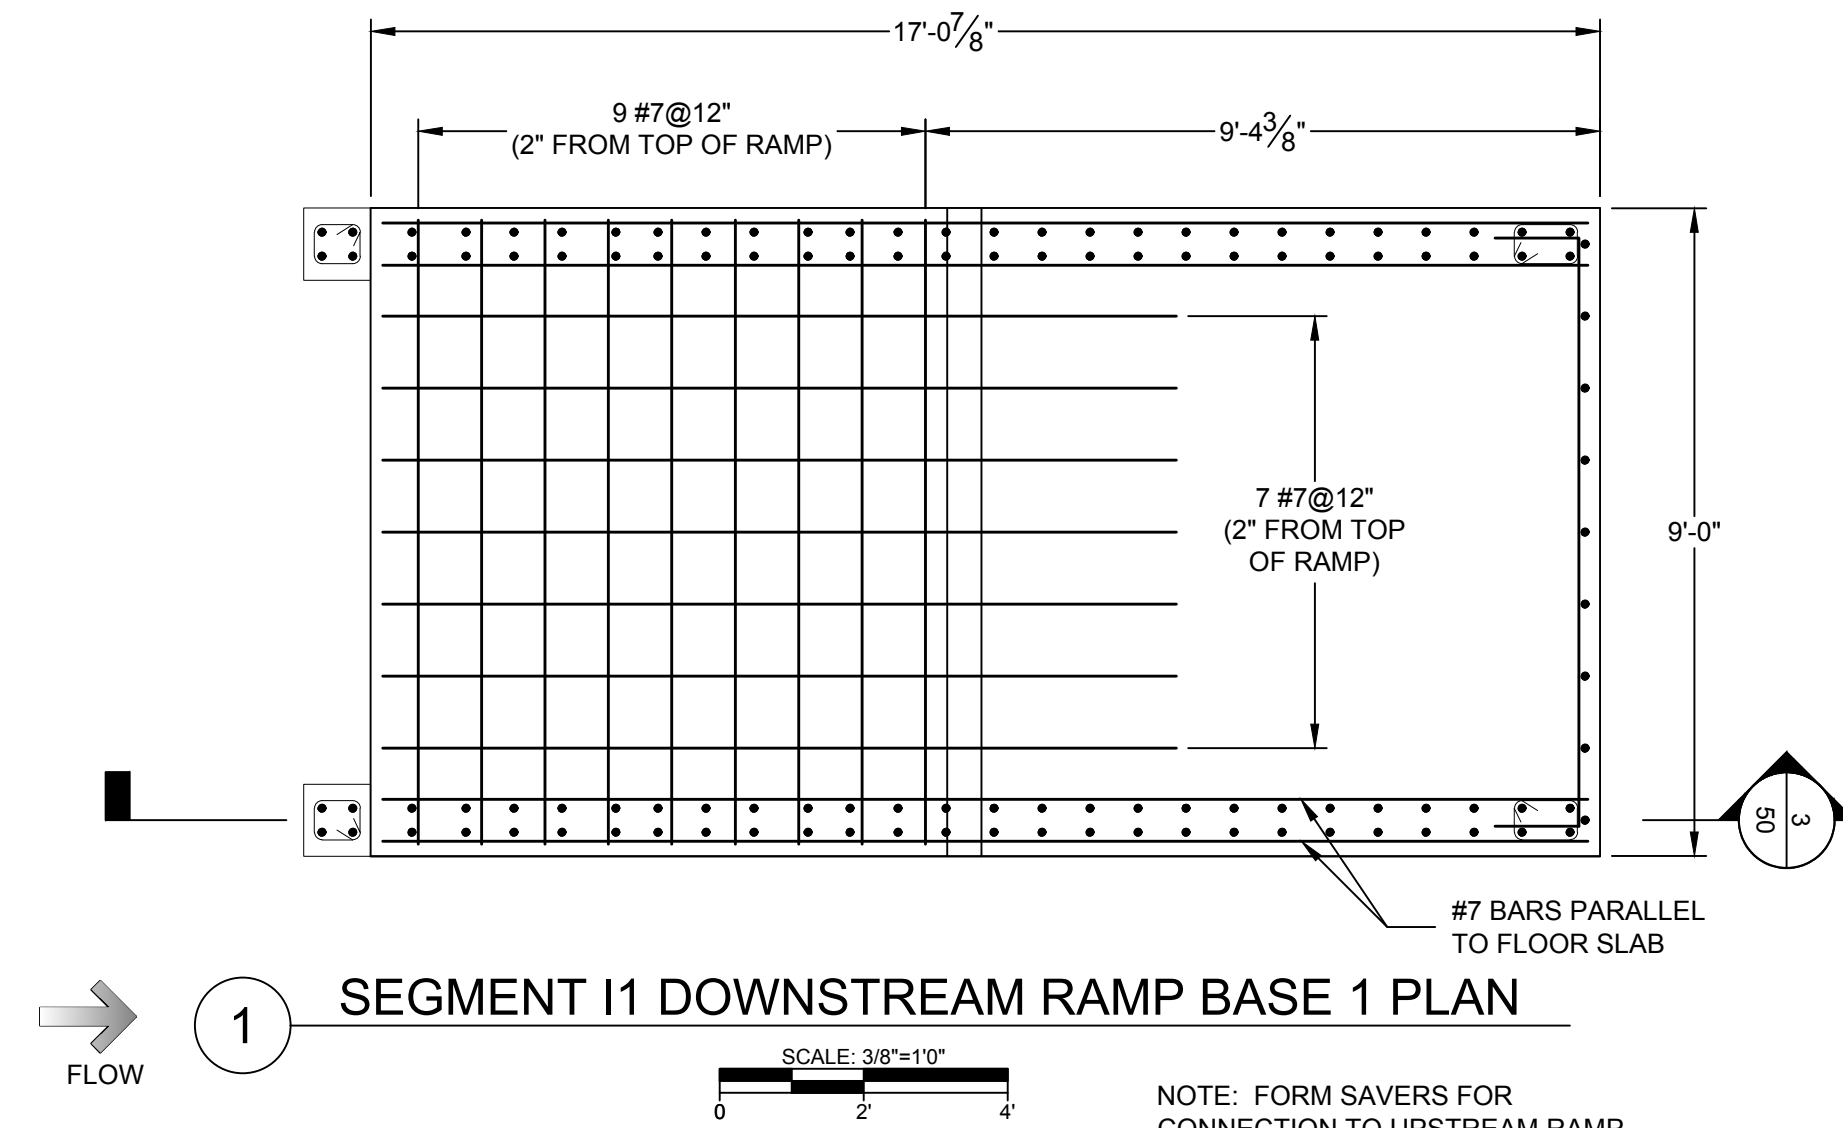
1 SEGMENT I1 DOWNSTREAM RAMP BASE 1 PLAN
SCALE: 3/8"=1'0"
0 2 4

NOTE: FORM SAVERS FOR CONNECTION TO UPSTREAM RAMP NOT SHOWN FOR CLARITY.

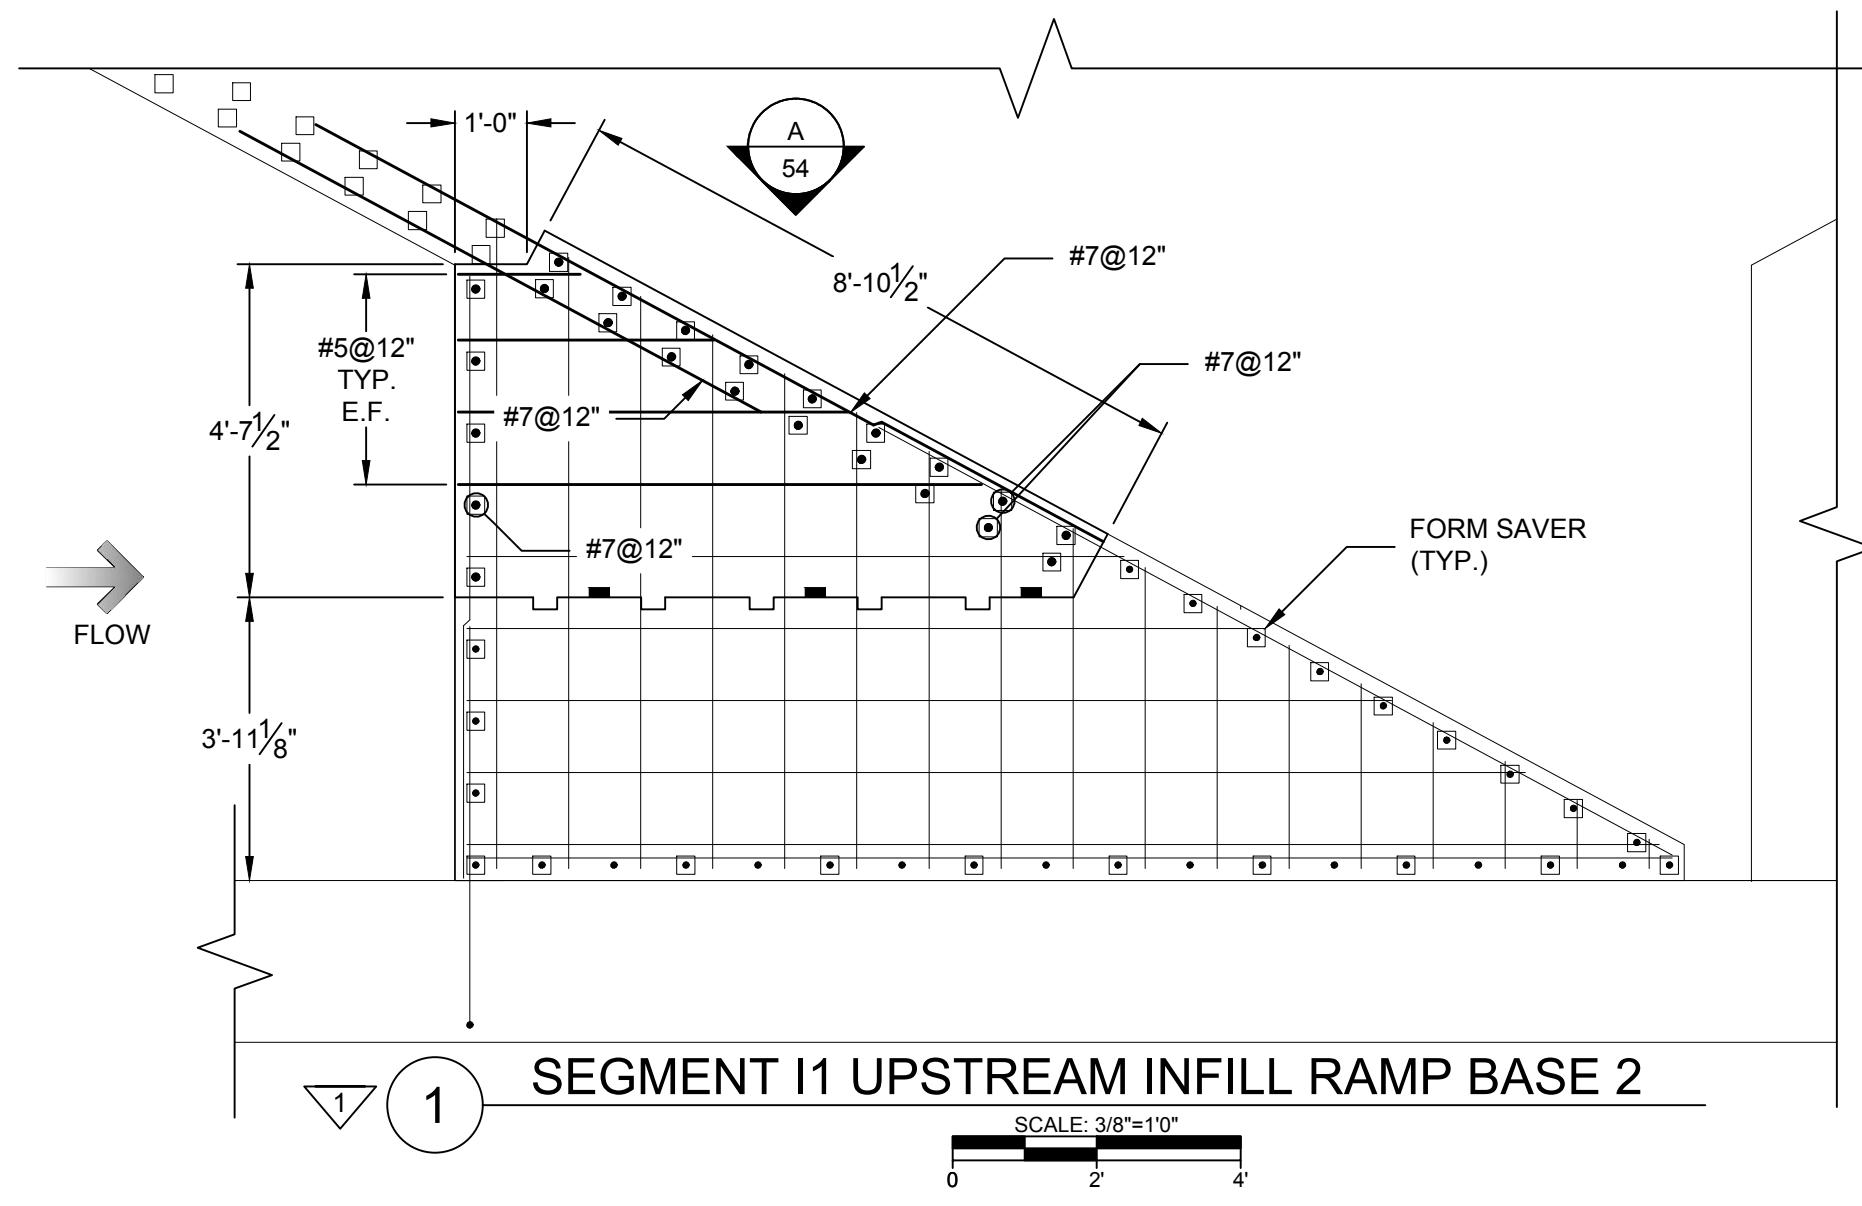
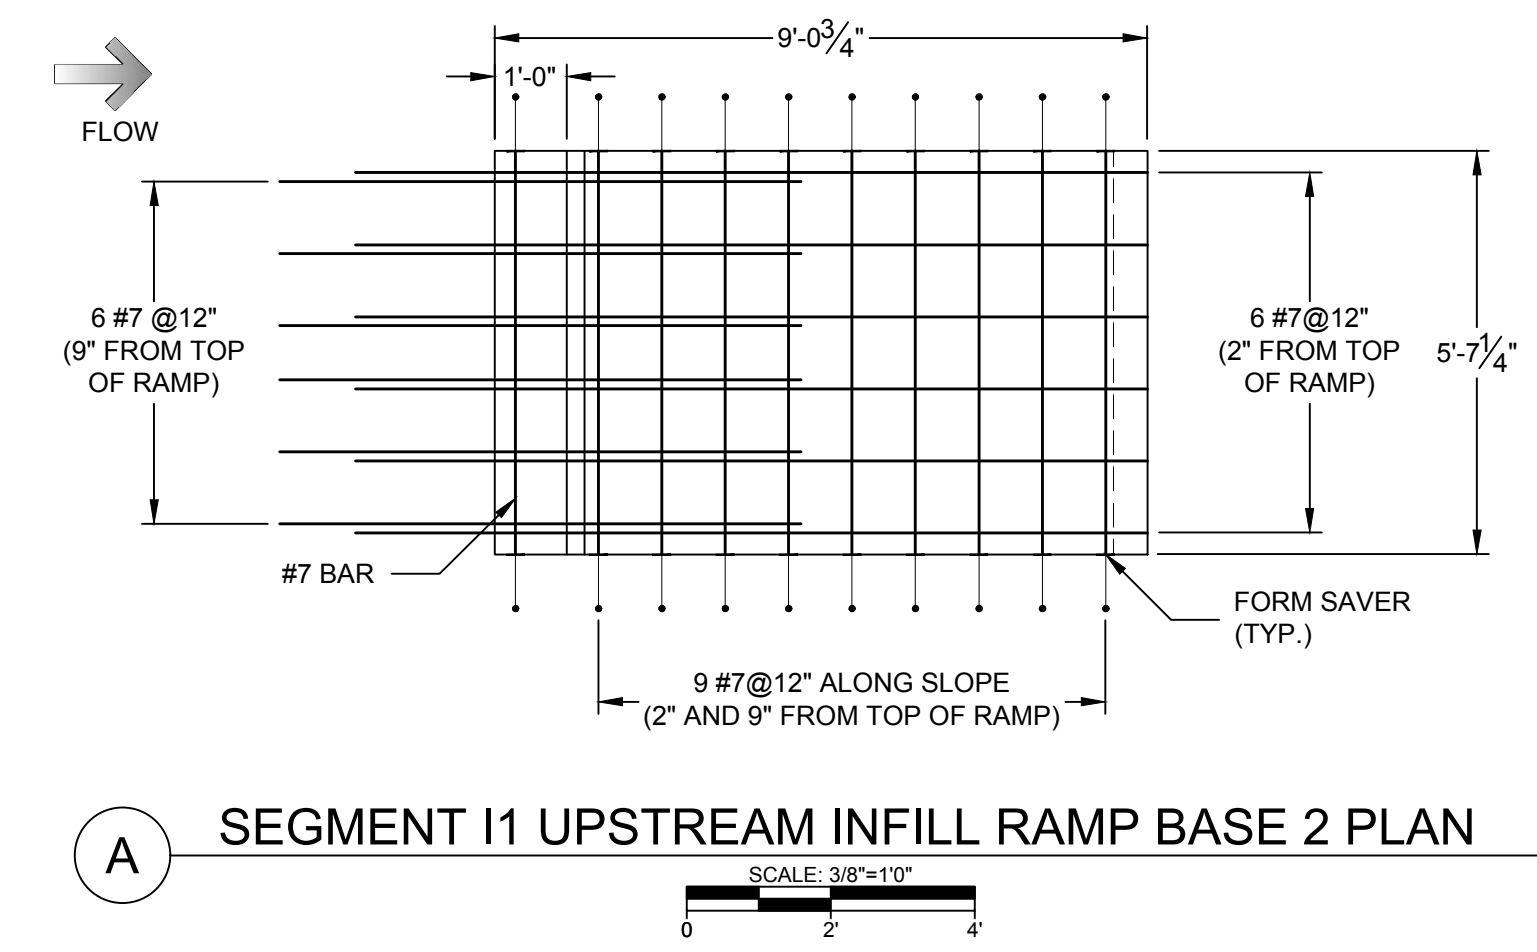
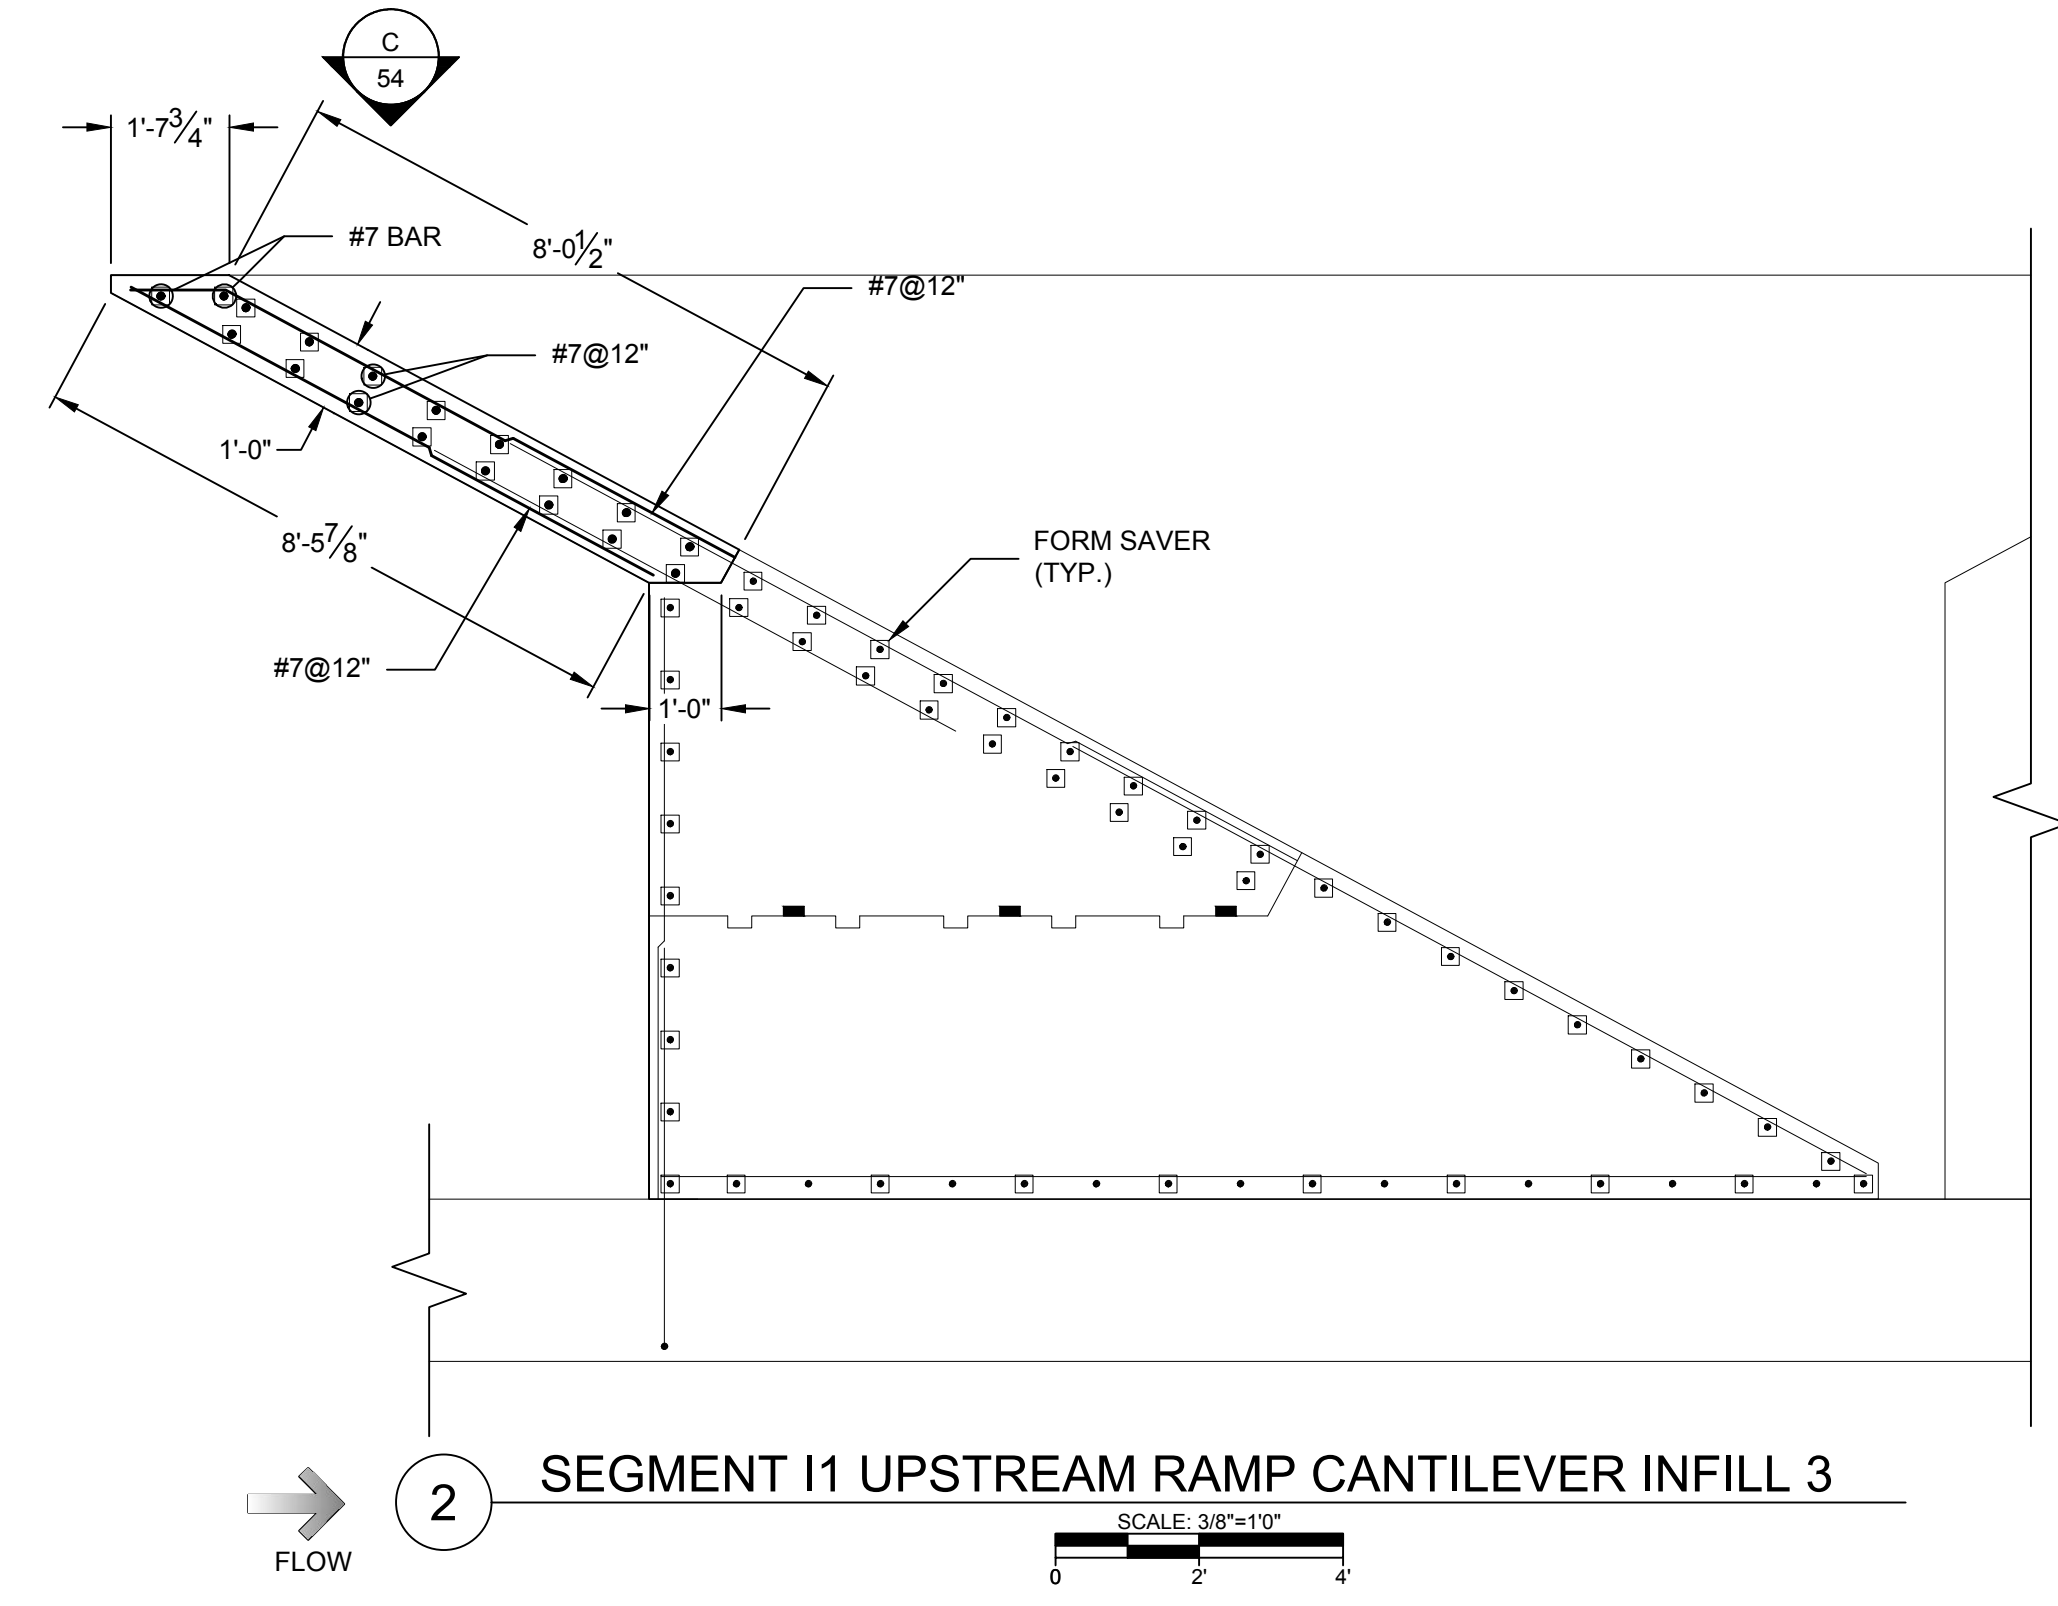
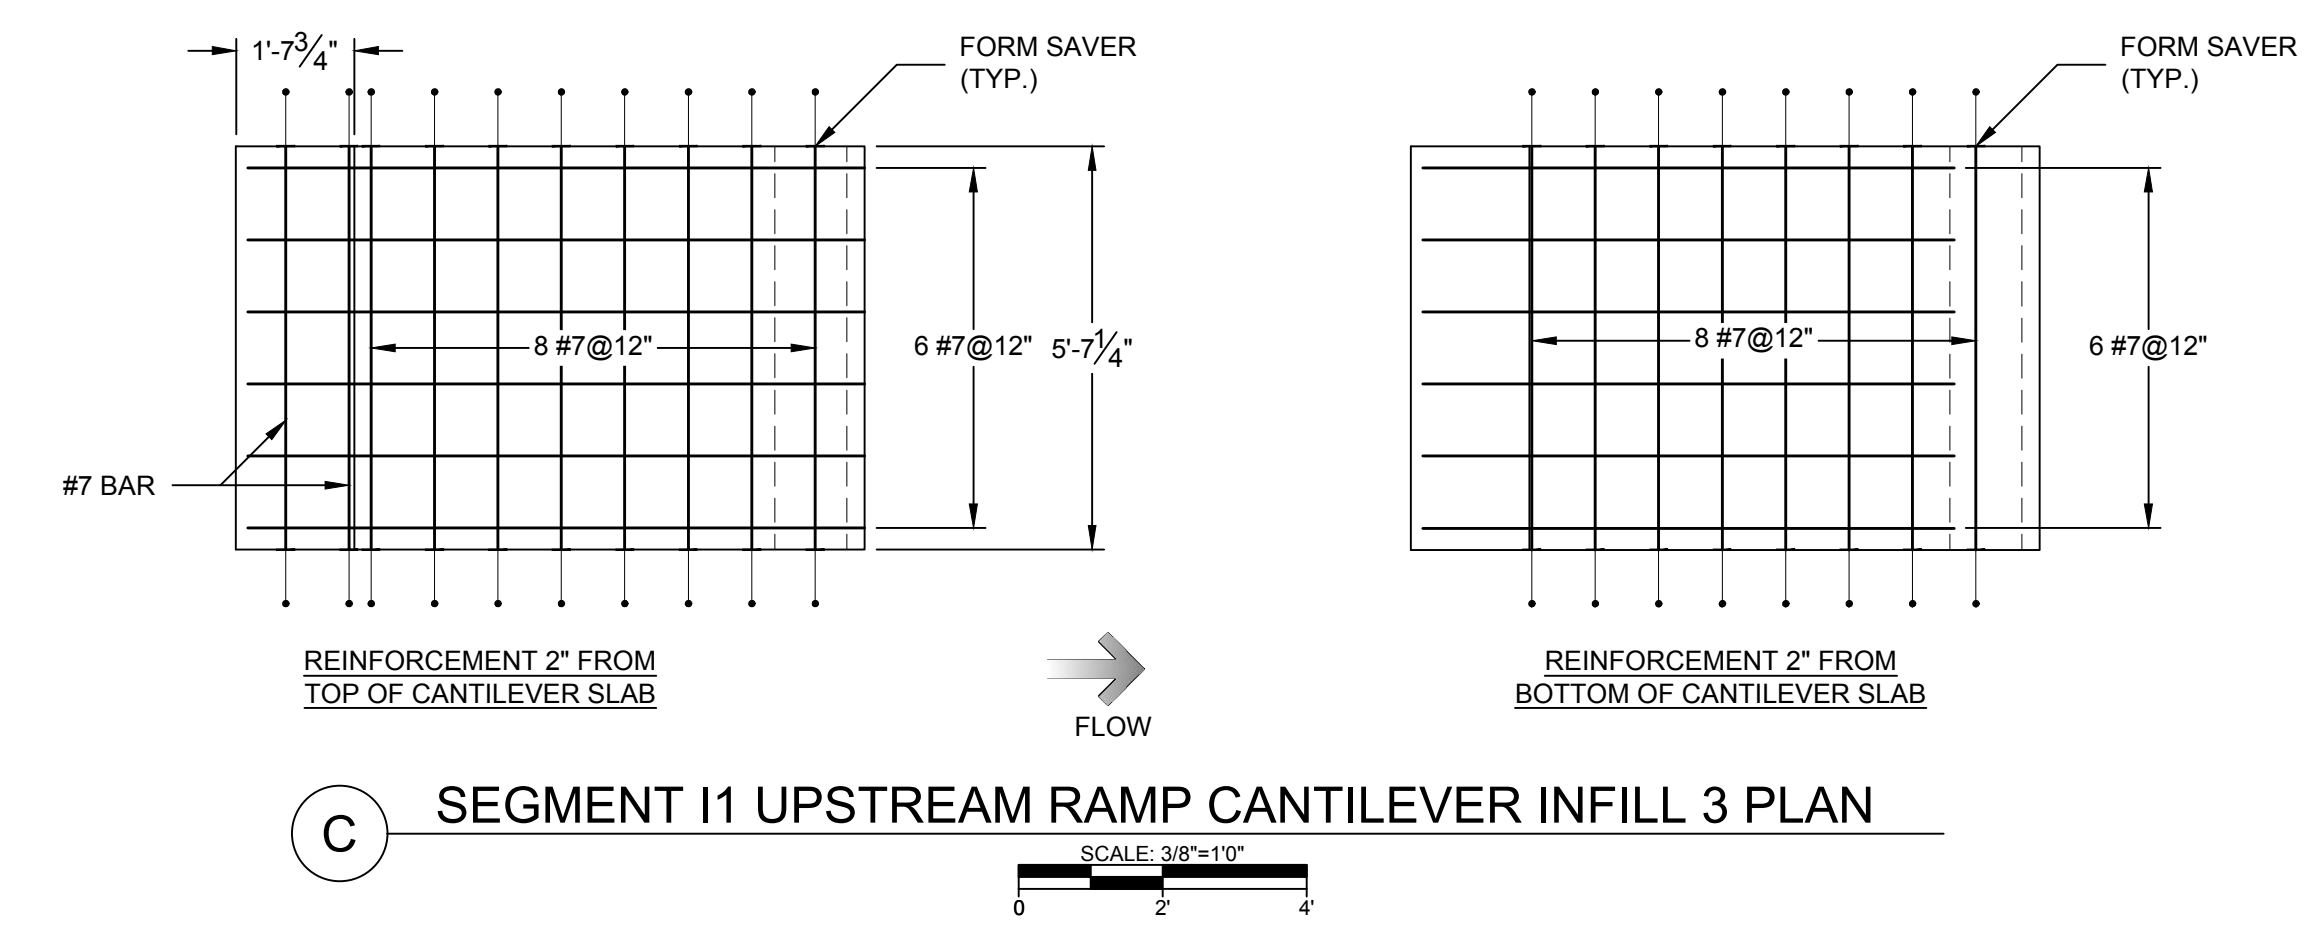
CONSTRUCTION PLANS FOR
 LAKE PEACHTREE SPILLWAY
 REPLACEMENT PROJECT
 PEACHTREE CITY, GEORGIA
**LOW STAGE UPSTREAM RAMP
 REINFORCEMENT DETAILS
 SEGMENT I1**

NOTE: FOR CONTRACTION JOINT BETWEEN PIANO KEY SEGMENTS I1 AND H2, PROVIDE 2-INCHES CLEARANCE FOR REINFORCEMENT EACH SIDE OF JOINT.

ADD: Attached Plan Sheets 1, 3, 11, 14, 15, 16, 29, 33, 34, 35, 36, 38, 39, 40, 43, 44, 45, 46, 47, 49, 50, 51, 52, 54, 65
Note: Additional temperature and shrinkage reinforcing steel was added in the ramp/infill sections of the piano key weirs. Sheets with material changes were notated as Revised per Addendum No. 3. Sheets that were inadvertently affected by the changes are included, but do not contain revision clouds/call-outs. The additional reinforcing typically includes the addition of #5@12" spacing, #7@12" spacing, and #4@24" spacing depending on the specific locations of reinforcing.
